YAKIMA BASIN
FISH AND WILDLIFE
RECOVERY BOARD

Geomorphic Assessment of the Little Naches River Mainstem

prepared for the Yakima basin Fish and Wildlife Recovery Board
by
WPD, LLC, May 2017

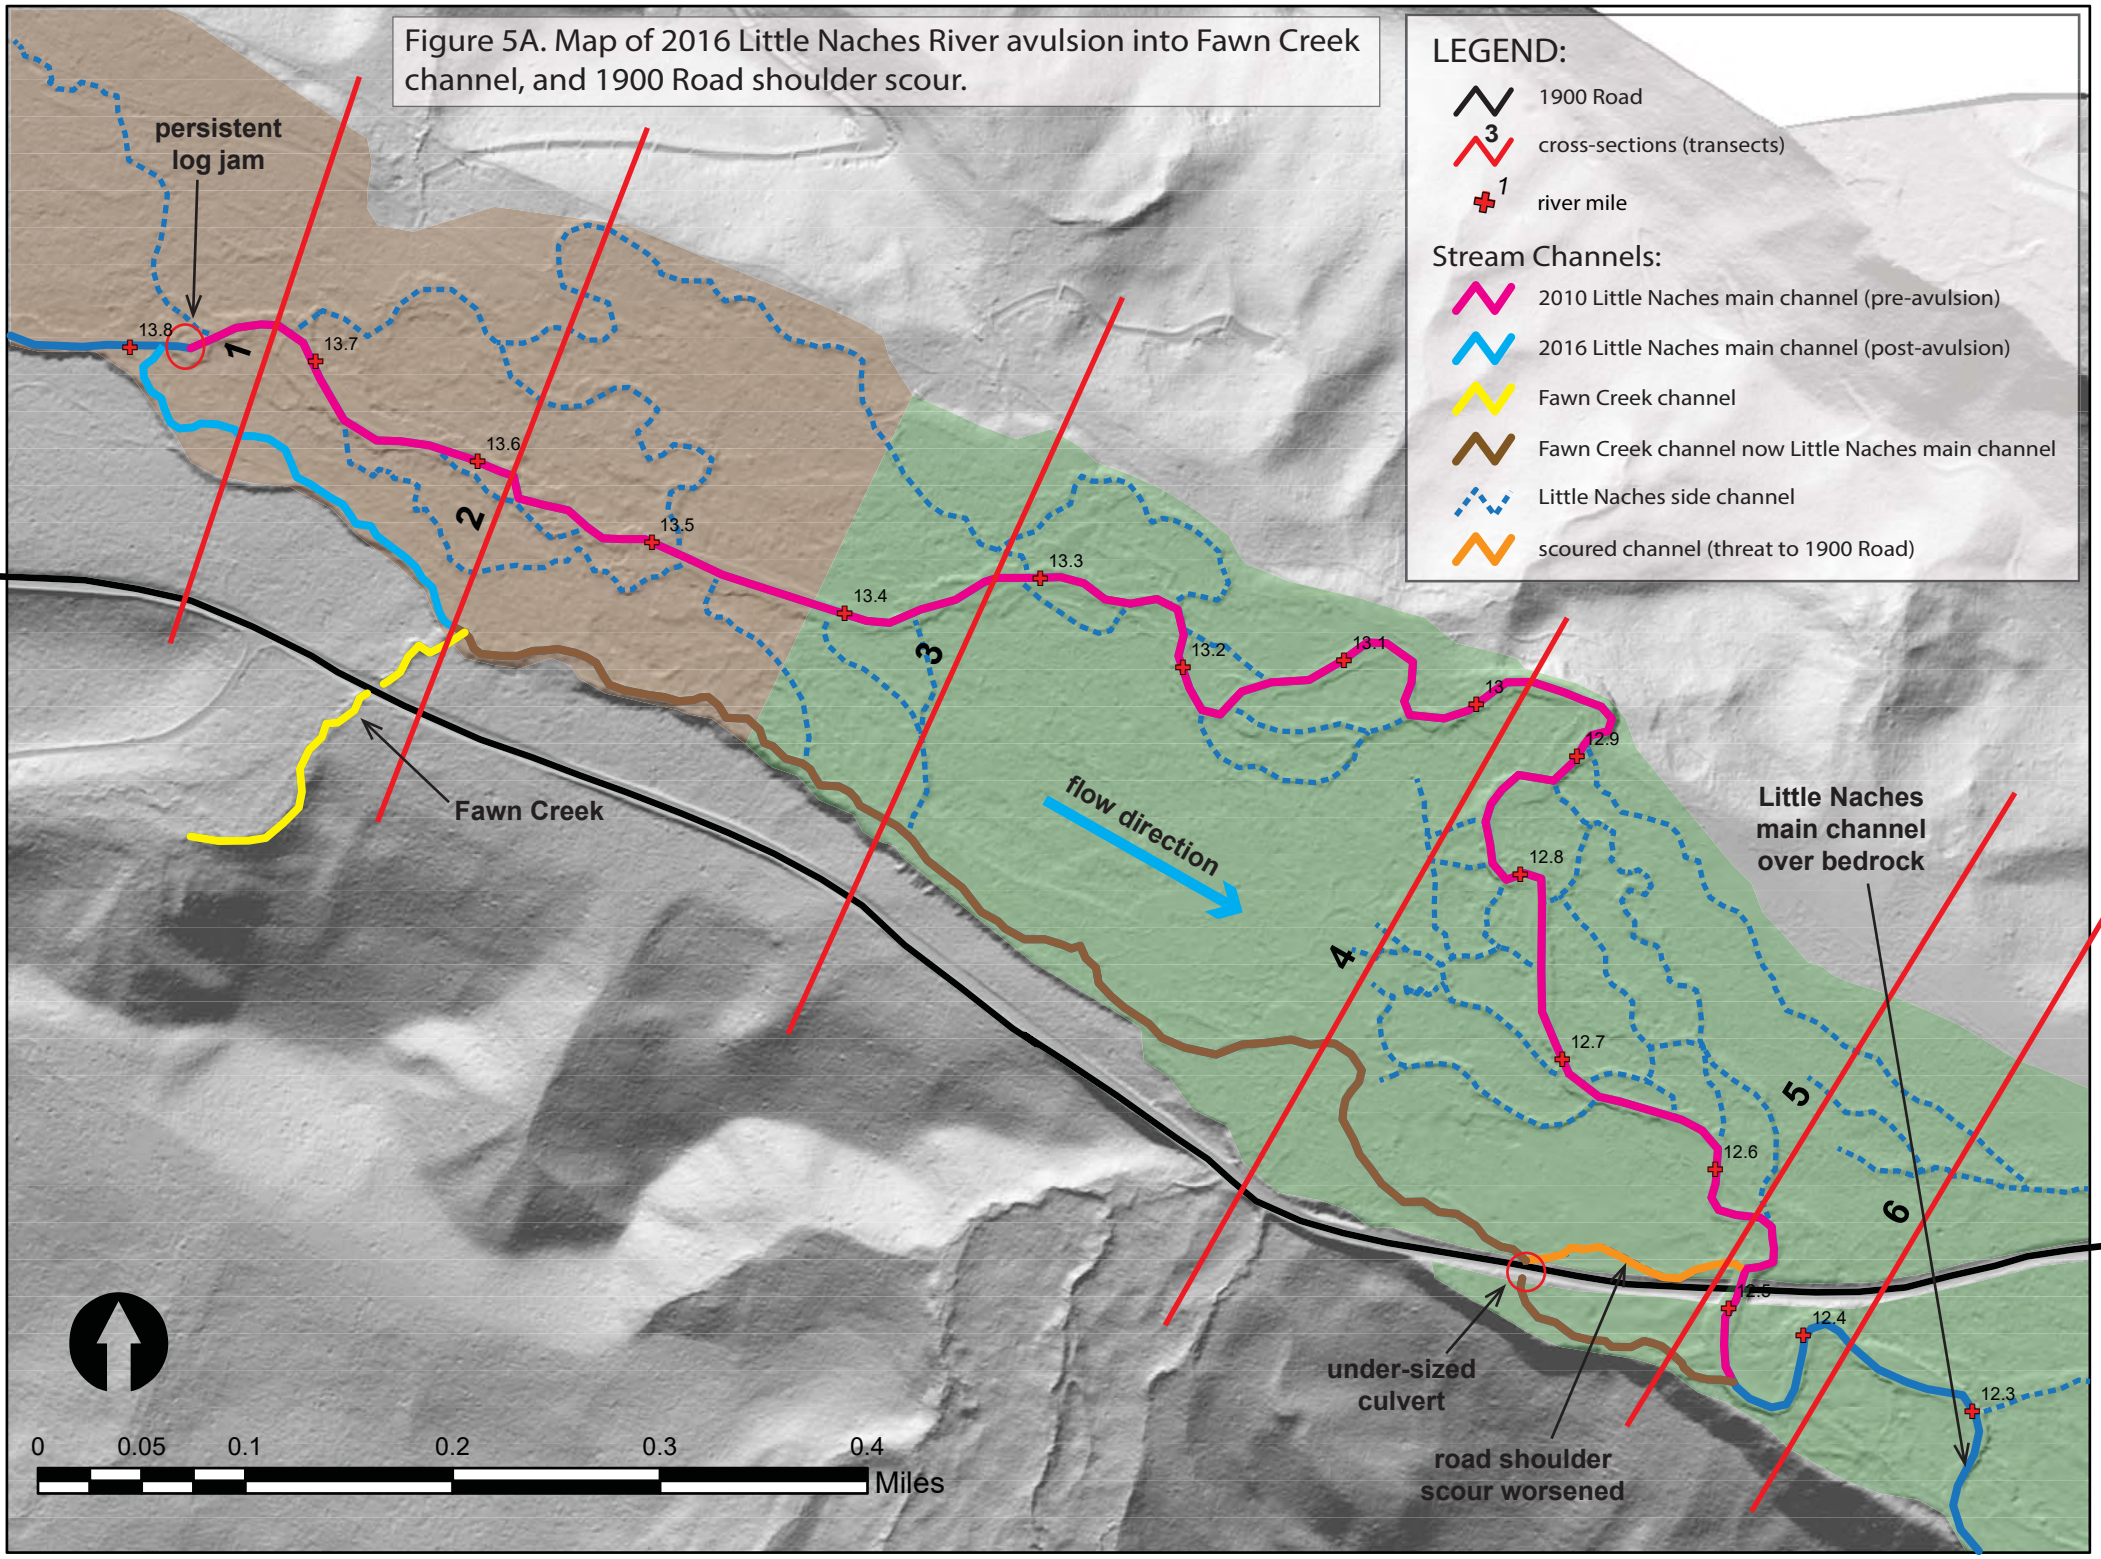
1900 Road, intended only for Fawn Creek (Figures 5A and 5B), has been overwhelmed by the full flow of the Little Naches during low to moderate flow periods. During high and very high flows, many secondary channels re-route water to the former channel of the Little Naches River, and this culvert is largely bypassed. Flow has been redirected along the north side of the 1900 Road at least since 2013 (Torretta, written communication), incising a channel, eroding the road shoulder, and causing damage to the road immediately upstream of the bridge over the Little Naches. In 2016, baseflows through the culvert were high enough to create a presumed velocity barrier to fish, preventing summer/fall migrating chinook and potentially, bull trout, from reaching upstream spawning areas. Increasing conveyance capacity at this crossing would allow improved fish passage and reduce flows into the new channel along the road. However, it is unlikely that the Fawn Creek channel and the new roadside channel will be the persistent, “natural” alignment of the Little Naches main channel.

Figure 5A. Map of 2016 Little Naches River avulsion into Fawn Creek channel, and 1900 Road shoulder scour.

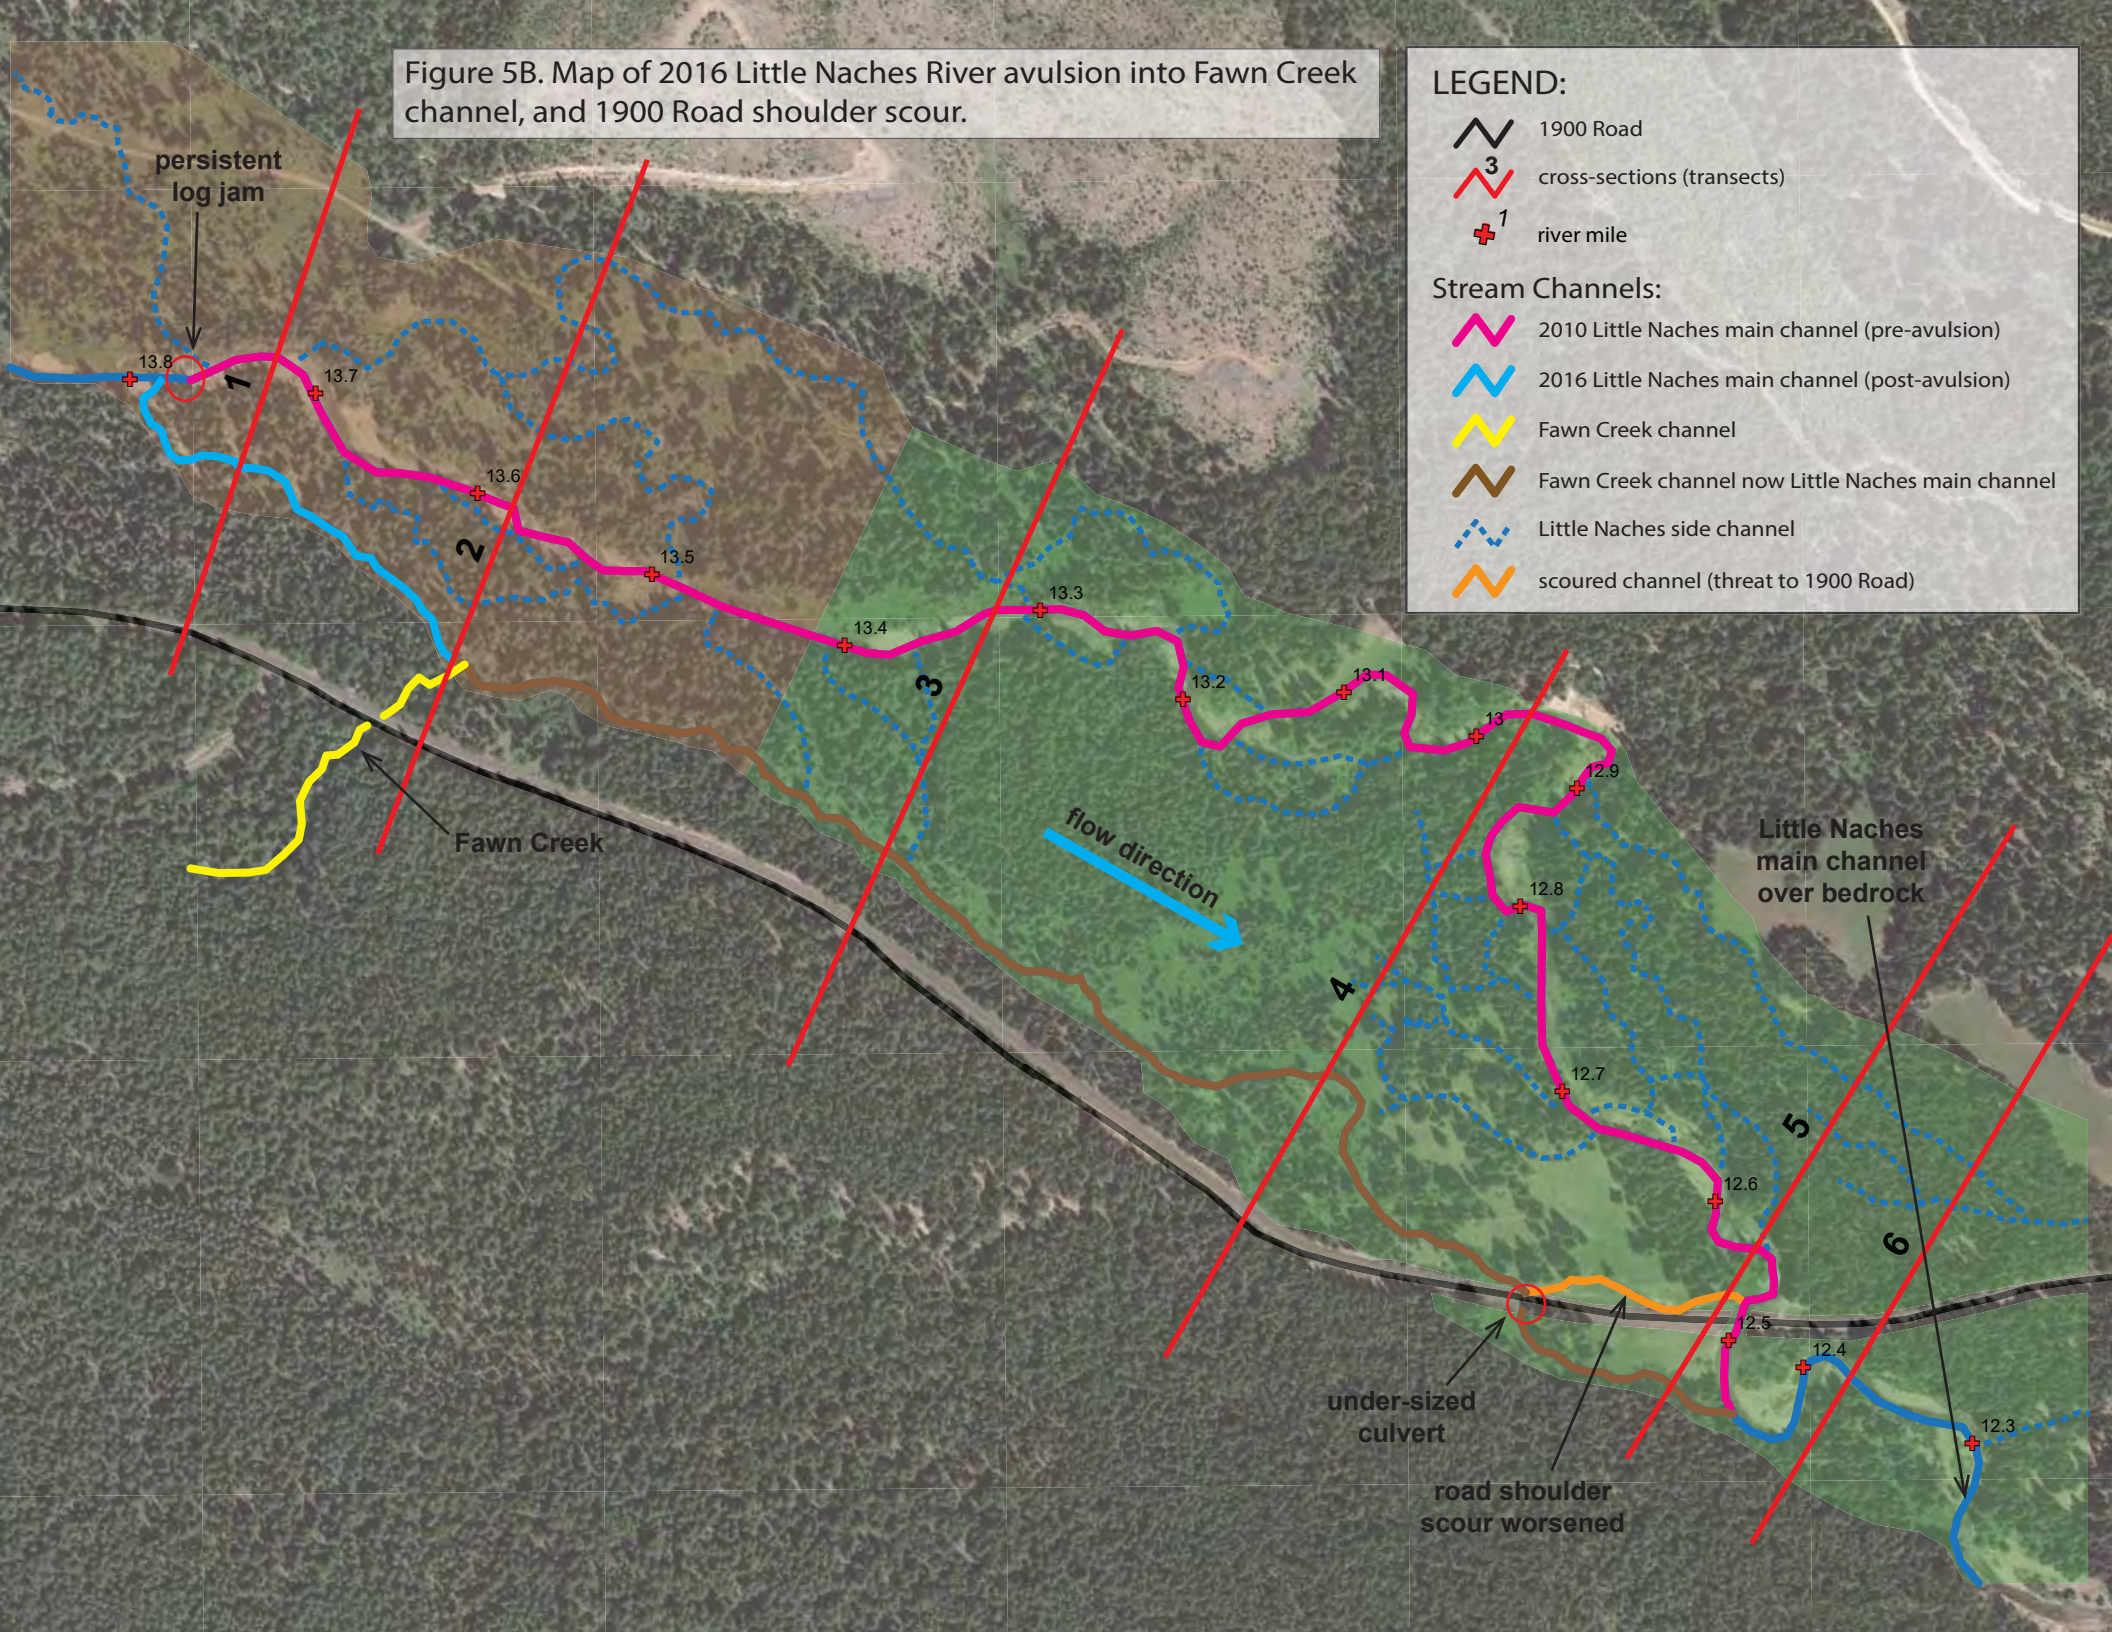
Figure 5B. Map of 2016 Little Naches River avulsion into Fawn Creek channel, and 1900 Road shoulder scour.

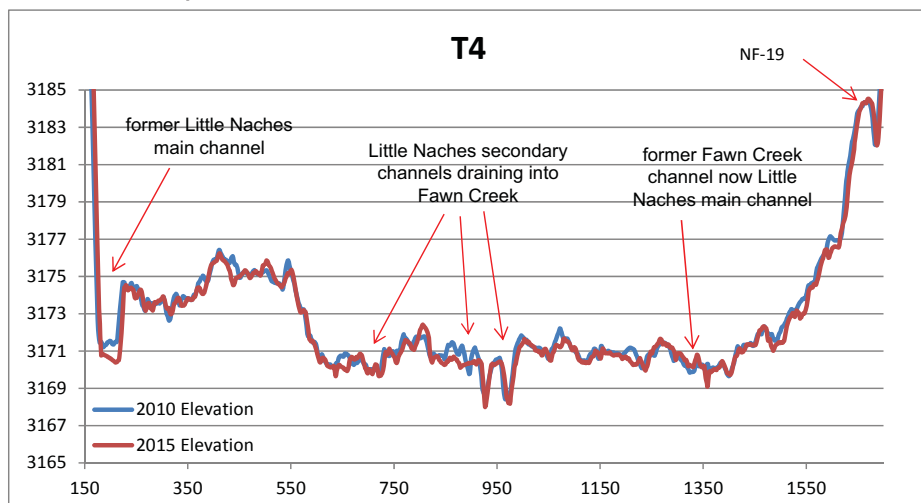
Figure 5F. Transect 4, showing the perched main channel of the Little Naches River, prior to the 2016 avulsion.

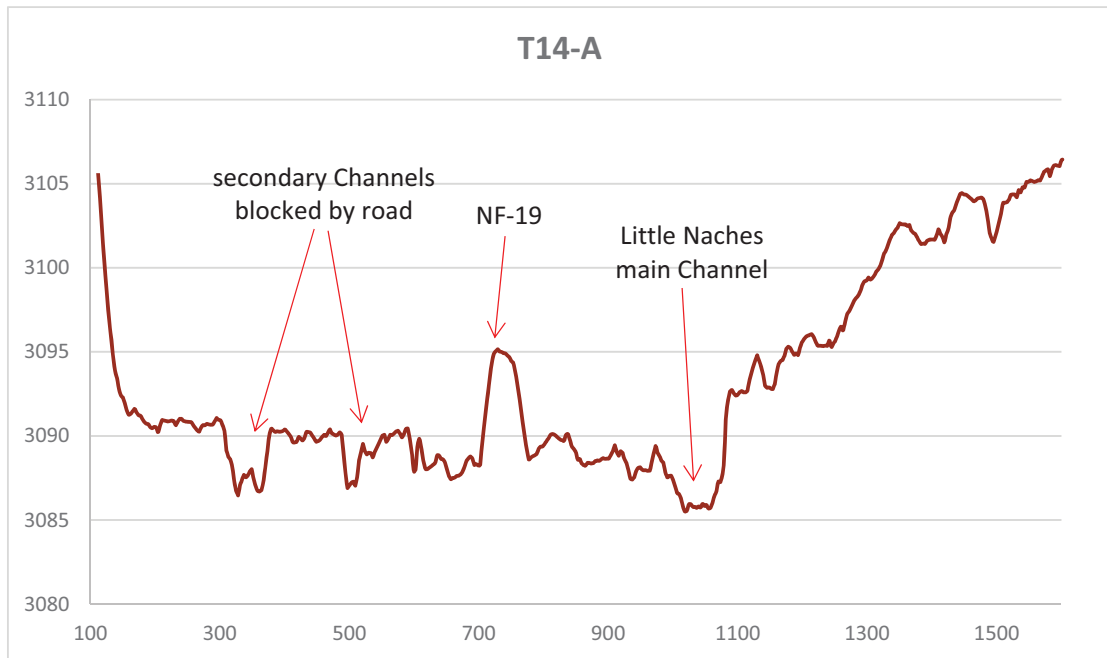
Figure 6D. Transect 14A, perpendicular to the floodplain, shows the 1900 Road prism and secondary channels blocked by it, as well as the S. F. Little Naches alluvial fan.

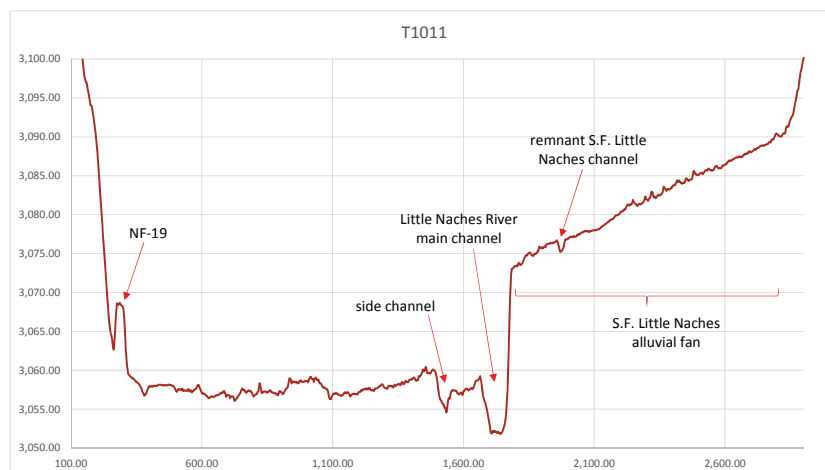
Figure 7E. Transect 1011, shows the Little Naches River channel, in its wider floodplain, attacking the toe of the S.F. Little Naches fan.

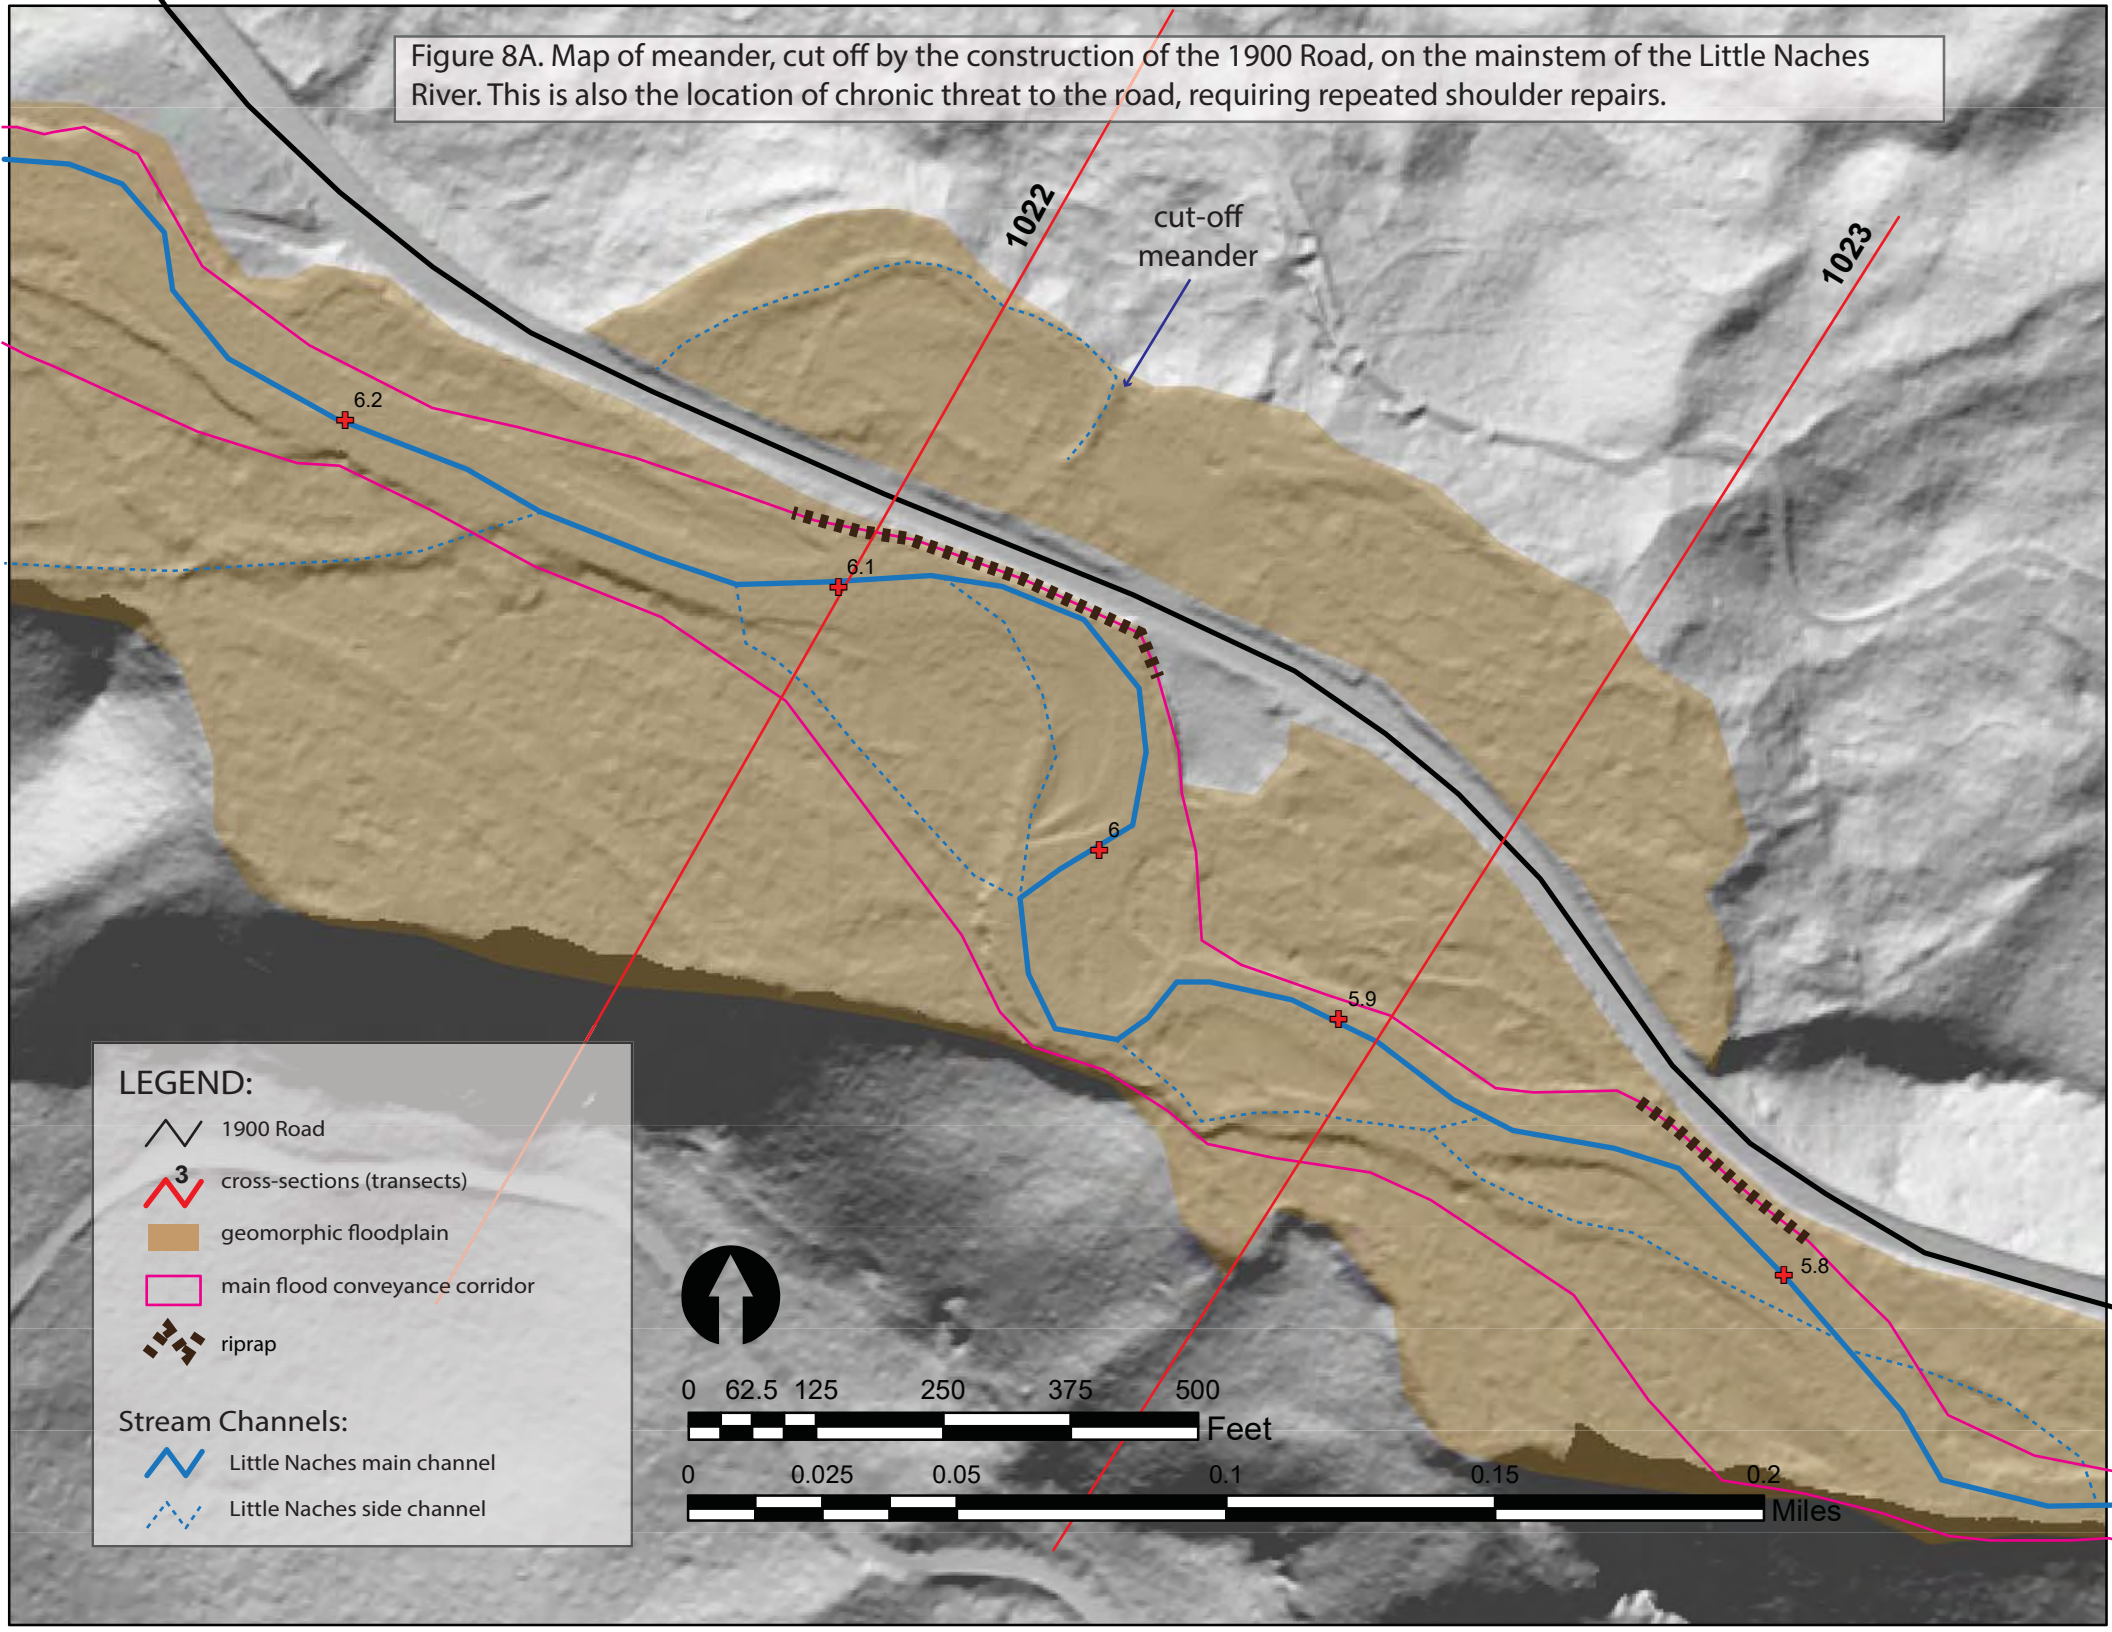
The most significant human-caused alteration in Reach 4 was caused by the construction of the 1900 Road. The alignment of the 1900 Road was established by 1954 (Figure 8B). A meander bend was artificially cut off and abandoned north of the roadway, and 2 sections of floodplain totaling 10.8 acres in area were disconnected from the mainstem Little Naches River (Plate 5 and Figures 8A-8D). The 608-foot long abandoned portion of the stream channel is clearly identifiable from the LiDAR data (Figure 8A). The 1900 Road has needed repeated repairs over the decades at this location to prevent further damage. Currently, a 414-foot riprap line protects the roadway.

Figure 8A. Map of meander, cut off by the construction of the 1900 Road, on the mainstem of the Little Naches River. This is also the location of chronic threat to the road, requiring repeated shoulder repairs.

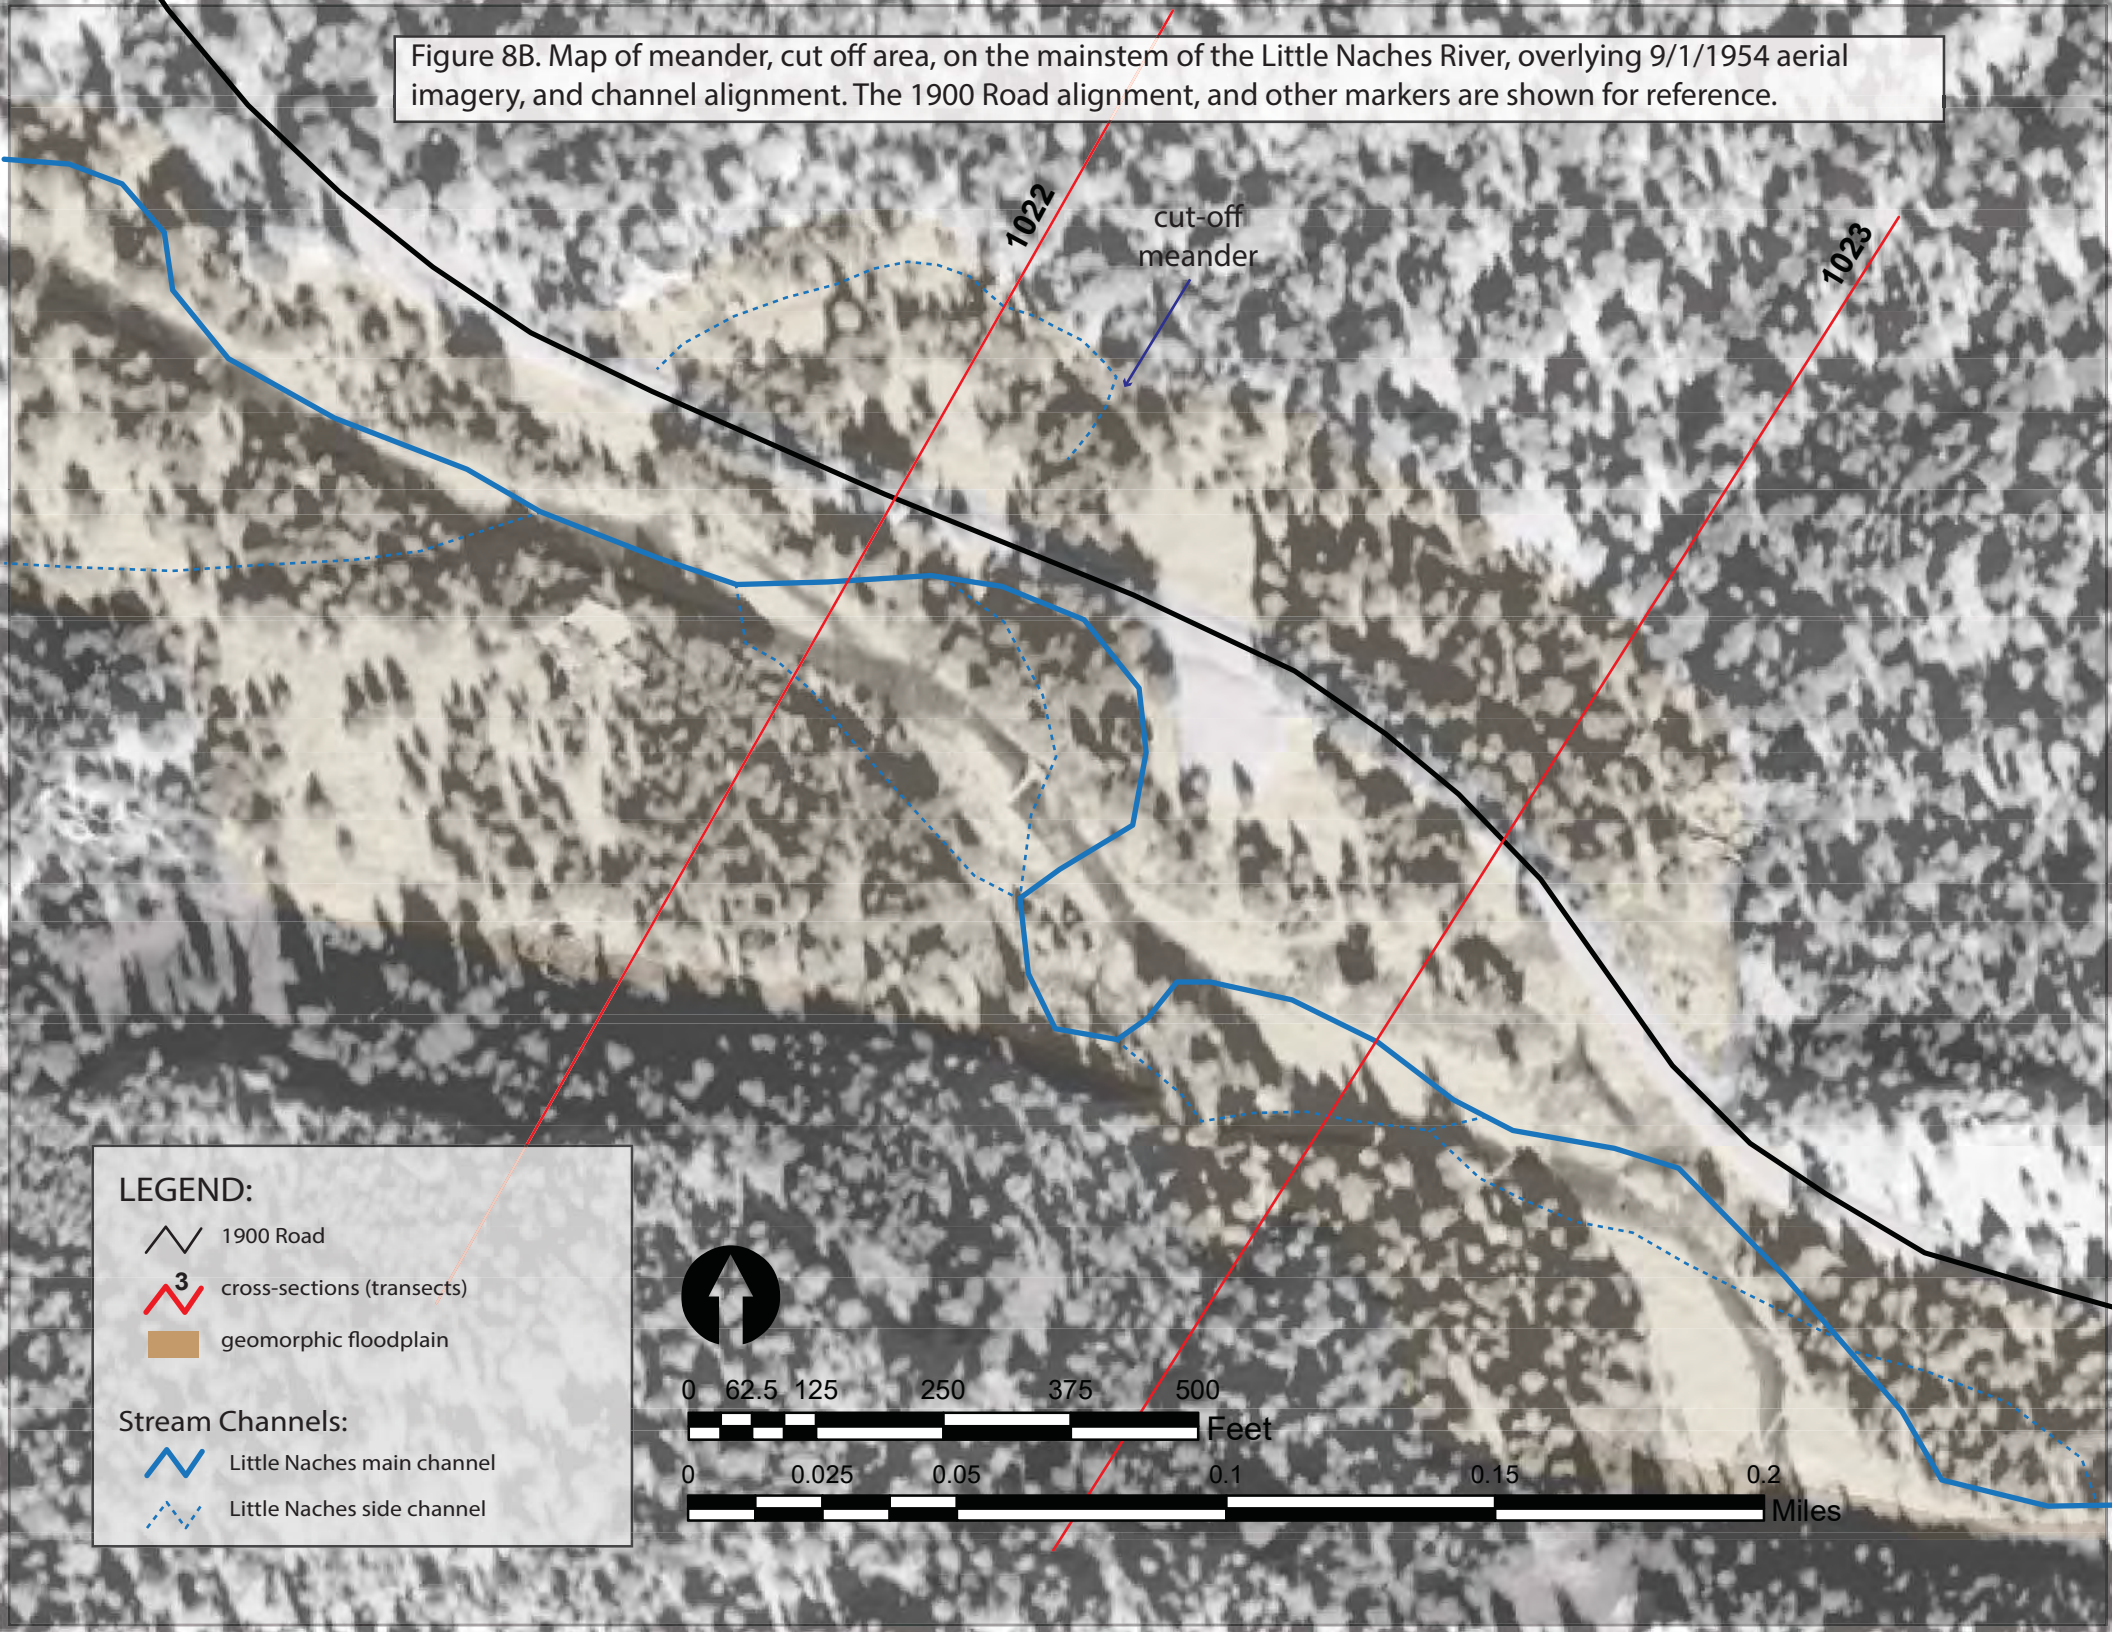
Figure 8B. Map of meander, cut off area, on the mainstem of the Little Naches River, overlying 9/1/1954 aerial imagery, and channel alignment. The 1900 Road alignment, and other markers are shown for reference.

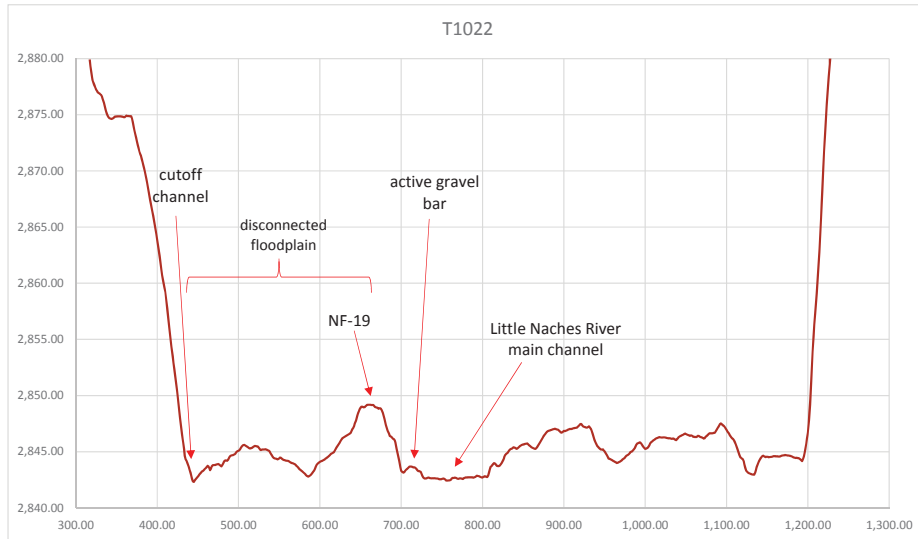
Figure 8C. Transect 1022, shows the meander cut-off by the construction of the 1900 Road.

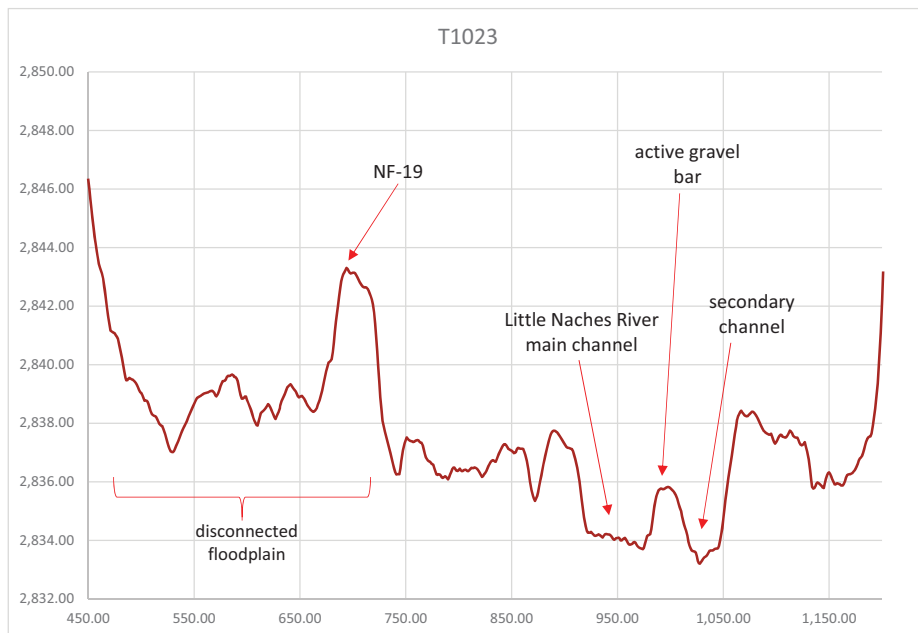
Figure 8D. Transect 1023, shows the disconnected floodplain of the Little Naches River north of the 1900 Road prism.

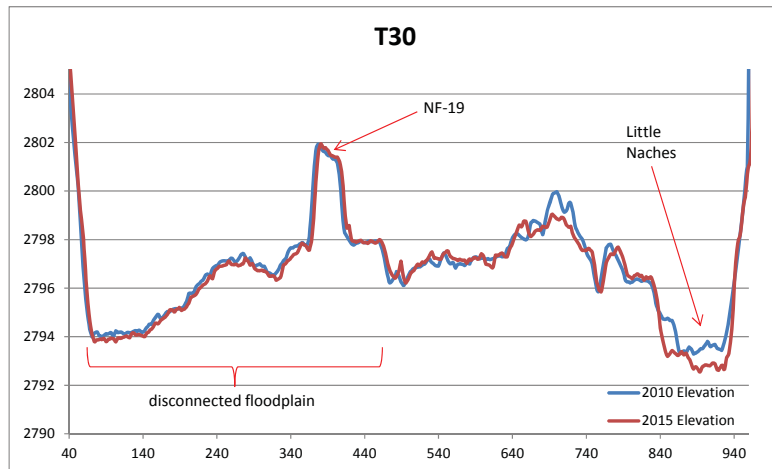
Figure 9C. Transect 30 in Longmire Meadow, shows the disconnected floodplain north of the 1900 Road.

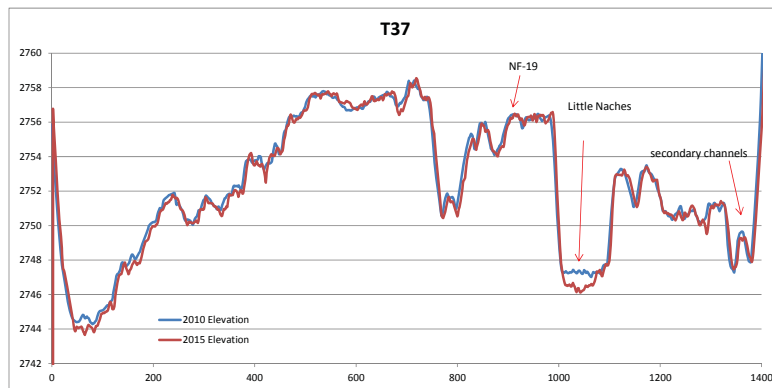
Figure 9D. Transect 37 below the slide that formed Salmon Falls. Note that the north side of the disconnected floodplain is topographically lower than the main channel of the Little Naches River, and probably housed the channel prior to slide release.

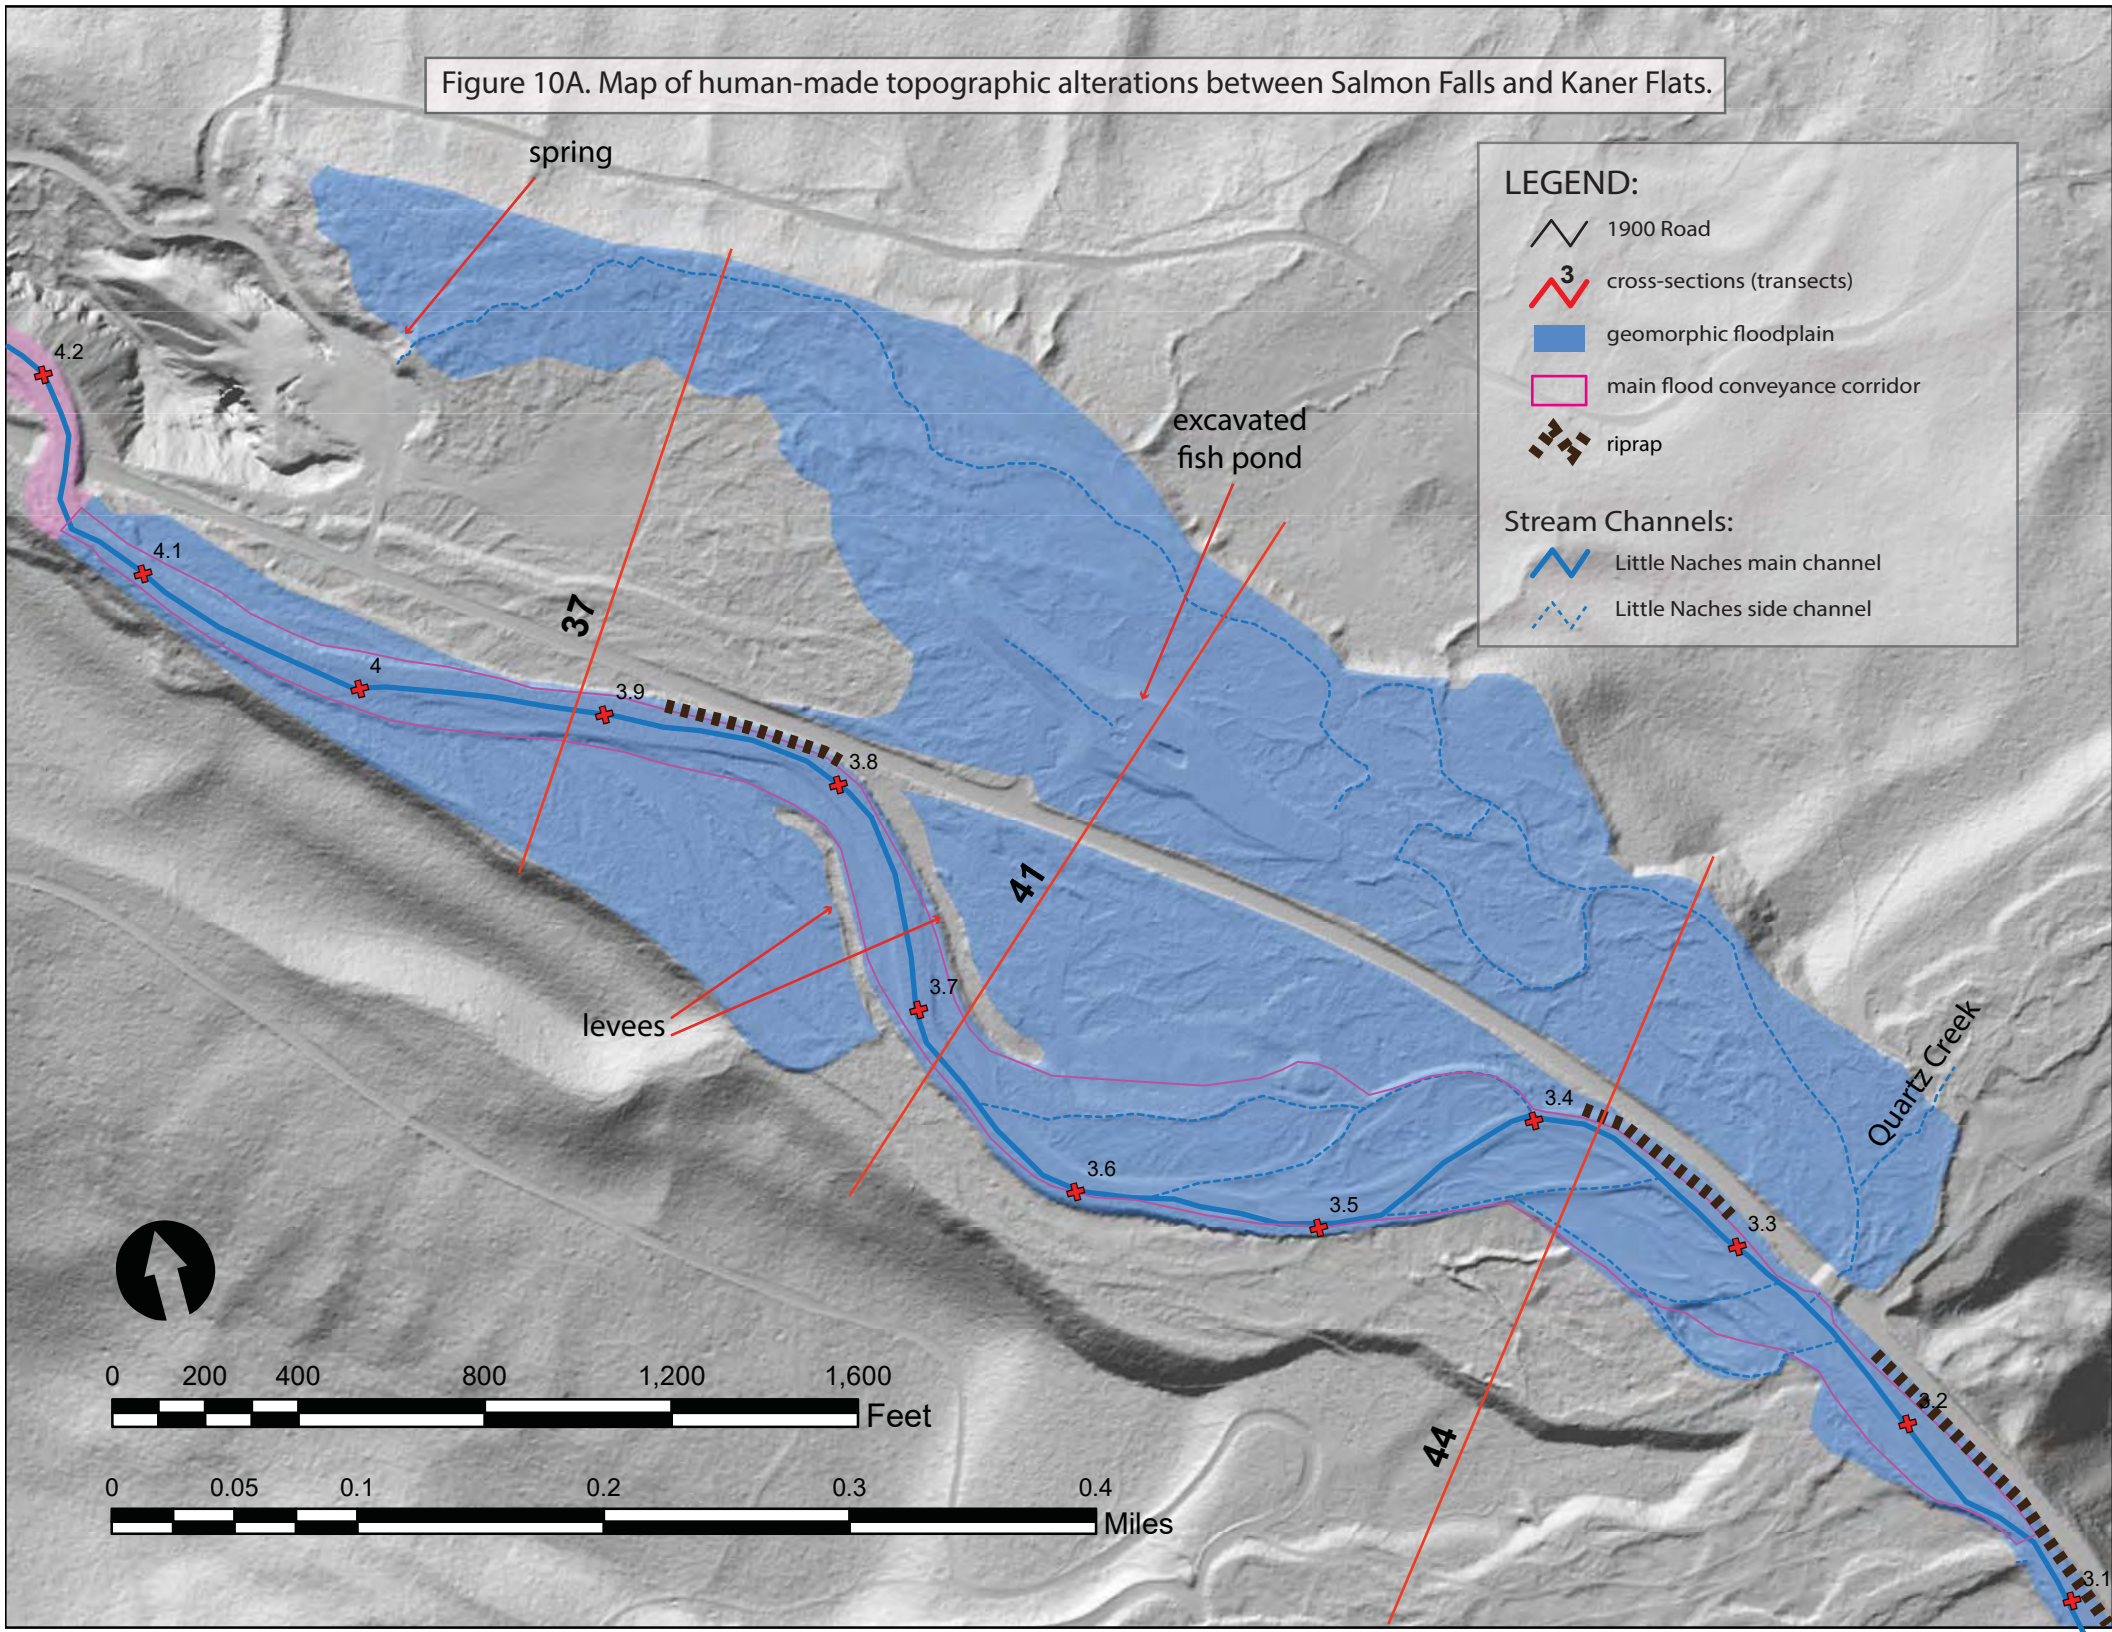
Figure 10A. Map of human-made topographic alterations between Salmon Falls and Kaner Flats.

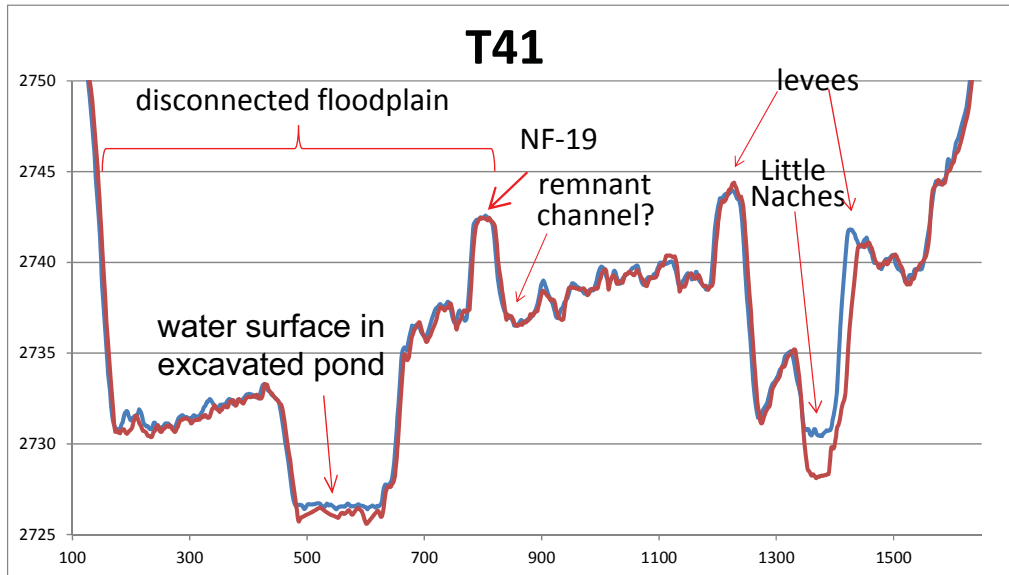
The levees have created an artificial constriction in the floodplain, causing the river to flow deeper and faster at flood stage, increasing stream power, and transport capacity. This, along with the abrupt widening at the downstream end of the levees, causes deposition of bedload in the sub-reach below the levees. This excessive bedload deposition and the earlier removal of large wood and vegetation from the floodplain have caused the reach immediately downstream of the levees to destabilize. The sediment deposition overwhelms the transport capacity of the river causing frequent channel migrations at flood stage. A comparison of the 2010 and 2015 LiDAR data for this area shows significant reworking of gravel bars and rapid channel changes (Figure 10C).

Figure 10C. Transect 41, shows the disconnected floodplain by the 1900 Road, and the excavated borrow pit, now used as a fish pond, as well as the levees.

- Fill in the fish pond, or build a series of causeways perpendicular to the floodplain aspect to raise the water table to a more natural level, if refilling is too cost prohibitive **(5c)**

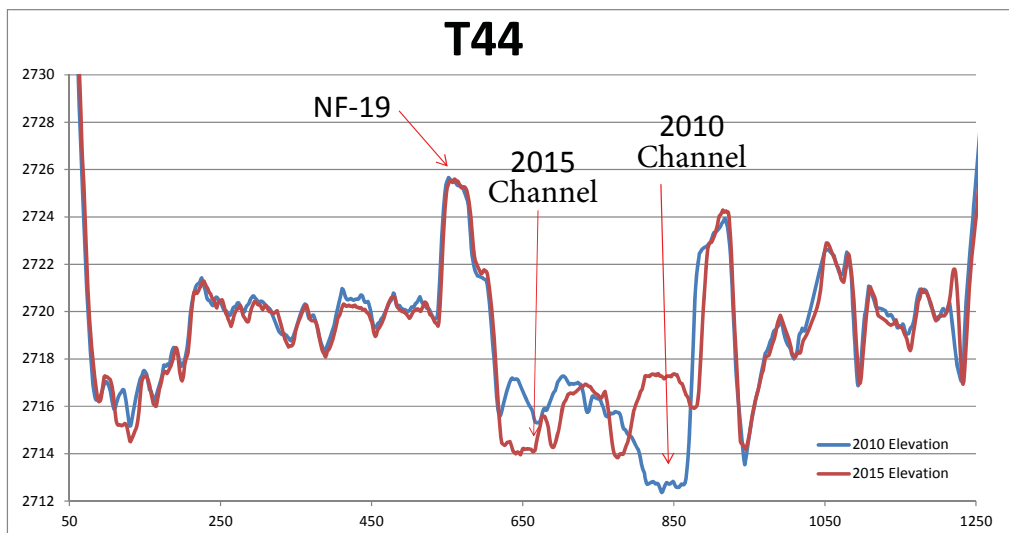
Figure 10D. Transect 44, shows the disconnected floodplain of the Little Naches River north of the 1900 Road prizm, and the reworking of gravel bars between 2010 and 2015.
