Little Naches RM 3.3 to 4.3 Floodplain Restoration

Rebecca Wassell
Eastern Washington Riparian Planting Symposium
February 26, 2026

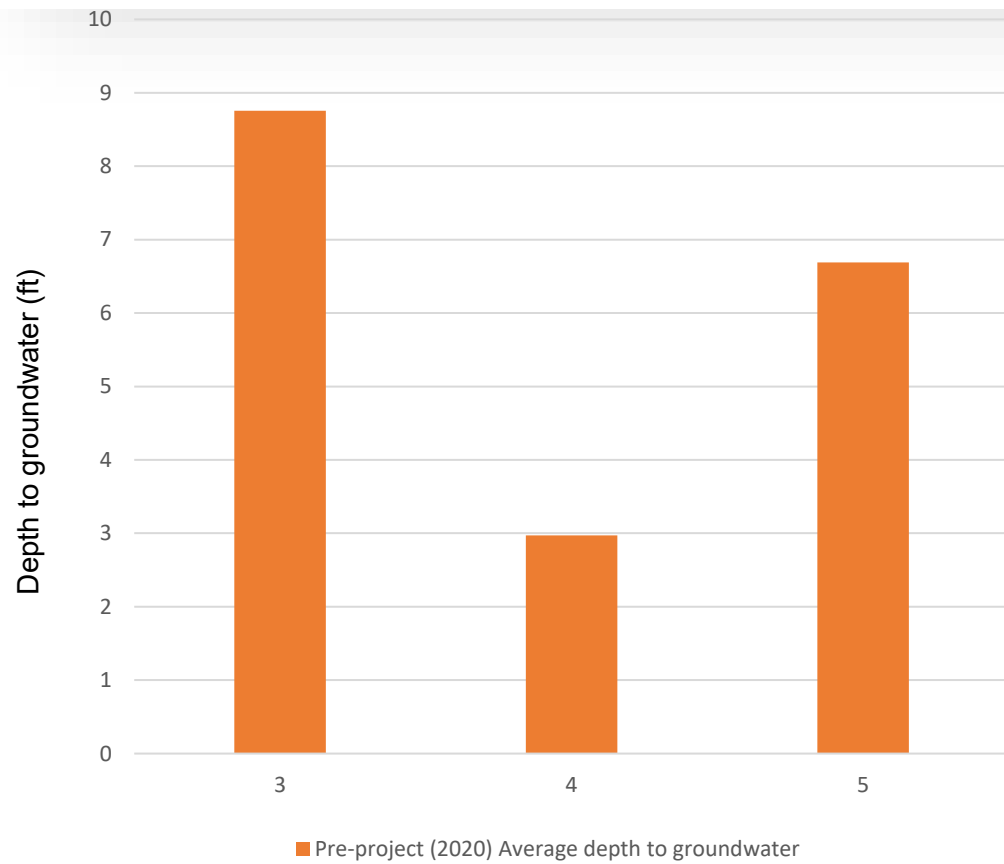
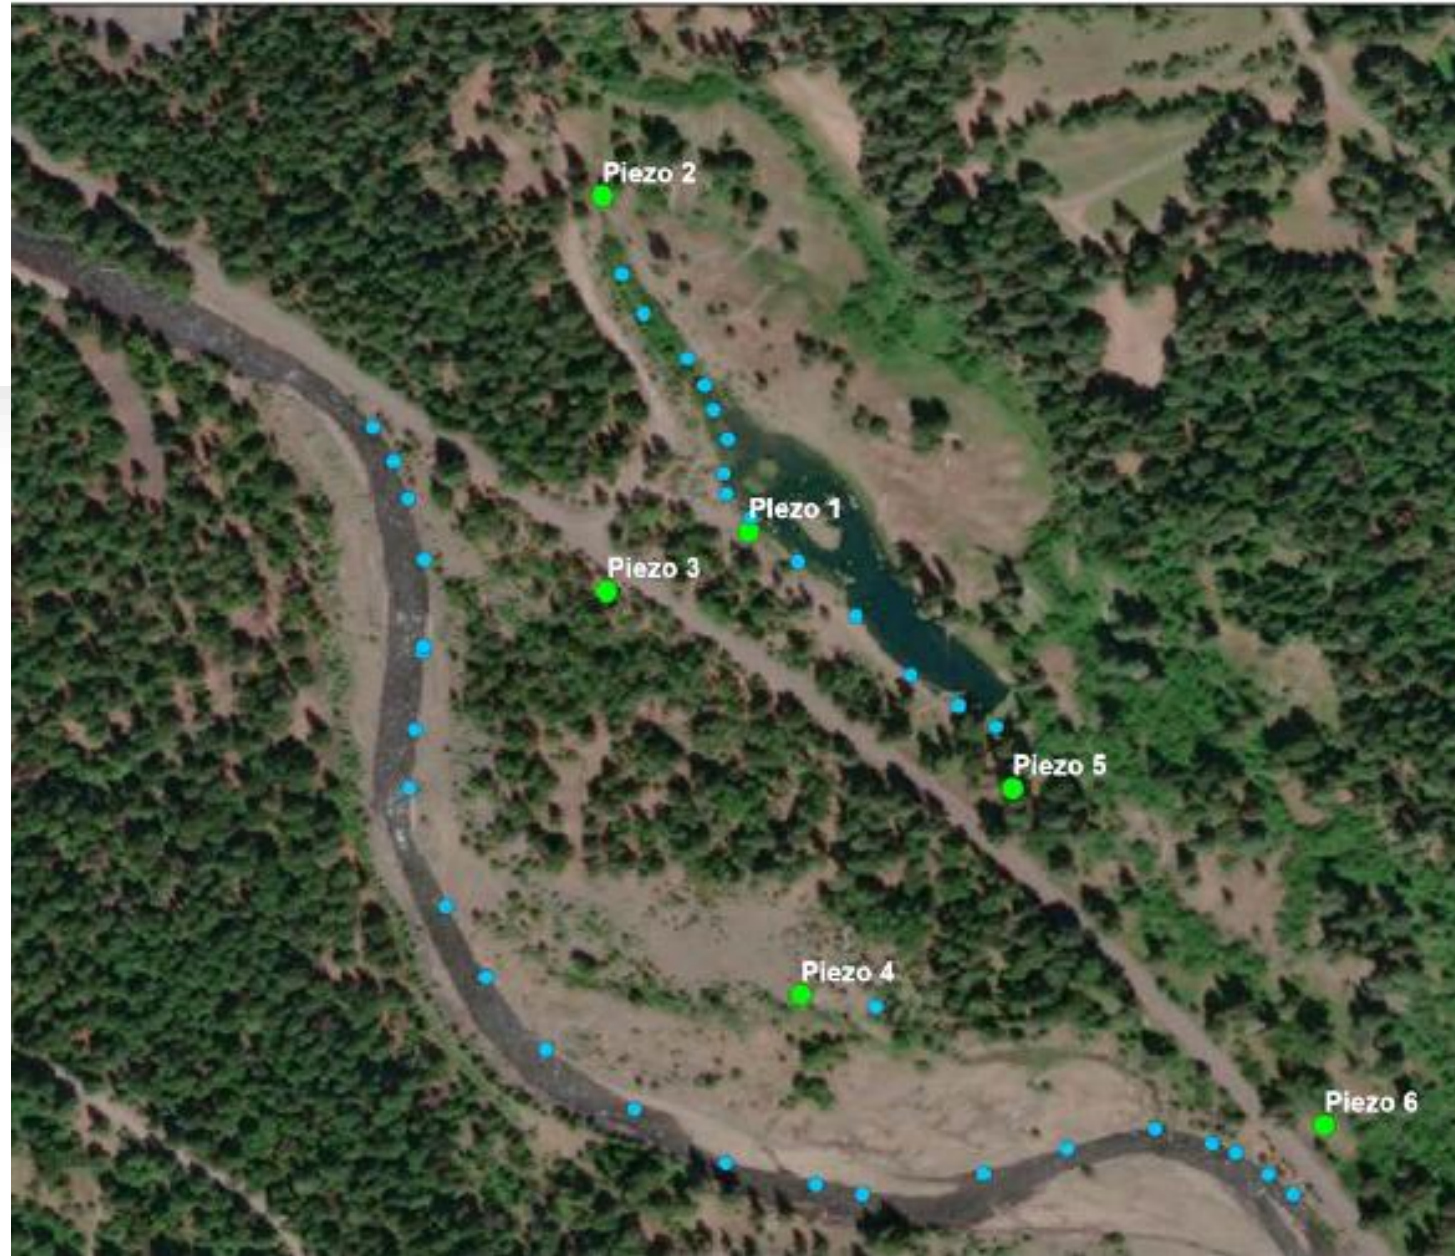
Groundwater before

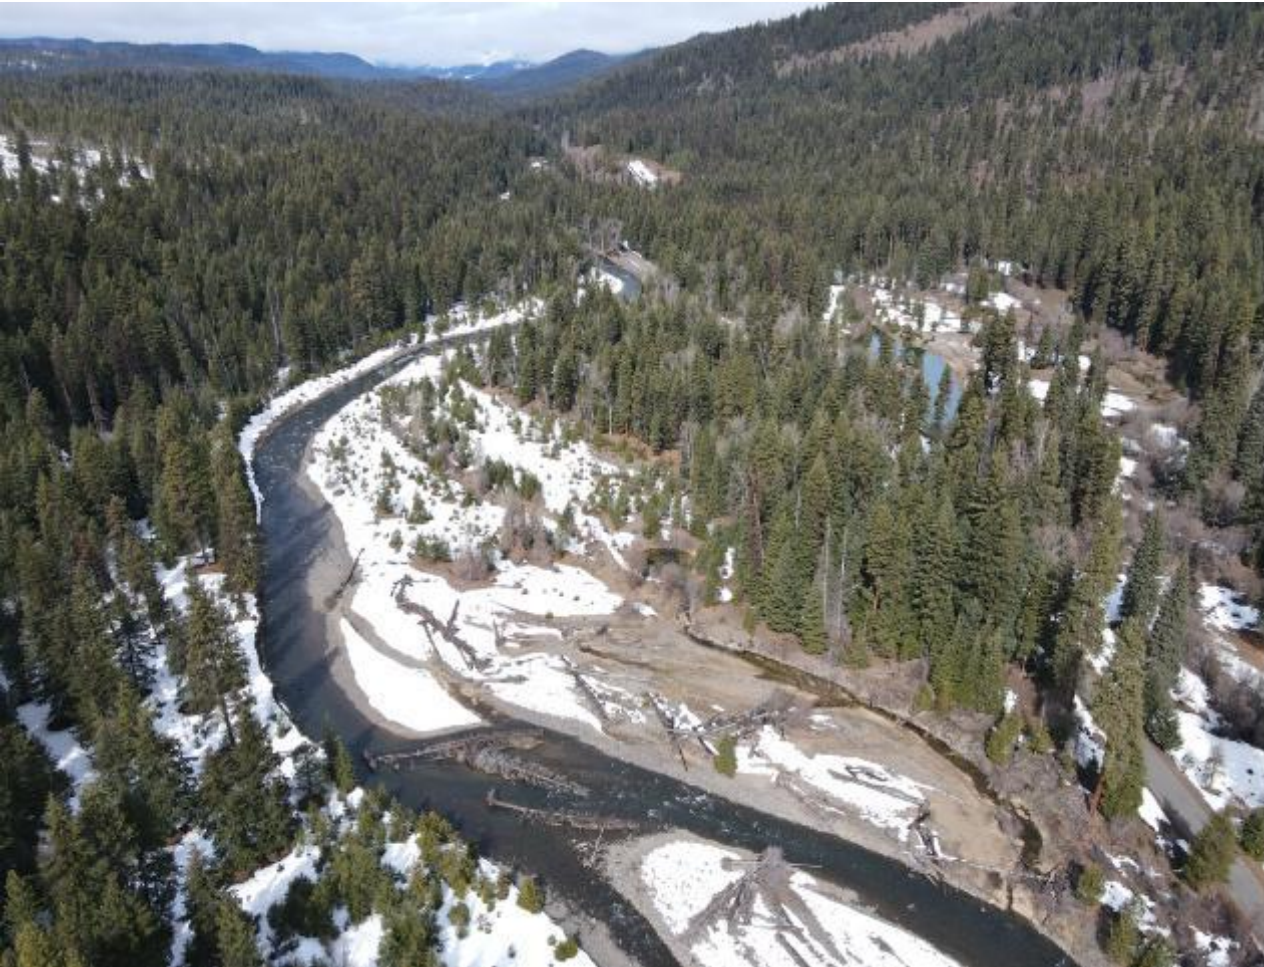
March 22, 2022

**Pre-Project
~260 cfs**

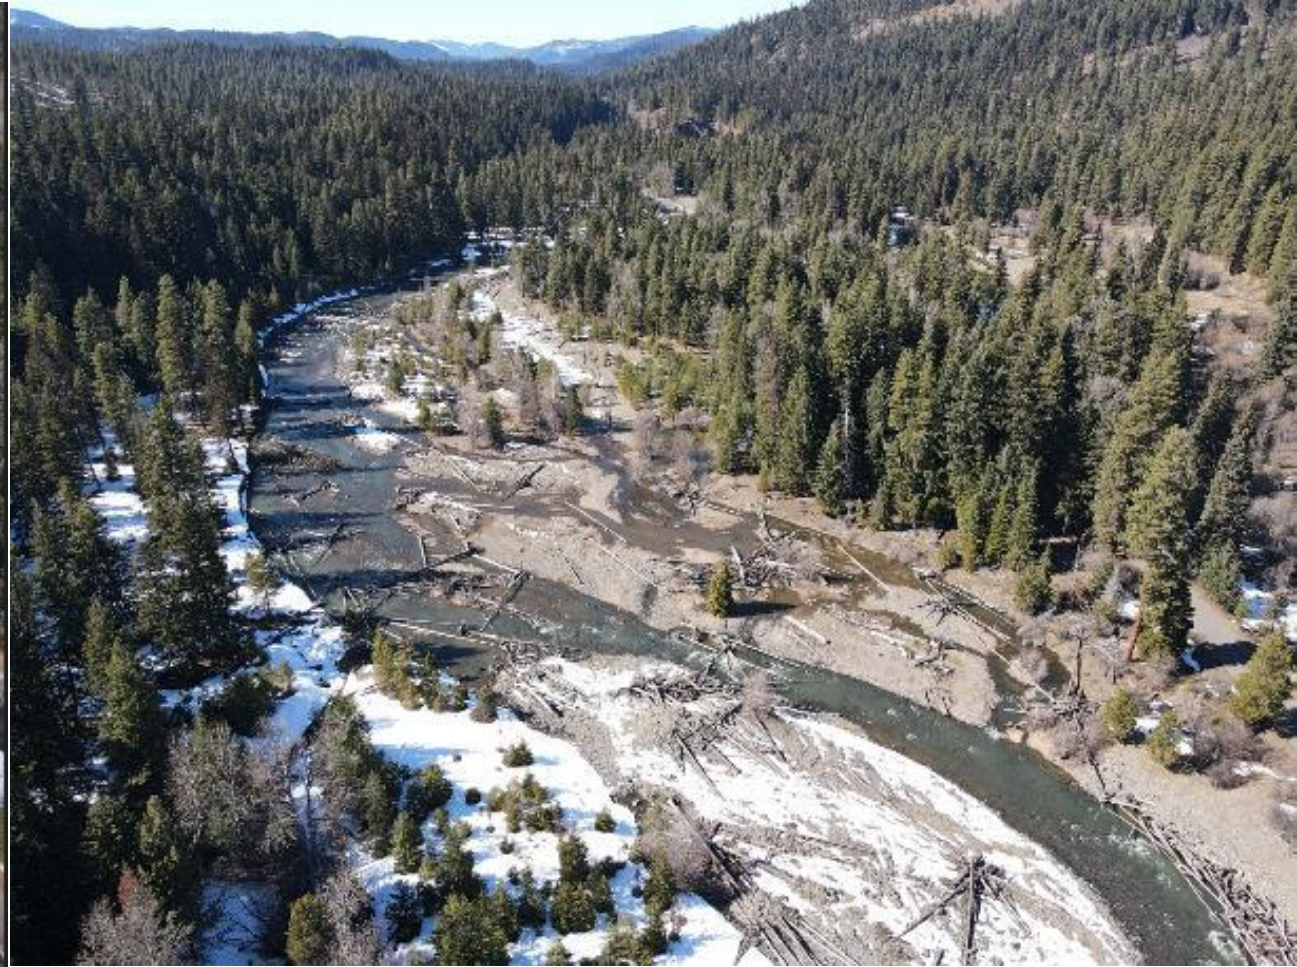
March 17, 2024

**Post Project
~141.38 cfs**

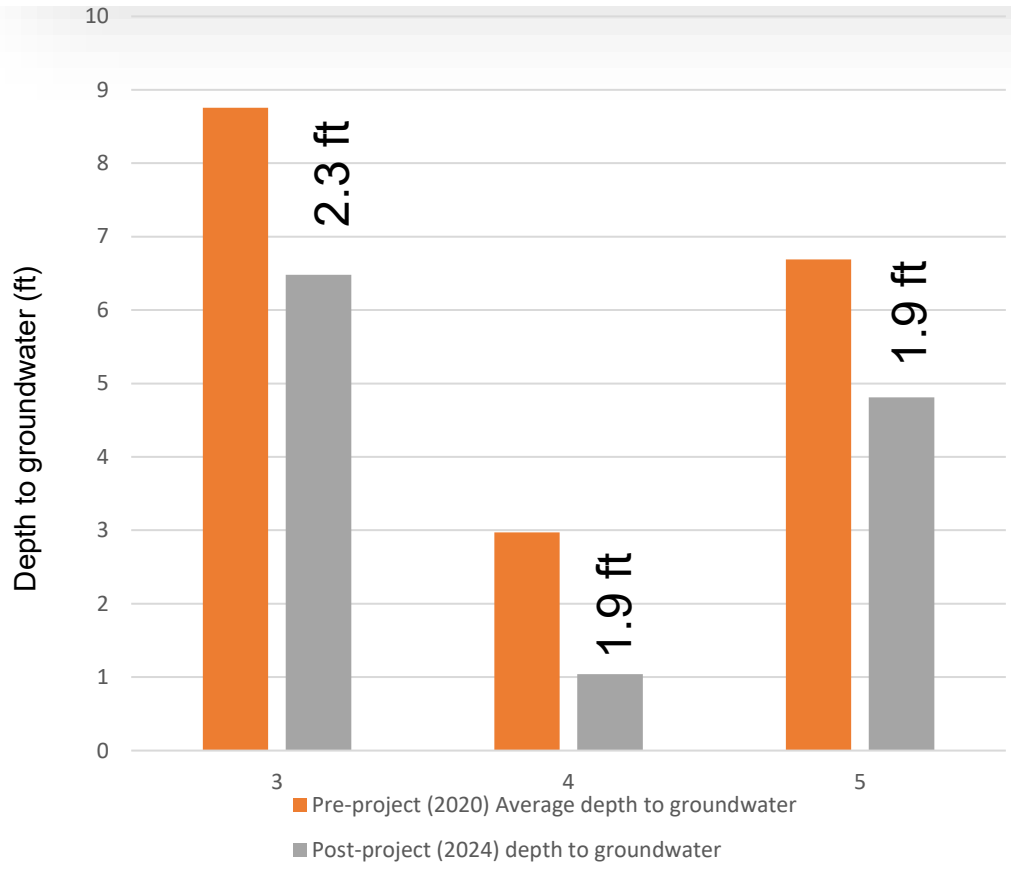
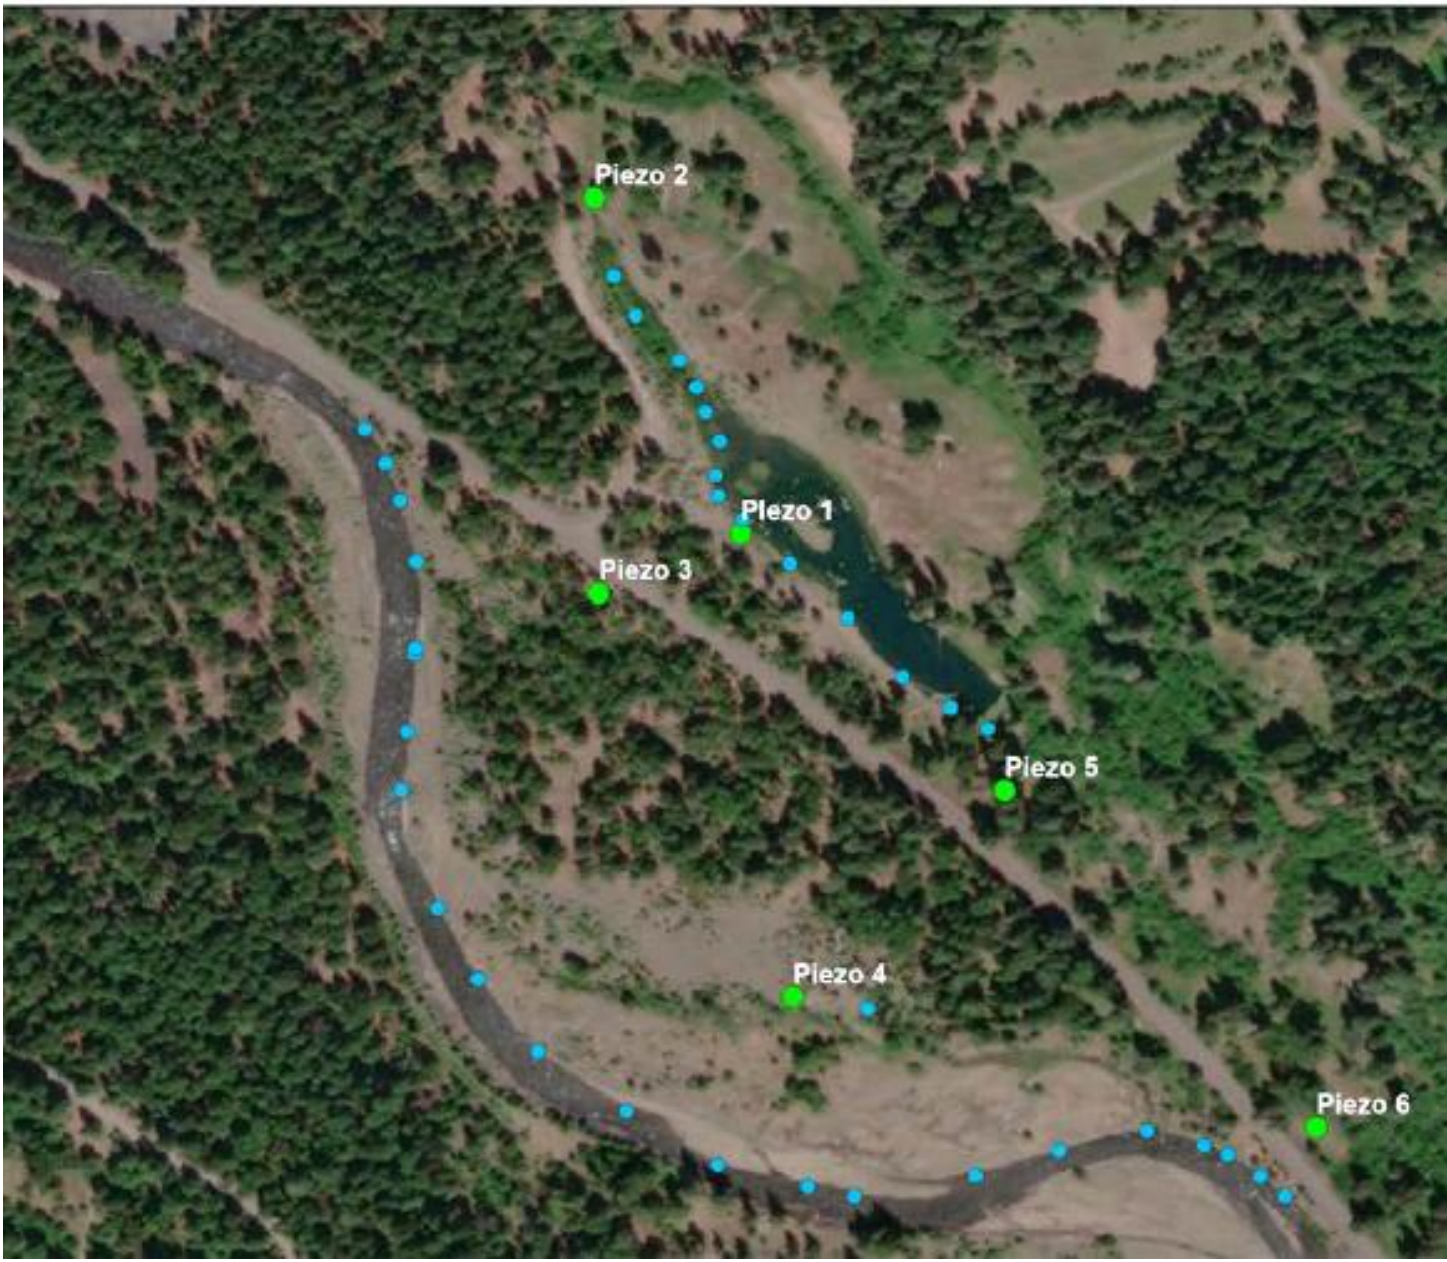
Groundwater before and after

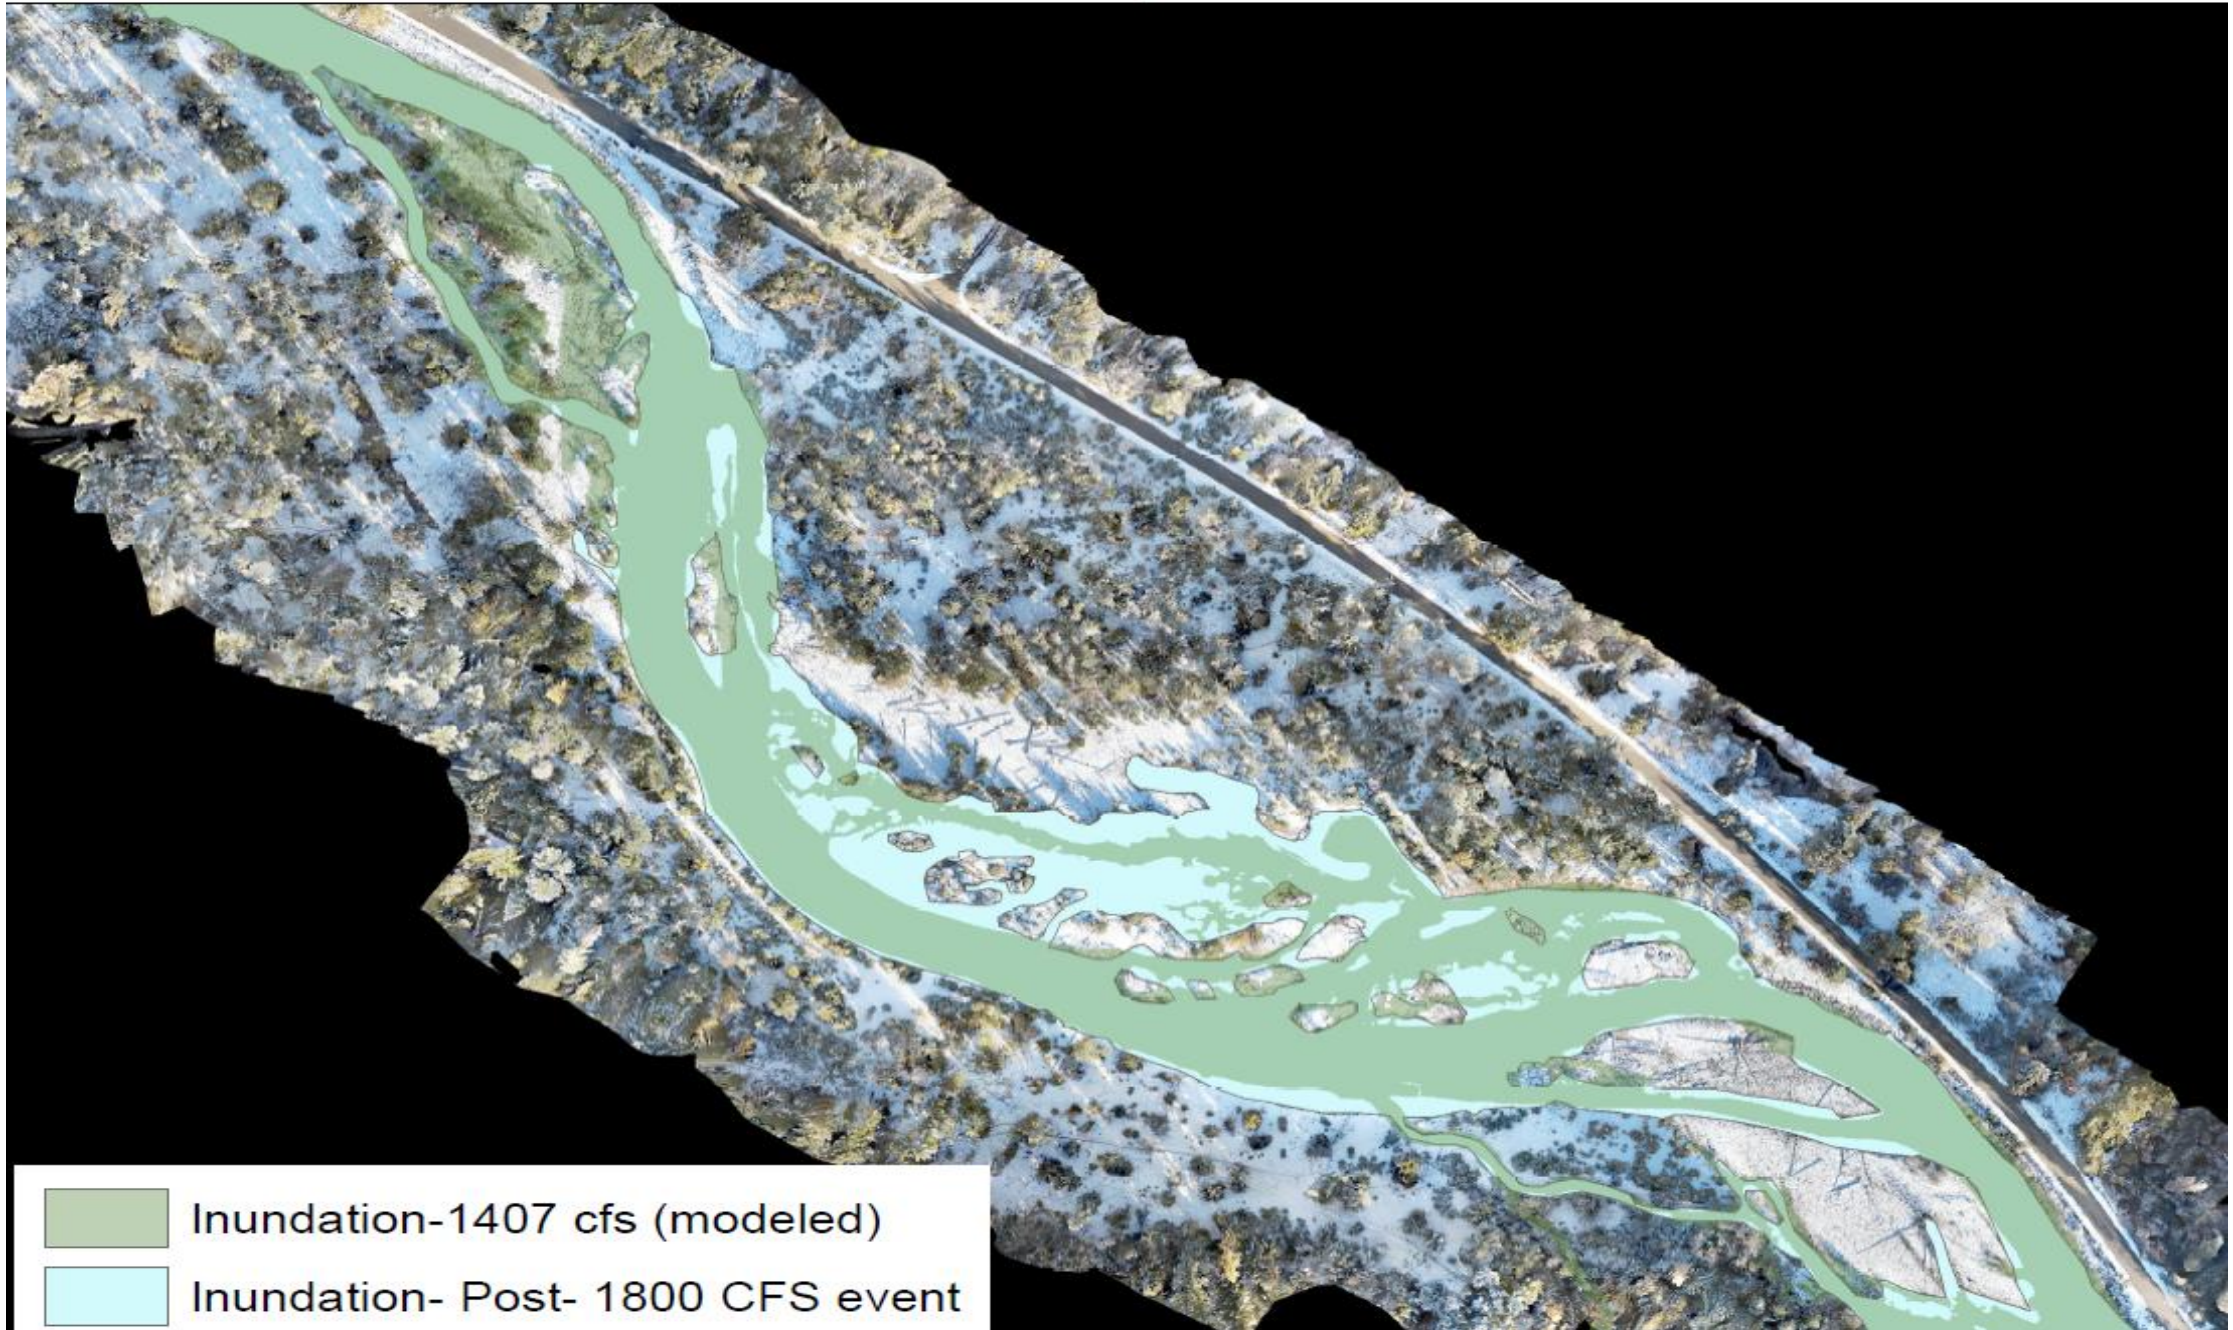
2-year Event Model Comparison
