Where in the
heck did all the
Cottonwoods go?
I know we
planted them...

Ryan Watts

Project Manager, WildLands, Inc.
Nursery Manager, WildLands Nursery

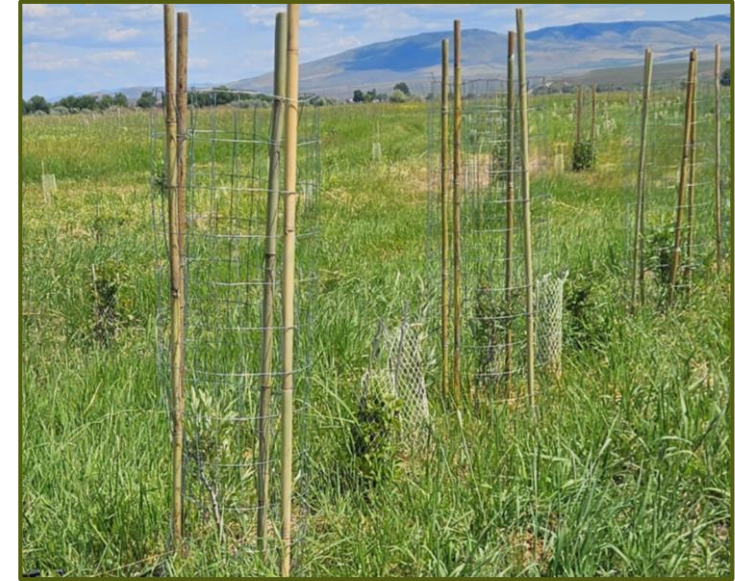
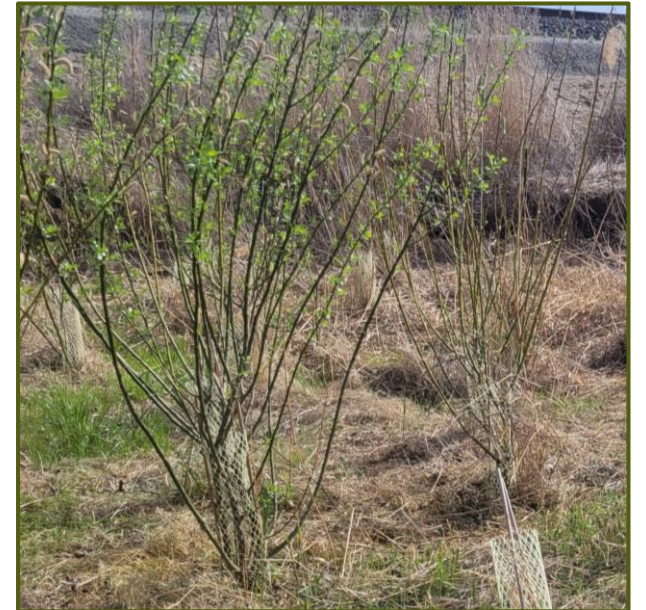
Techniques for Protecting Cottonwoods

- ▶ Many options; some more effective than others
 - ▶ Vexar browse protectors, solid wall tubes, repellent sprays, painting bark (low cost, short term, low efficacy)
 - ▶ Wire cages, enclosures (higher cost, longer term, high efficacy)
 - ▶ Planting strategies: Willows closest to water, then cottonwoods further away from water (but beaver will travel)
- ▶ Wire cages: Built from welded wire, bamboo stakes
- ▶ Enclosures: Built from welded wire, t-posts, bamboo stakes
 - ▶ Height important consideration for both cages and enclosures (5 foot vs. <5 foot)
 - ▶ Can be used to protect other plants from beaver as well as cottonwoods

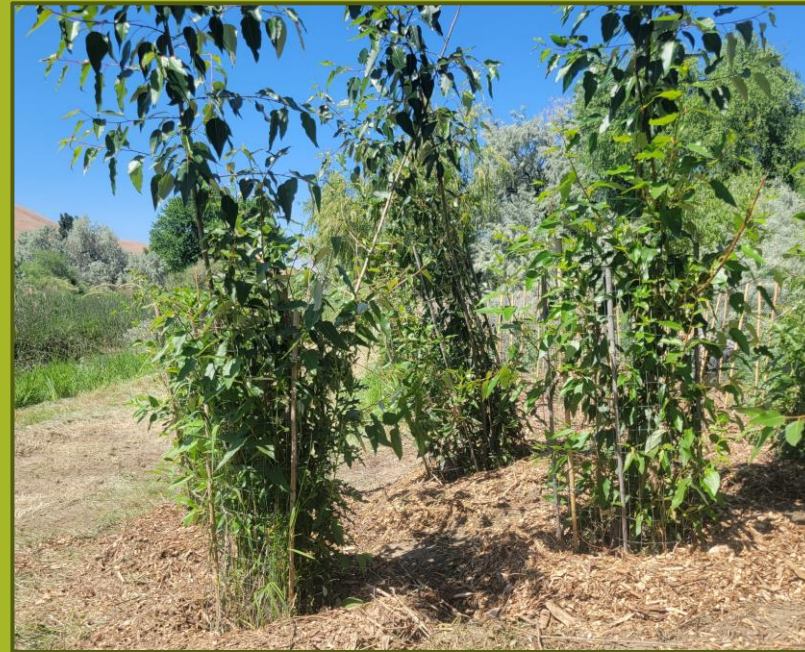
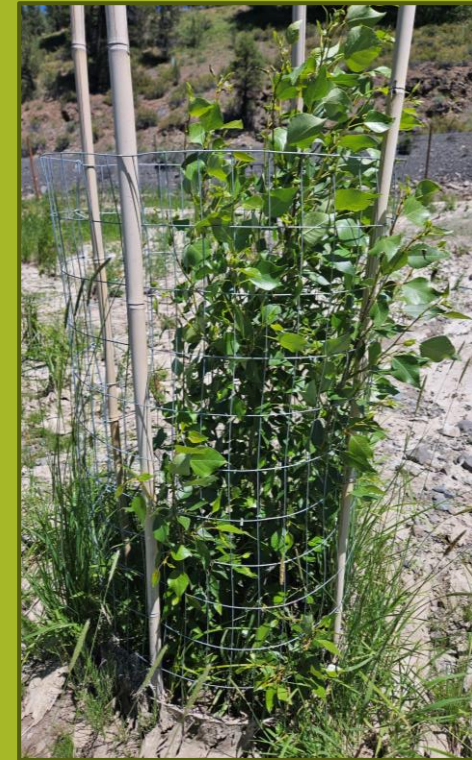
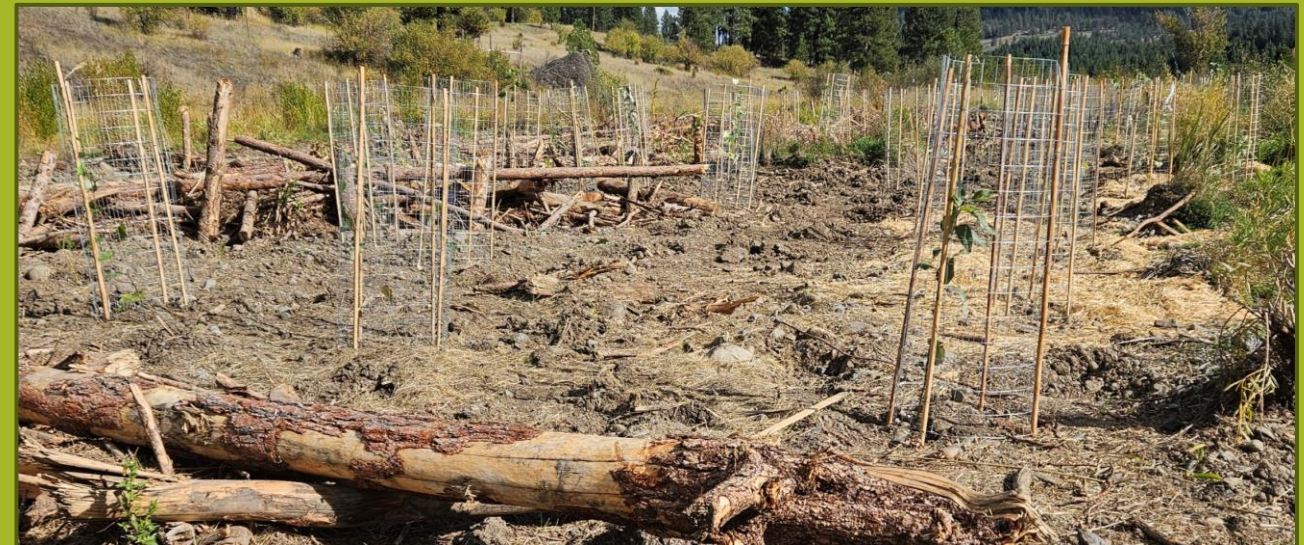
Wire Cages

- ▶ Useful for individual plants
- ▶ Useful in areas with varying topography or high amount of floodplain wood/debris
- ▶ Larger cages more effective long term
 - ▶ Larger diameter cages allow for larger plant growth, no need to install new cages as plants grow – will eventually need removal to prevent constriction
 - ▶ Taller height protects taller plants
 - ▶ Use of welded wire provides long-term stability and protection; Beaver can chew through plastic

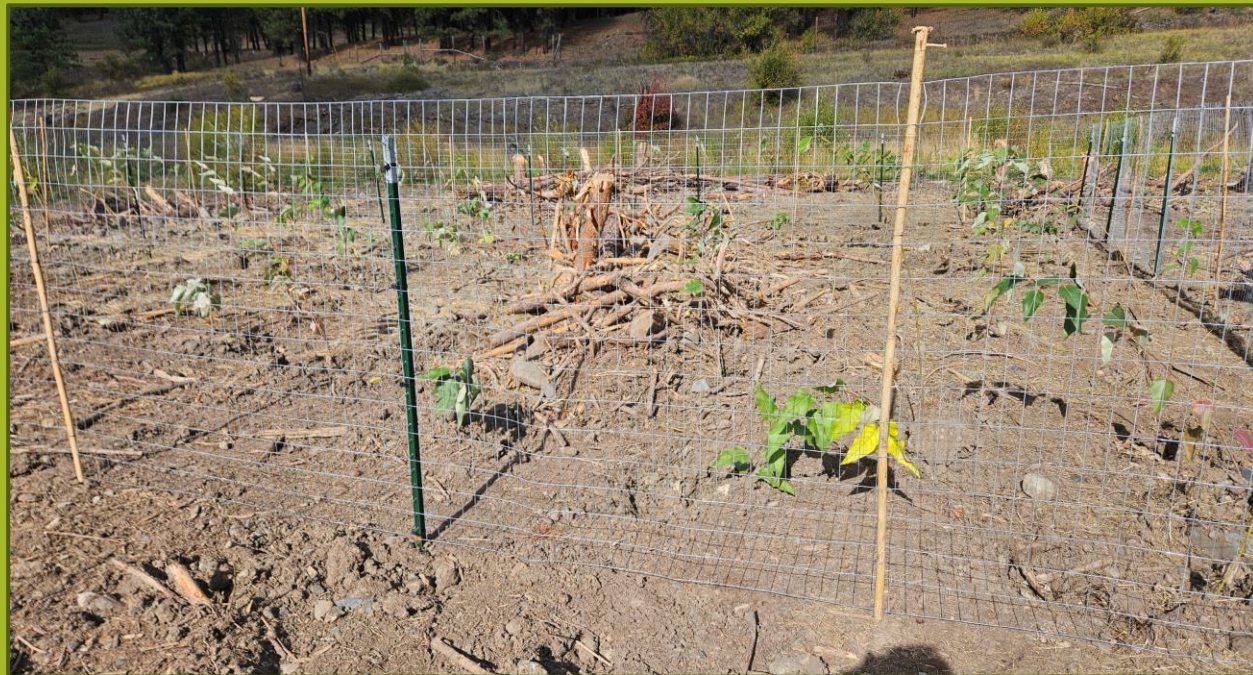
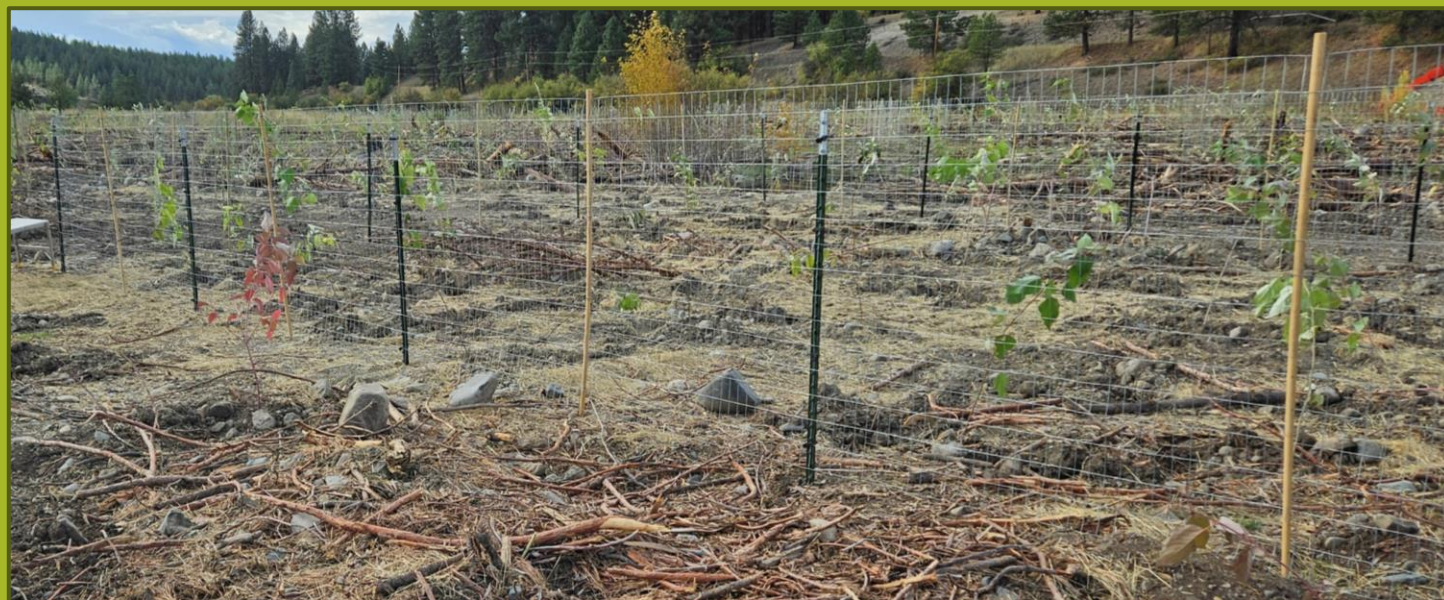
Enclosures

- ▶ Useful for protecting multiple plants
- ▶ Lower cost per plant protected than cages
- ▶ Useful in large areas with relatively flat ground and little debris
 - ▶ Use staples to secure enclosures to the ground to prevent digging in softer substrates
 - ▶ Beaver can chew through plastic deer fencing; Welded wire provides protection from beaver

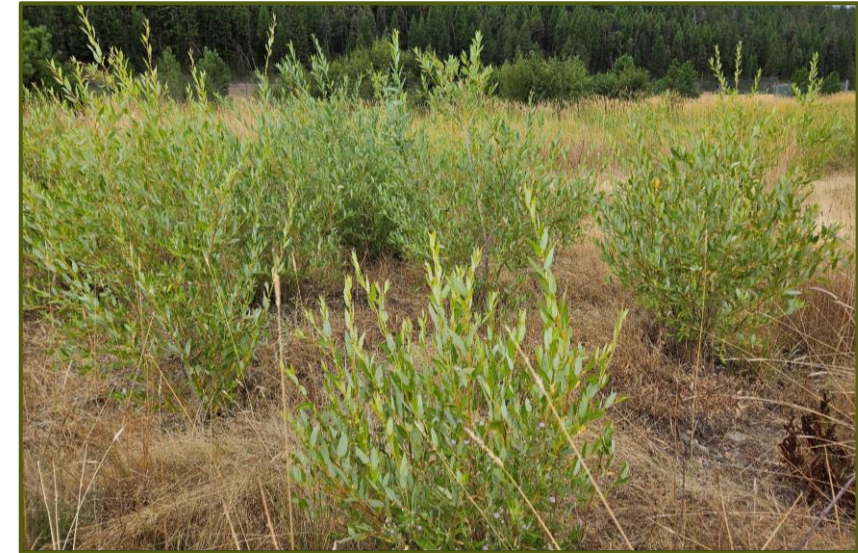
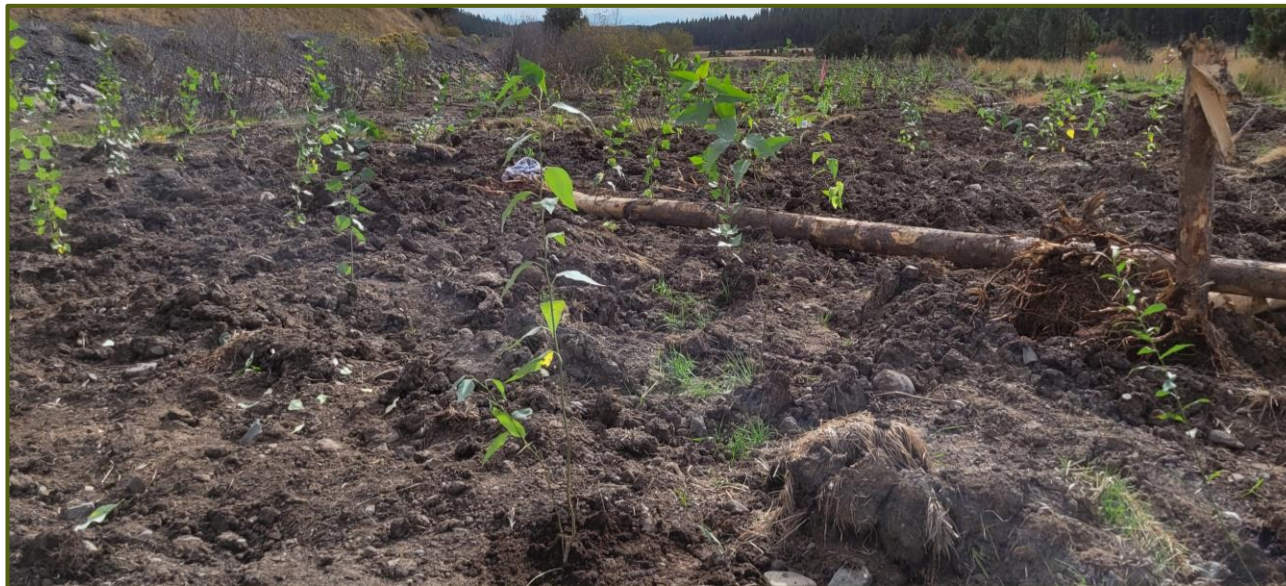
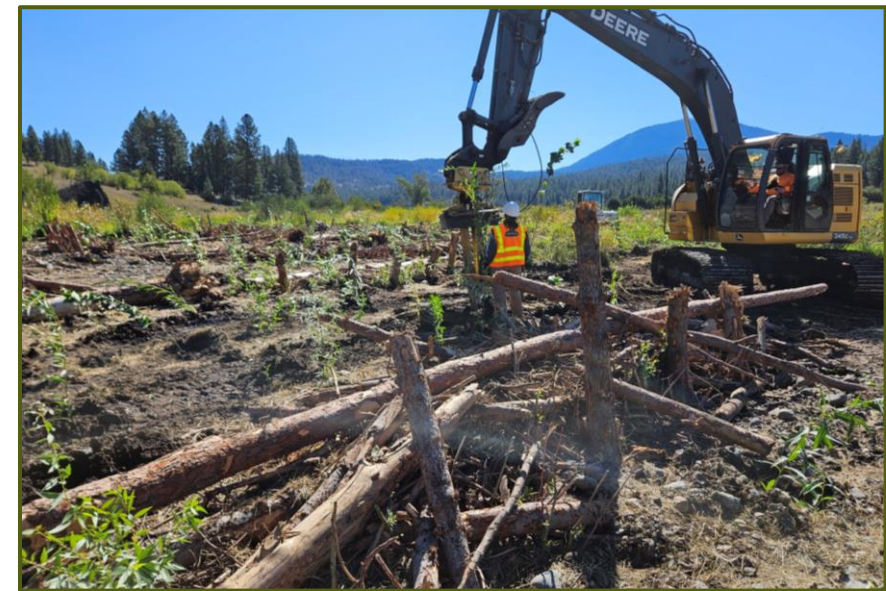
Field Example: Middle Fork John Day River

- ▶ 2020 – Current; Confederated Tribes of the Warm Springs Reservation of Oregon
- ▶ Heavy beaver damage inside 8-foot-tall project area enclosures
- ▶ 31,776 Cottonwoods installed to date; very few without cages/smaller enclosures remain – mostly bushy willows
- ▶ Began using cages/smaller enclosures in 2023, after observing high mortality on cottonwoods but no trace of dead sticks

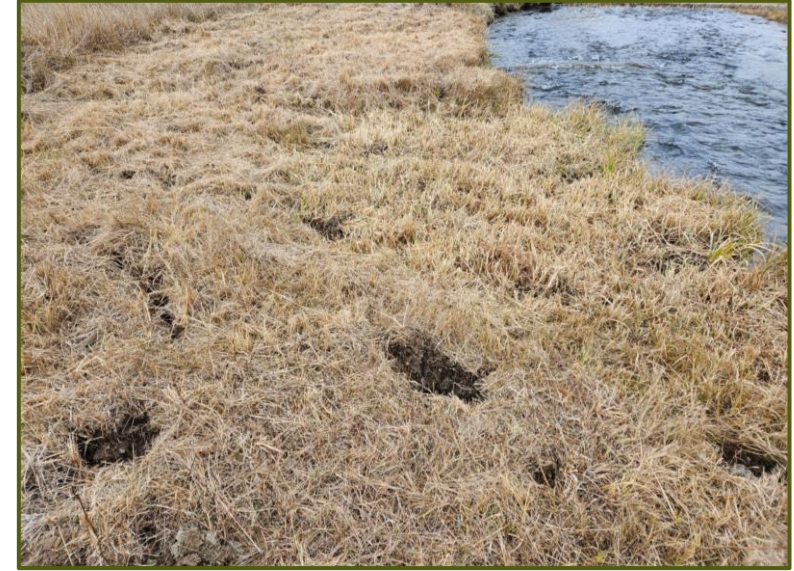
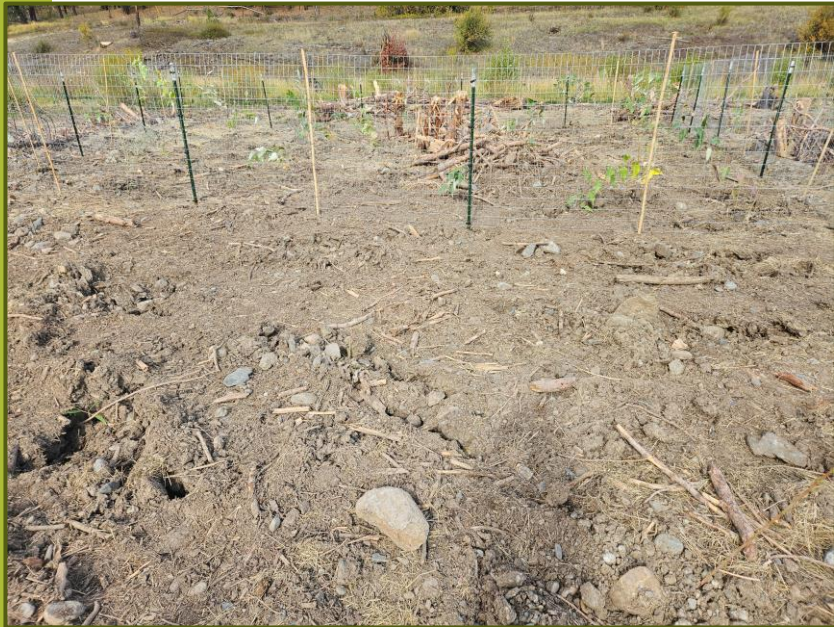
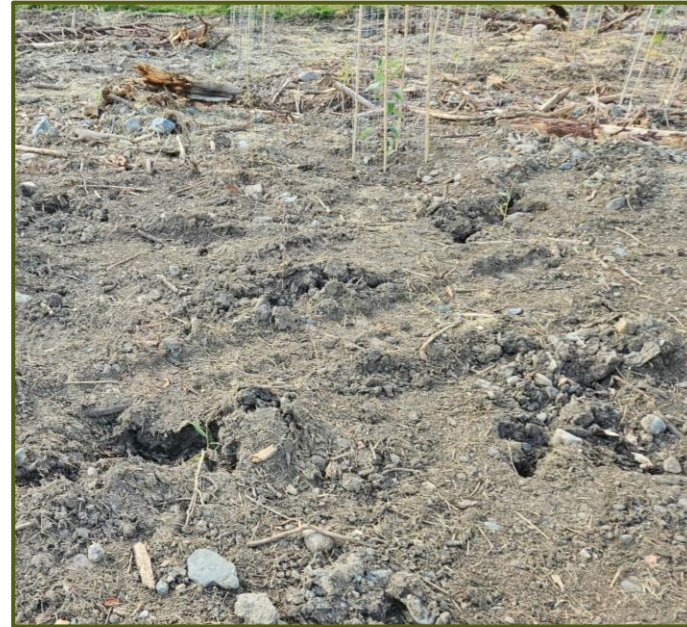
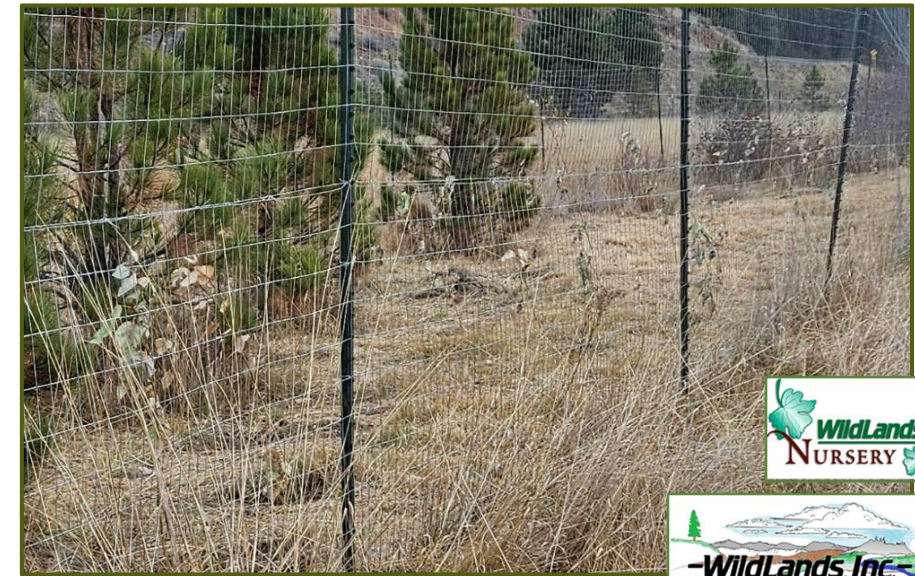
Field Example: Middle Fork John Day River

- ▶ Heavy beaver predation, some sites only days after planting
 - ▶ 2023, right – seen one week after planting, directly adjacent to plants in smaller enclosures – bottom right
 - ▶ 2025, bottom center and bottom left – overnight beaver damage on newly installed plants, only plants in cages and smaller enclosures remain undamaged

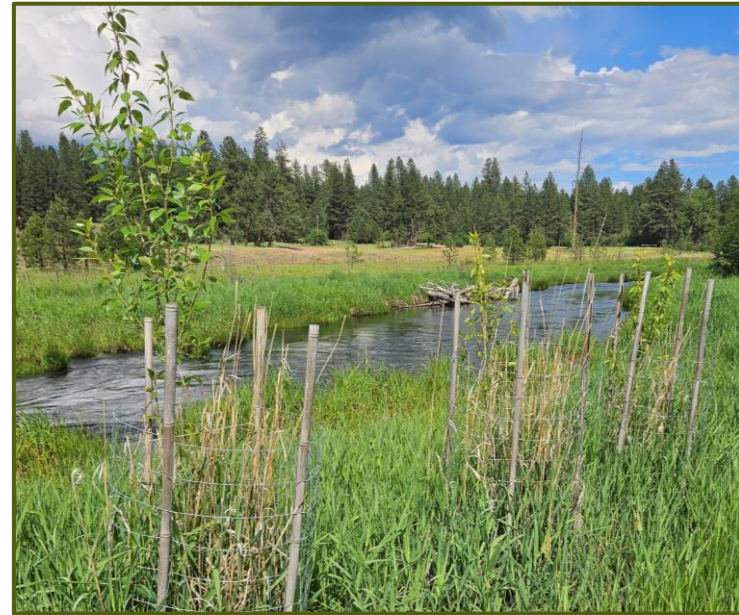
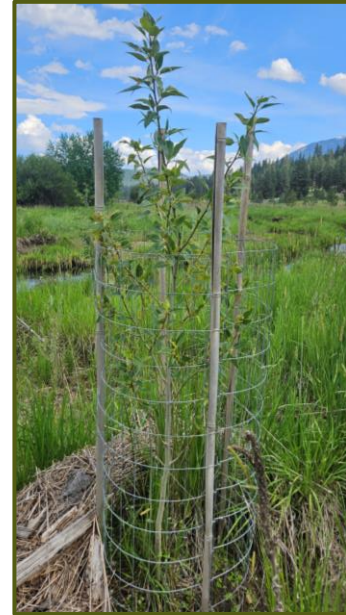
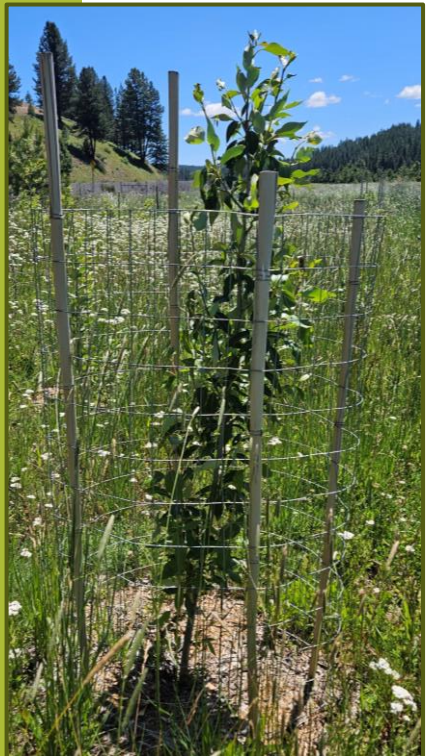
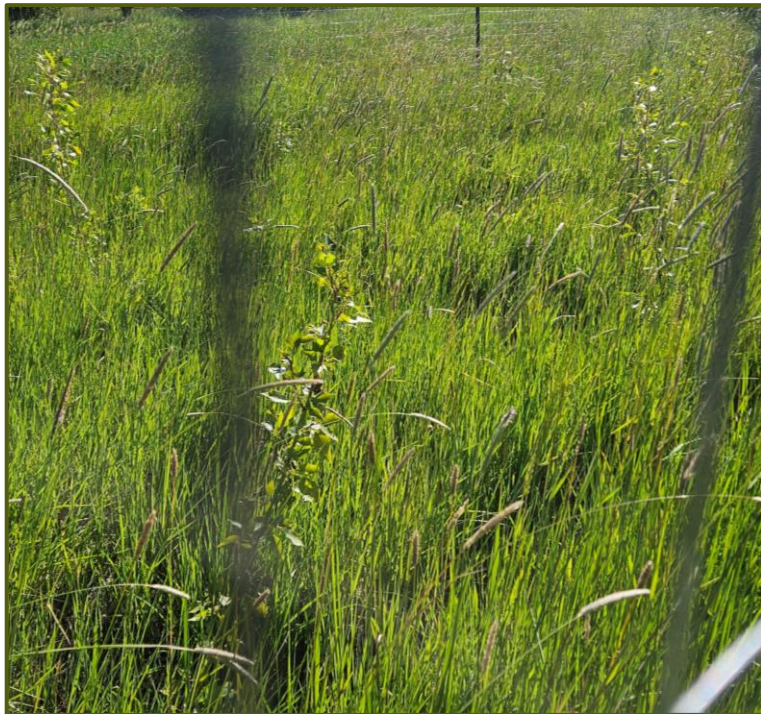
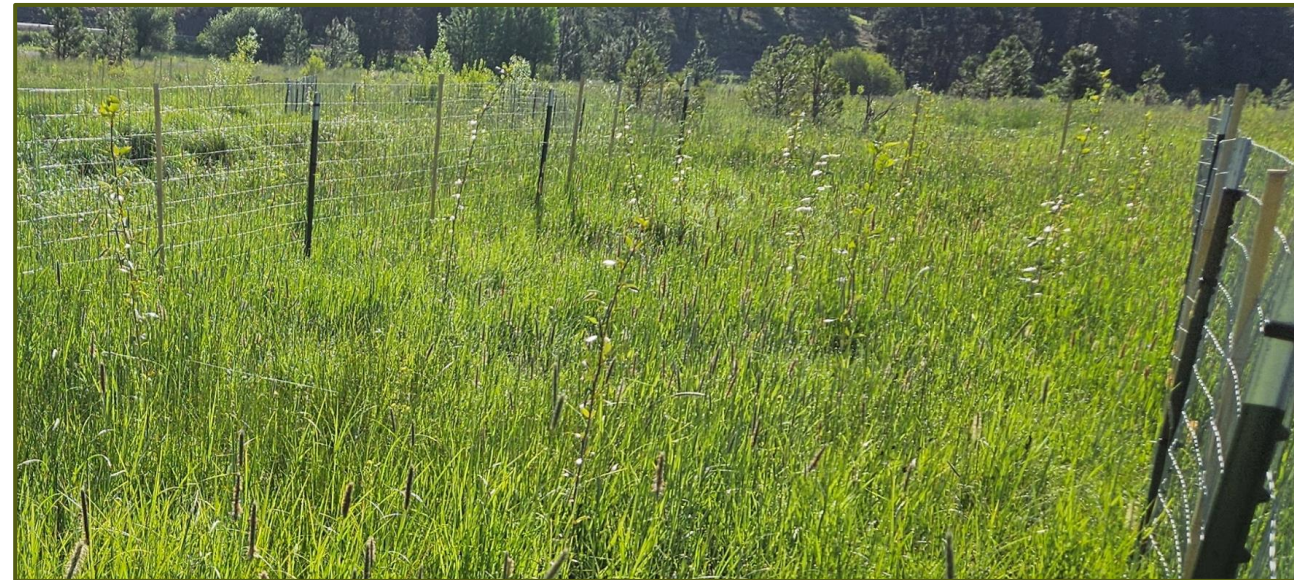
Field Example: Middle Fork John Day River

- ▶ In summer 2025, we observed:
 - ▶ ~75% survival on plants installed in fall 2023 in smaller enclosures
 - ▶ ~80% on plants installed between spring 2023 & fall 2024 in cages
 - ▶ ~90% survival on plants installed in fall 2024 in smaller enclosures

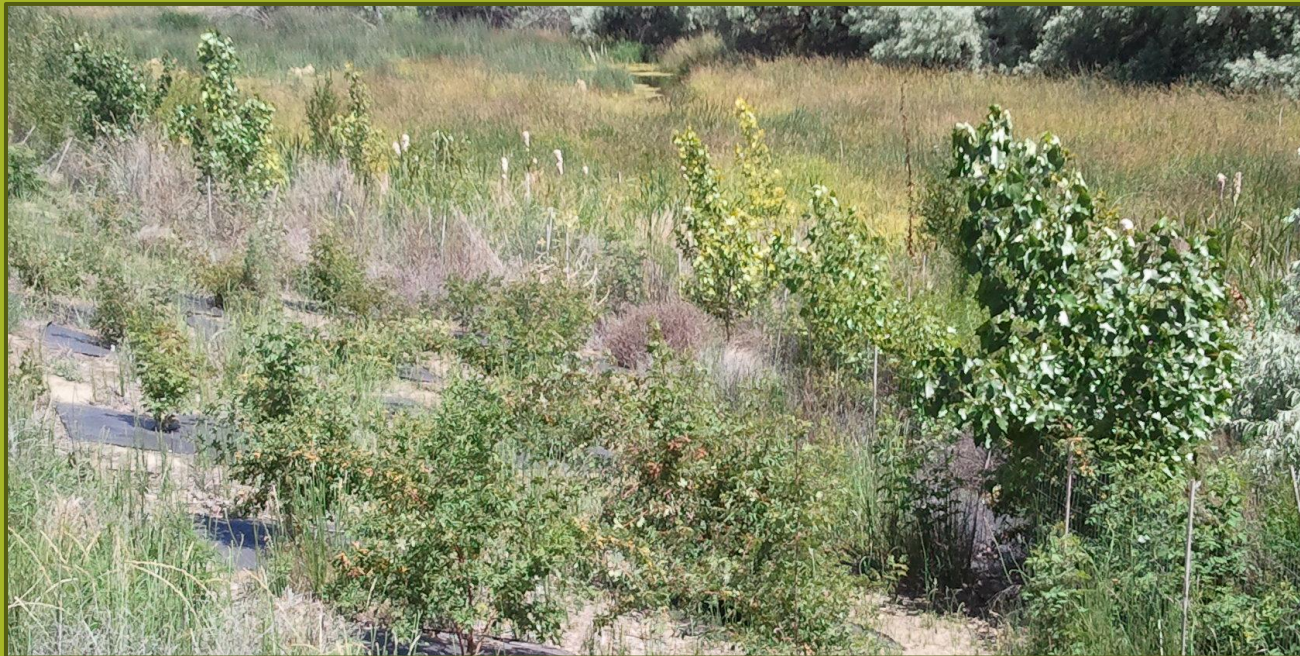
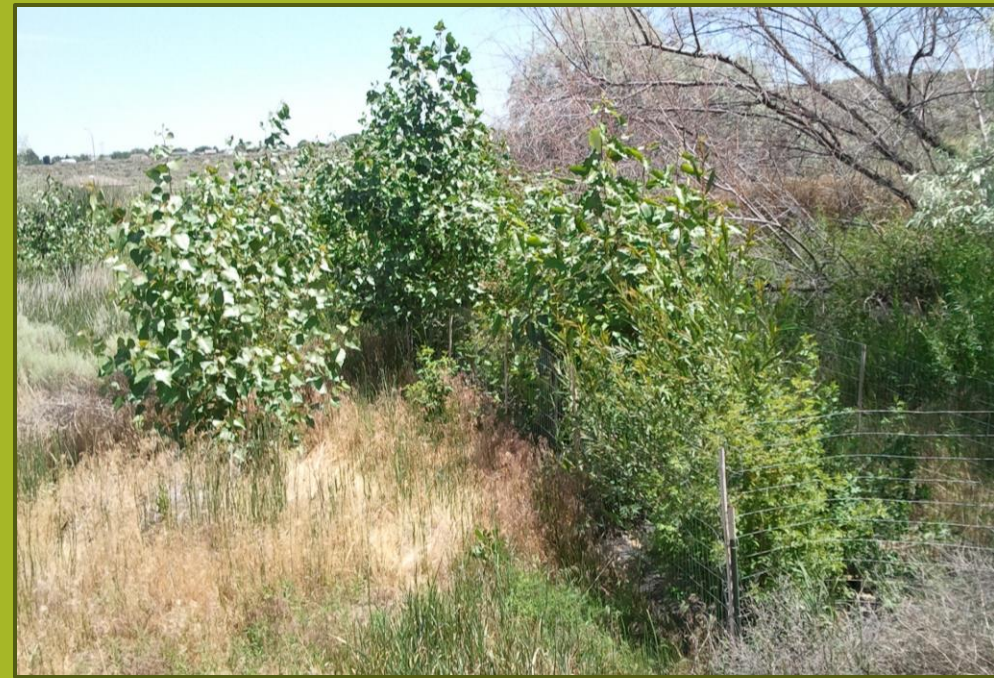
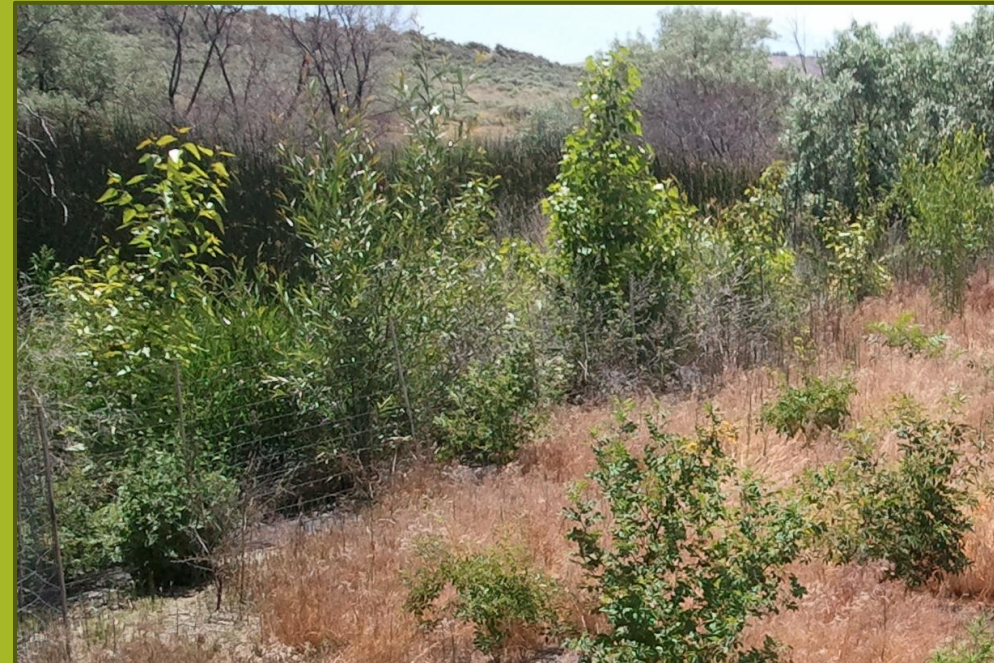
Field Example: Amon Creek

- ▶ 2010 – 2011; City of Richland
- ▶ Riparian plants installed late 2010/early 2011
- ▶ Heavy beaver activity, 6000 linear feet of welded wire fencing installed for plant protection

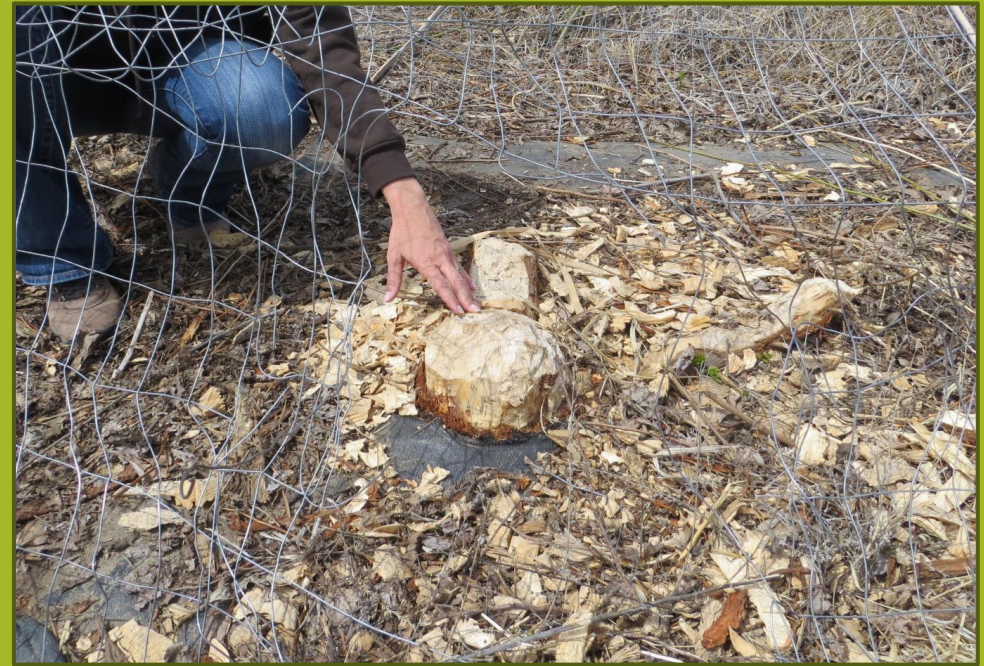
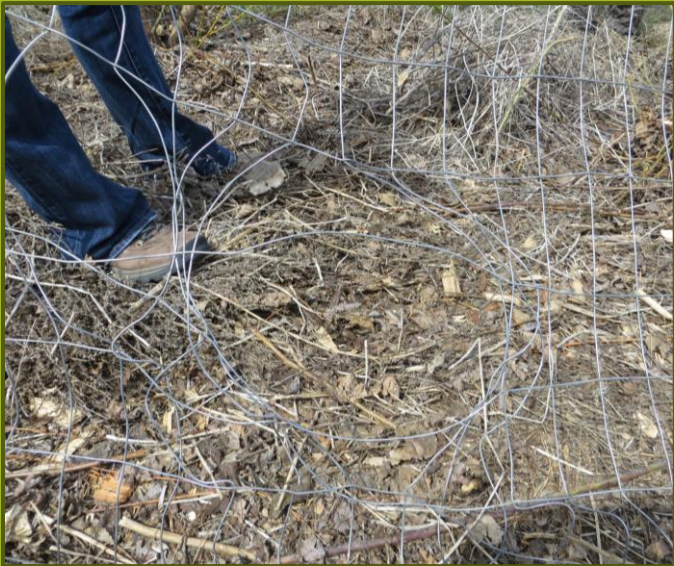
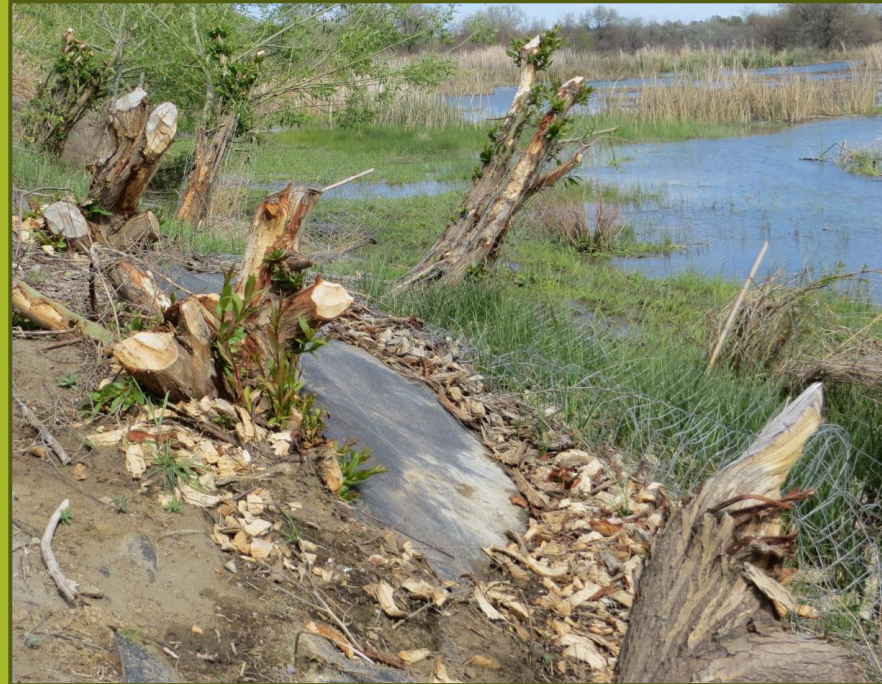
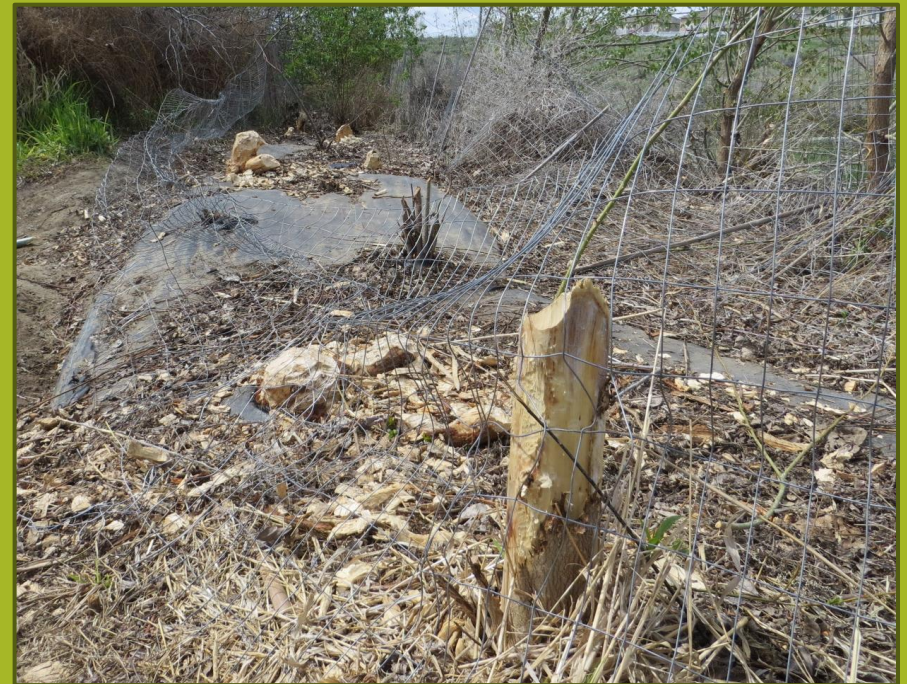
Field Example: Amon Creek

- ▶ Beaver destroyed enclosures and cages in 2014, damaged numerous cottonwoods; climbed fencing to access plants
- ▶ Beaver nicknamed Einstein due to ability to gain access to protected plants

Photos courtesy of Tapteal Greenway, Richland WA (2014)

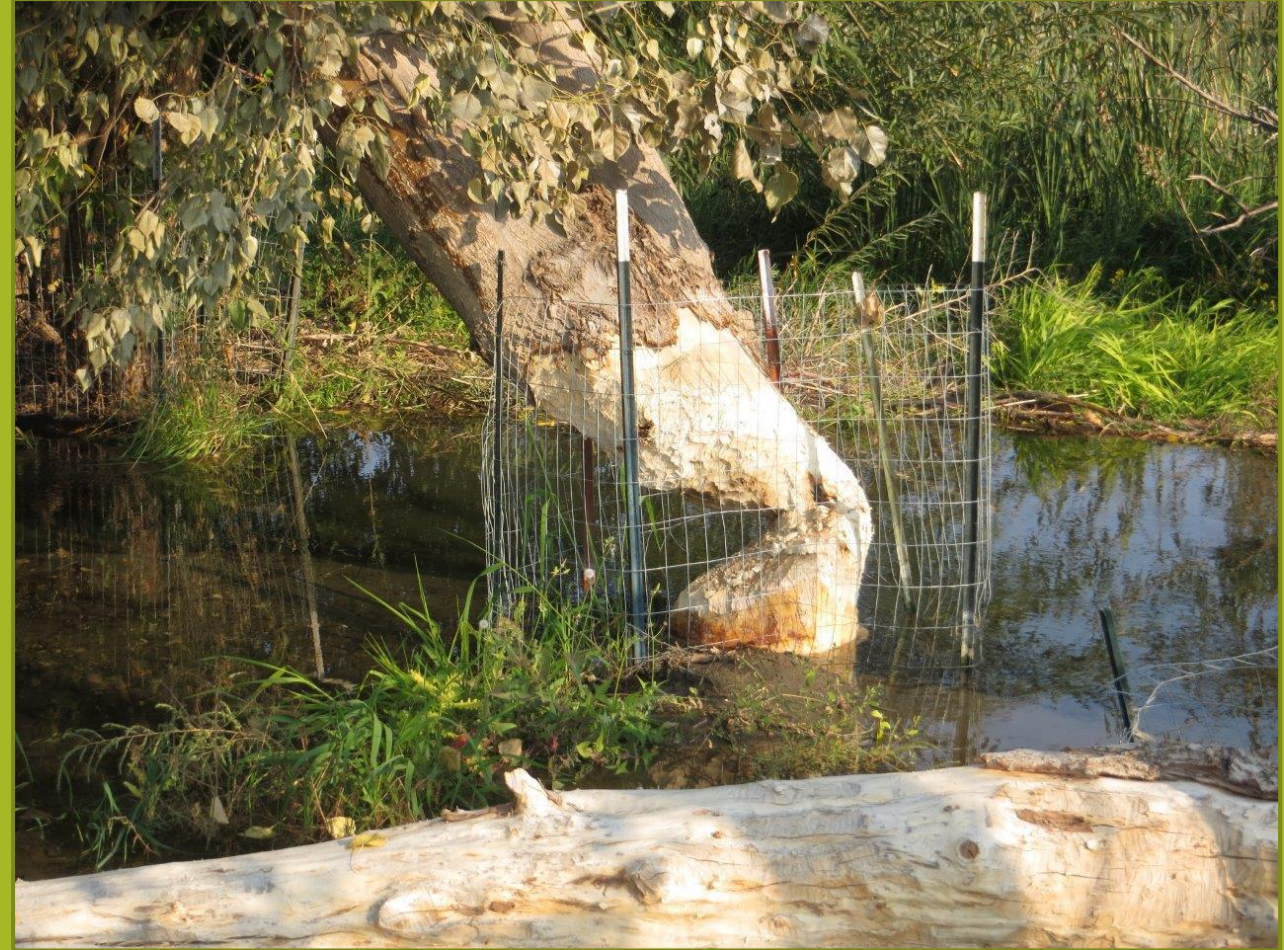
Field Example: Amon Creek

- ▶ Beaver damage in 2014 prompted Tapteal Greenway to repair/replace fencing around surviving cottonwoods
- ▶ Repair/replacement of fencing worked until Amon Creek migrated in 2020 and began flowing around protected cottonwoods
- ▶ Soil erosion around the base of plants undercut fencing and allowed beaver to dig/burrow under fences and begin damaging trees again

Photo courtesy of Tapteal Greenway, Richland WA (2020)

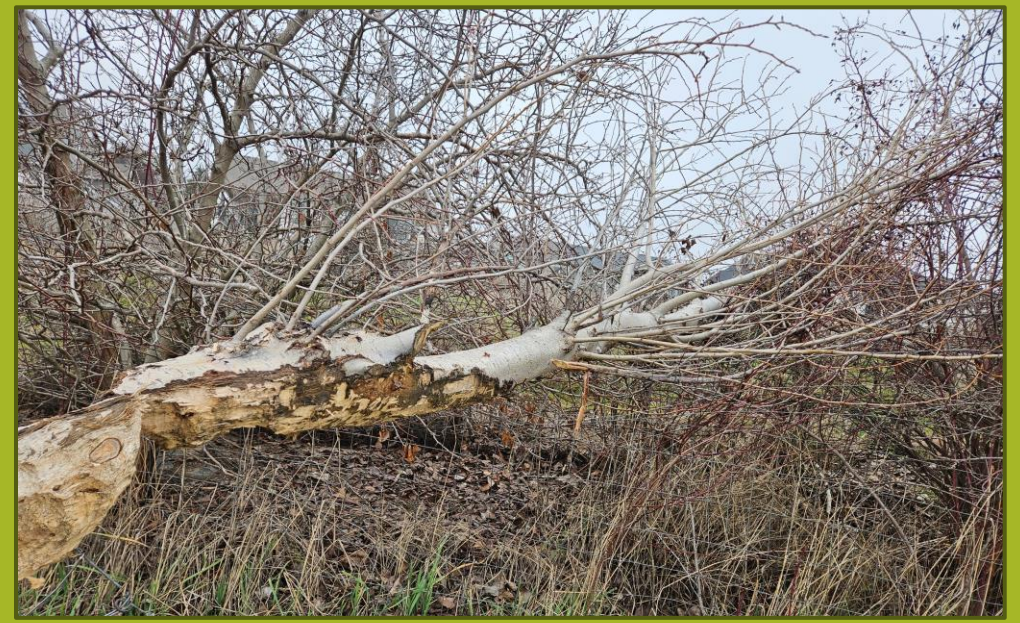
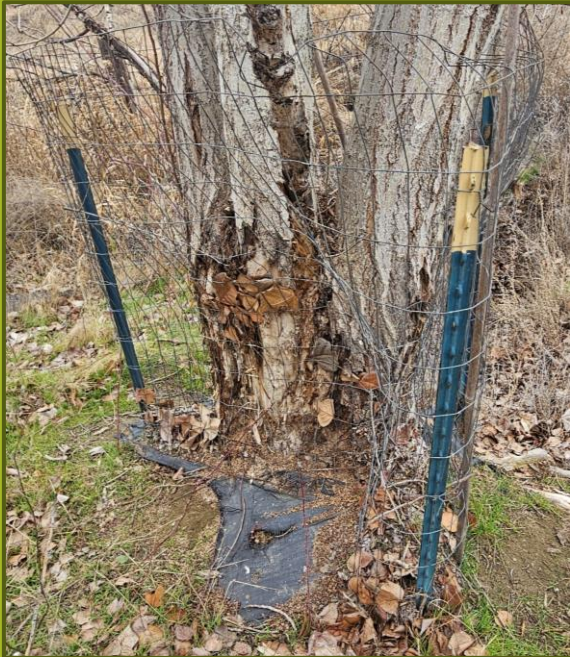
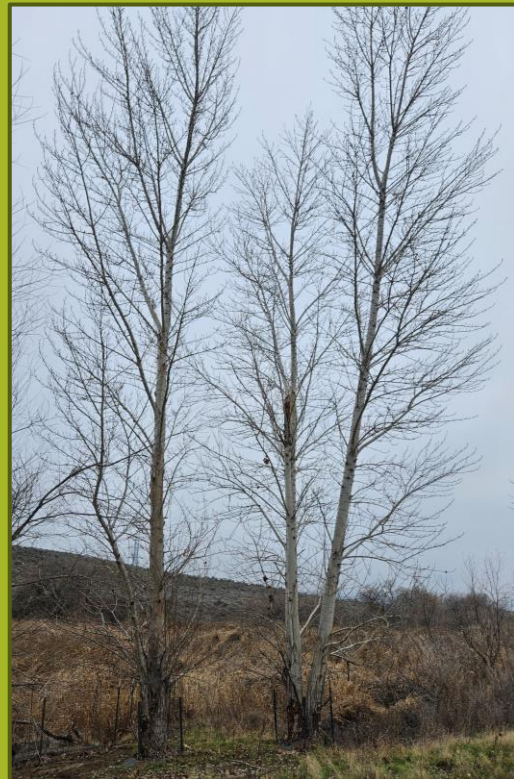
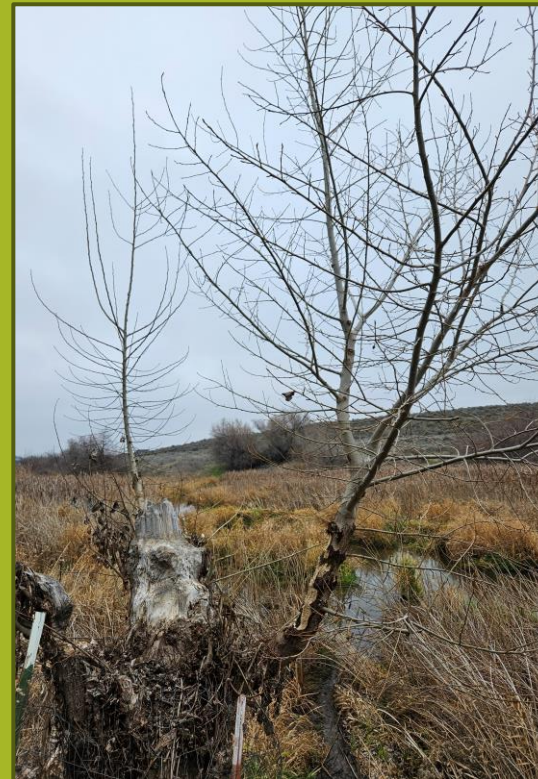
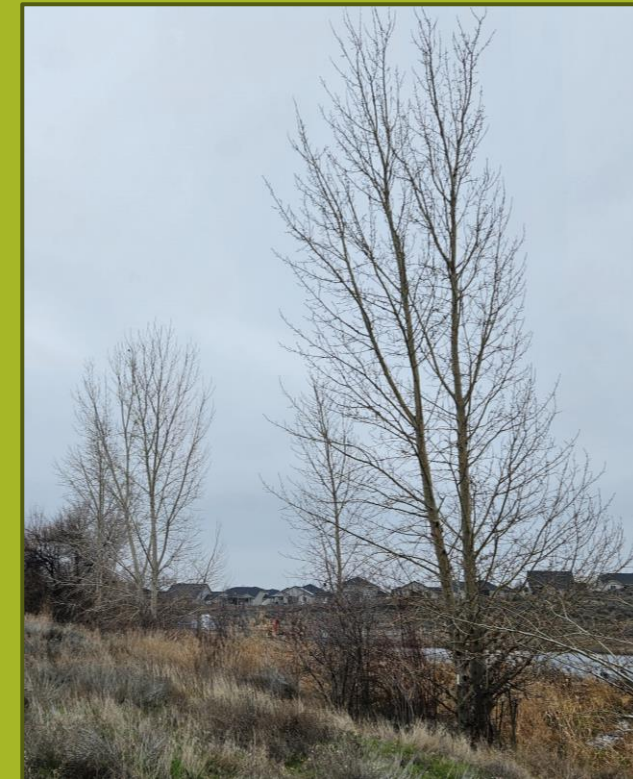
Field Example: Amon Creek

- ▶ 252 cottonwoods installed across 0.5-mile-long restoration area in 2010/2011
 - ▶ 10 alive as of 2/4/2026 (~4% of what was originally planted, even with beaver protection)
 - ▶ Beaver still active, fresh damage seen 2/4/2026

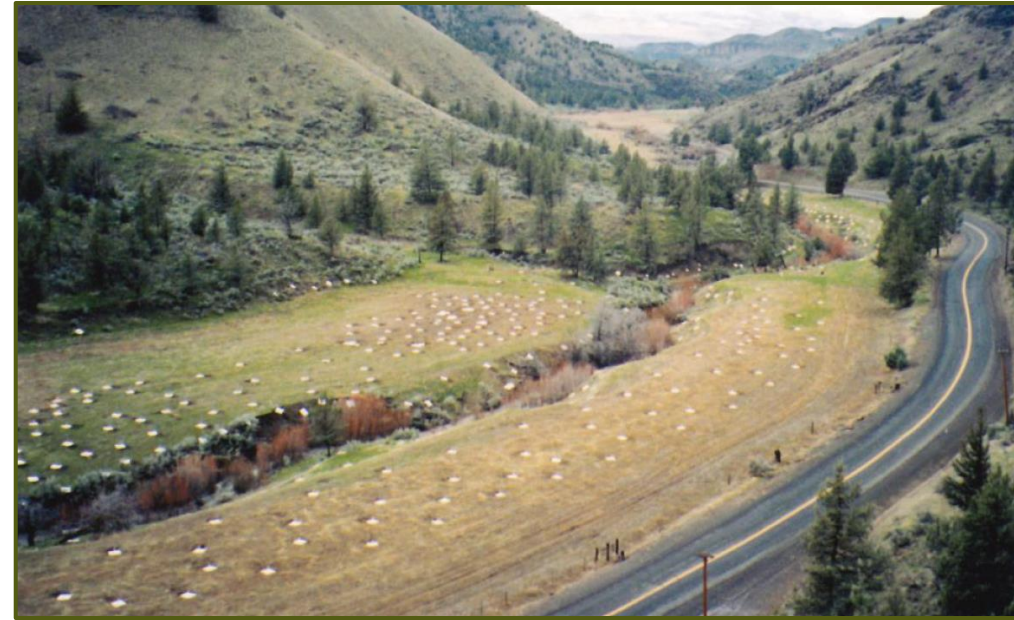
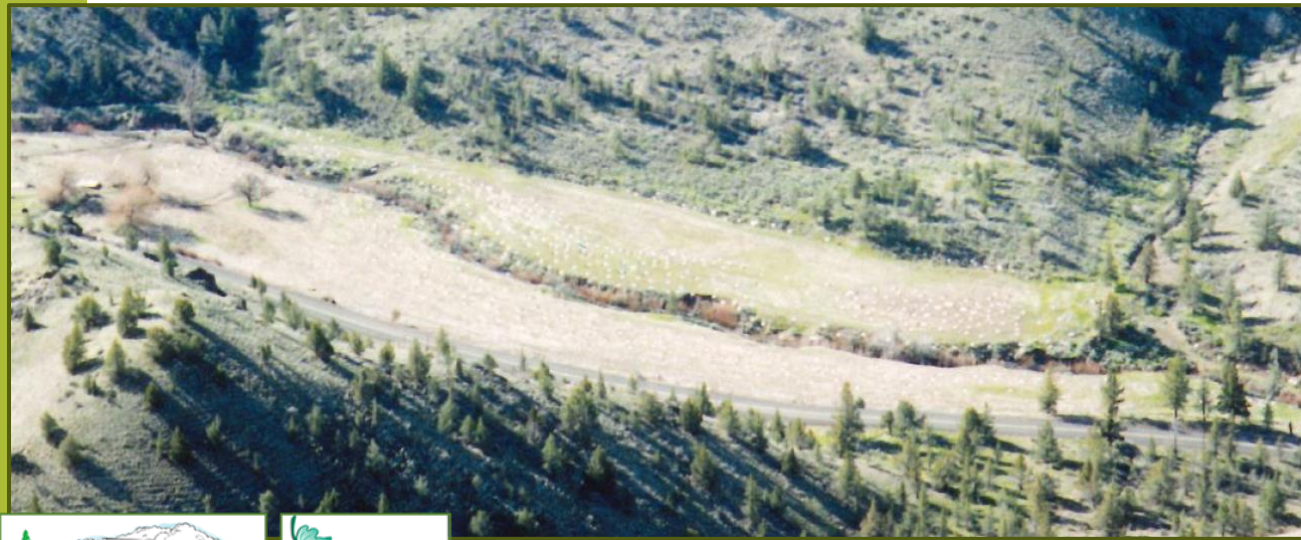
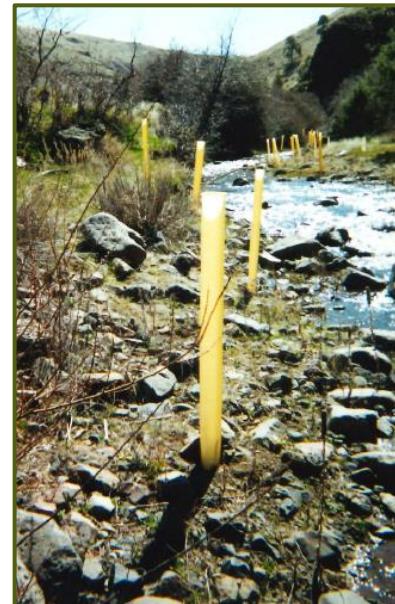
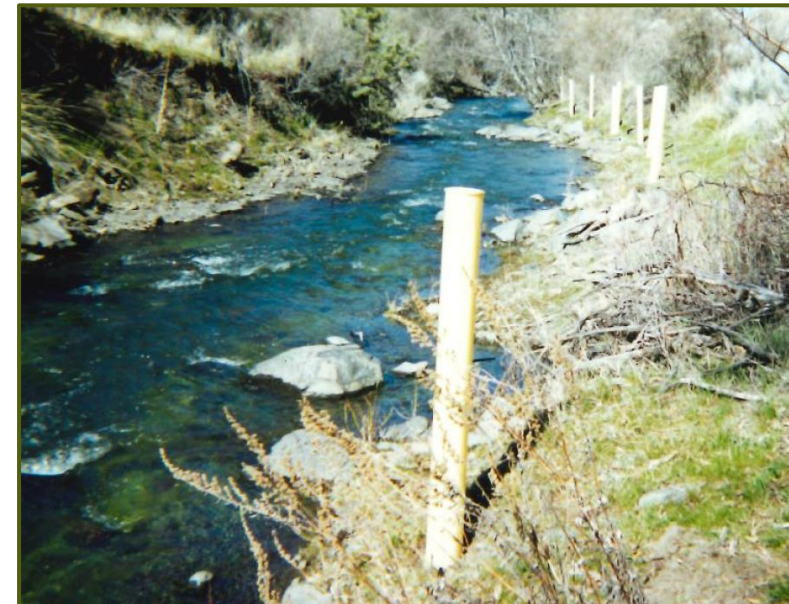
Field Example: Pine Creek Conservation Area

- ▶ 2002 – 2004; Confederated Tribes of the Warm Springs Reservation of Oregon
- ▶ 5-mile long CREP Project on Pine Creek Conservation Area
 - ▶ Highly incised channel
- ▶ Cottonwoods protected with solid wall tubes
