Where in the
heck did all the
Cottonwoods go?
I know we
planted them...

Ryan Watts

Project Manager, WildLands, Inc.
Nursery Manager, WildLands Nursery

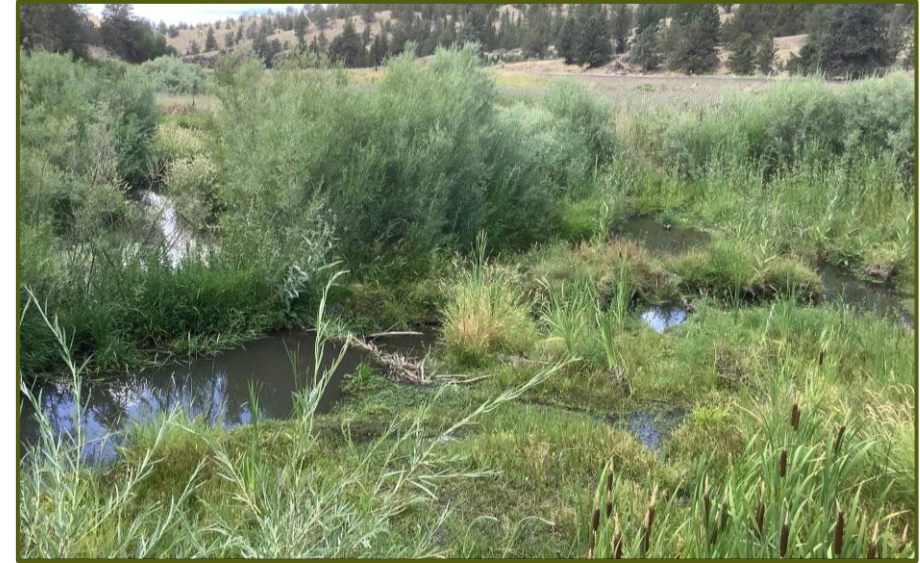
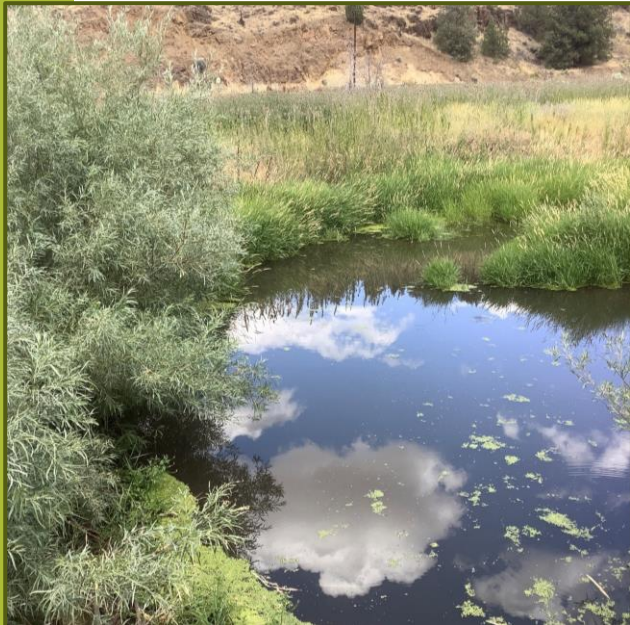
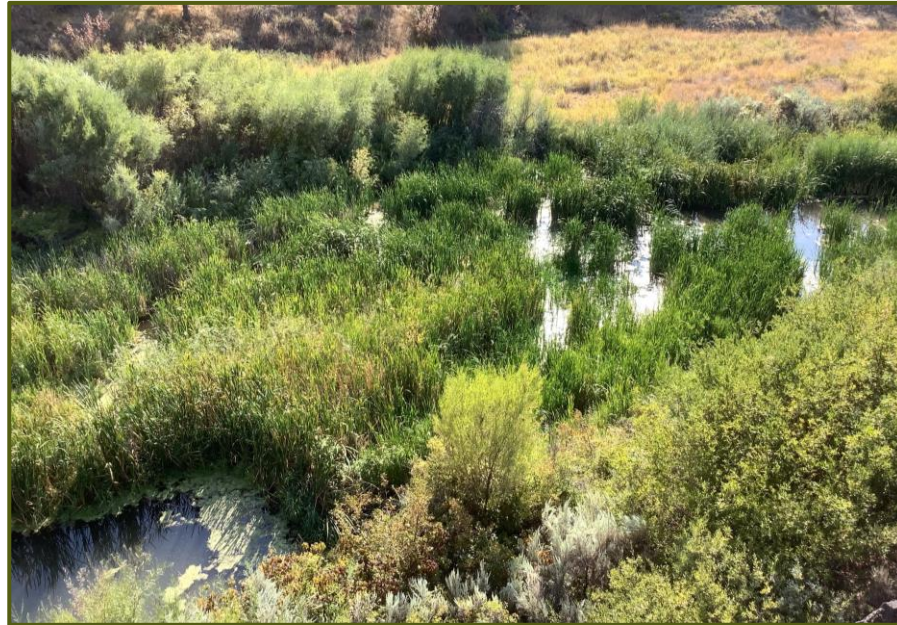
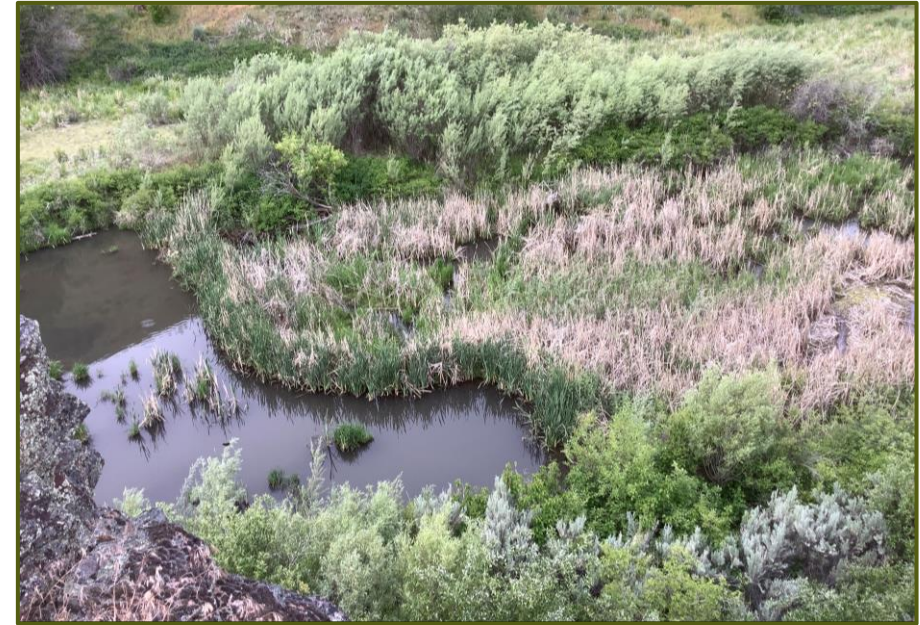
Field Example: Pine Creek Conservation Area

- ▶ 2000 total cottonwood cuttings installed in 2002 along 5 miles of Pine Creek
 - ▶ Heavy beaver predation; Only ~100 cottonwoods remain within entire 5-mile stretch
- ▶ Riparian ecosystem and function has improved, but with very few large trees for shade – mostly coyote willow

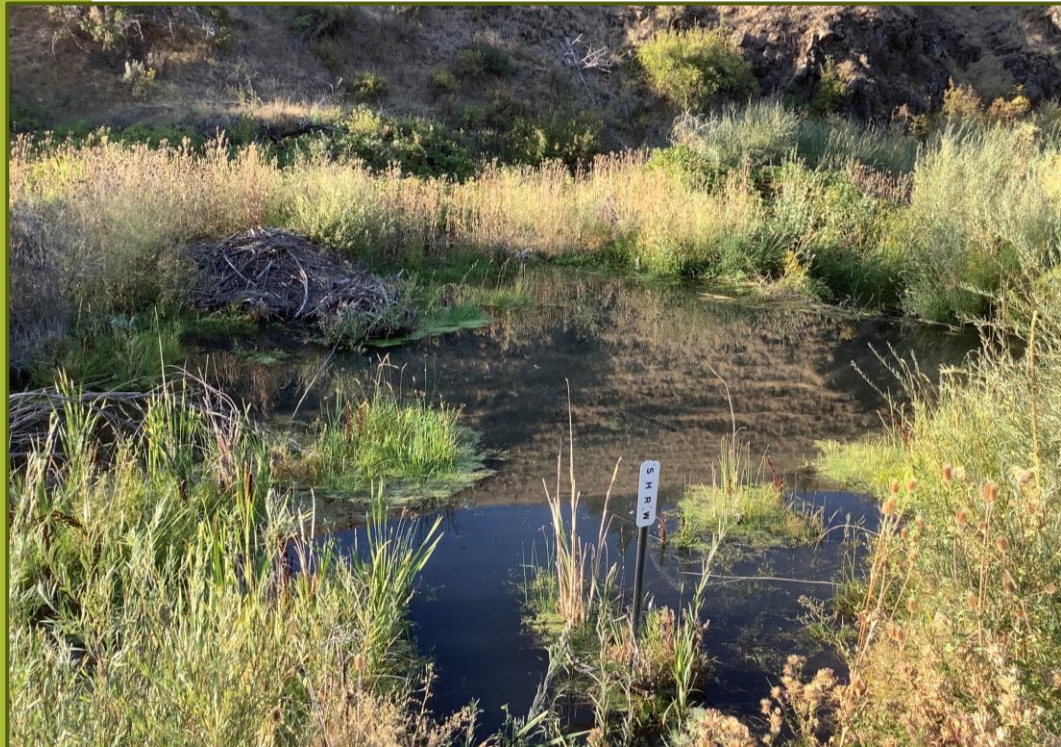
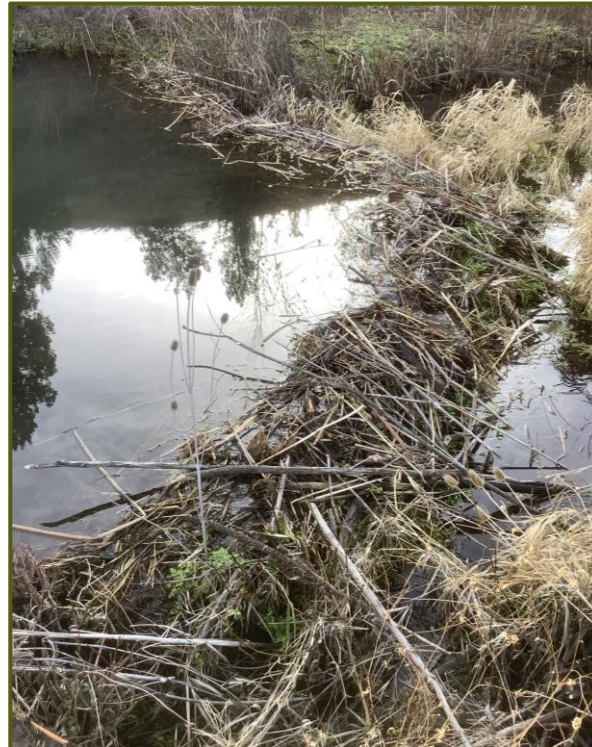
Field Example: Pine Creek Conservation Area

- ▶ CTWS has conducted beaver surveys along 9-mile stretch of Pine Creek over past 3 years, beaver expanding up and down the creek
 - ▶ 2023: 60-80 active dams with 9 active complexes
 - ▶ 2025: 165 dams total, 117 active dams and 11 active complexes
