YAKIMA BASIN
FISH AND WILDLIFE
RECOVERY BOARD

Geomorphic Assessment of the Little Naches River Mainstem

prepared for the Yakima basin Fish and Wildlife Recovery Board
by
WPD, LLC, May 2017

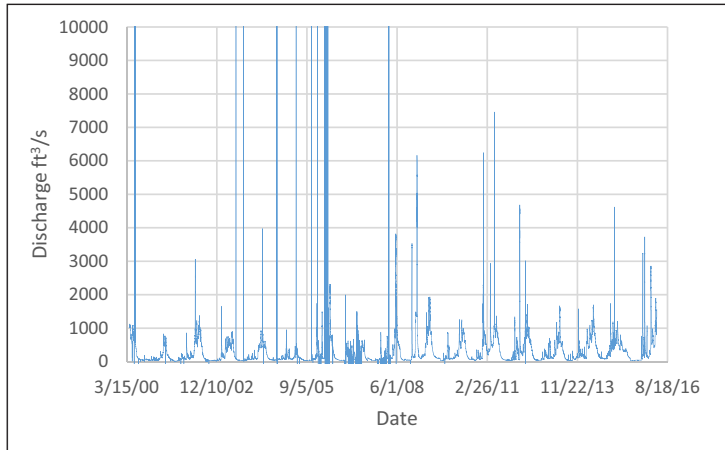
According to the USBOR’s 15-minute interval instantaneous discharge data (Figure 4A), the highest discharge between the dates of April 20, 2000 and April 21, 2016 is 2,043,563 cfs. This is greater than typical flood stage discharge of the Mississippi River, and obviously erroneous. There are at least a dozen other peak discharges exceeding 100,000 cfs reported in the dataset for the period of record. This is a clear indication of malfunction by the gage at high discharge.

Figure 4A. Instantaneous 15-minute interval discharge of the Little Naches gage, for the period of record.

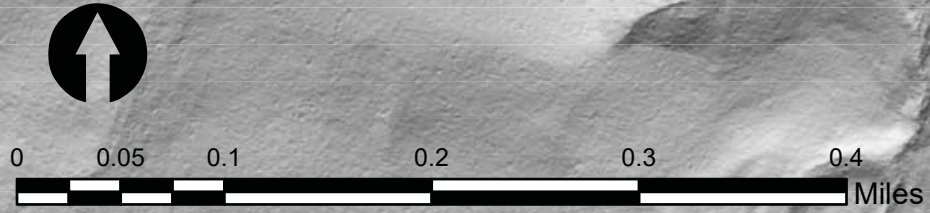
Figure 5A. Map of 2016 Little Naches River avulsion into Fawn Creek channel, and 1900 Road shoulder scour.

scoured channel (threat to 1900 Road)

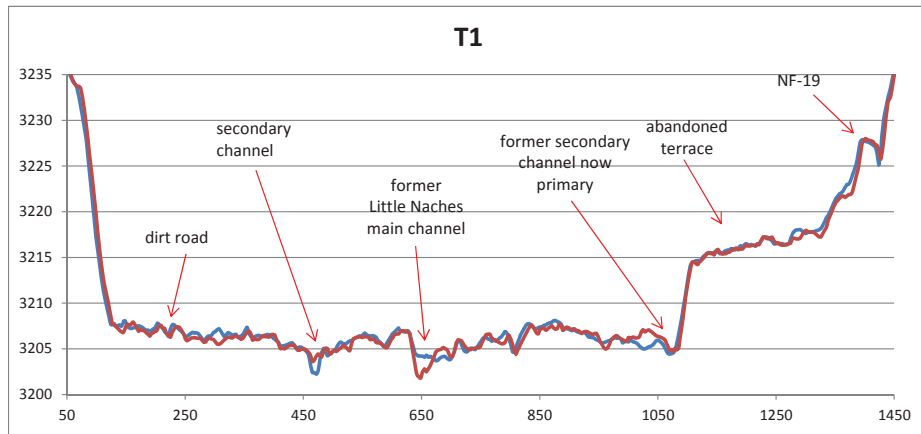
Figure 5D. Transect 1 in Reach 1, upstream of the new Fawn Creek confluence.

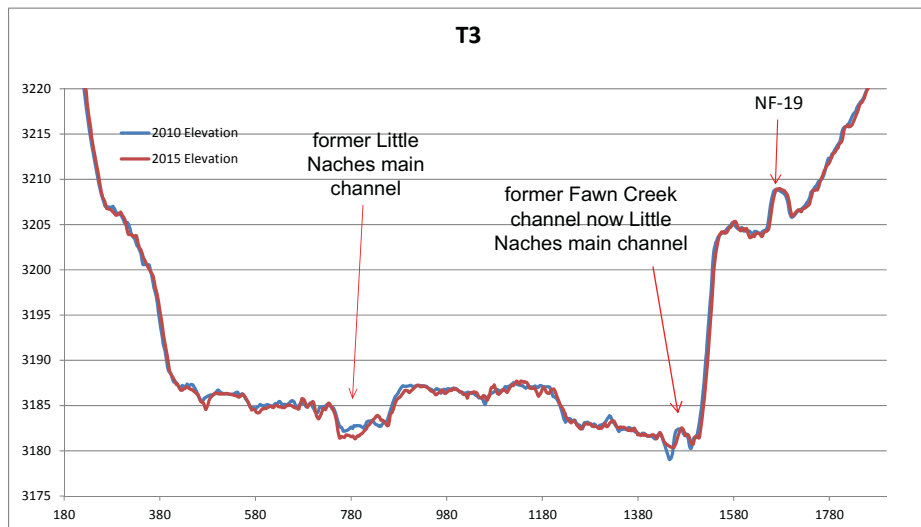
Figure 5E. Transect 3 in Reach 2, downstream of the new Fawn Creek confluence.

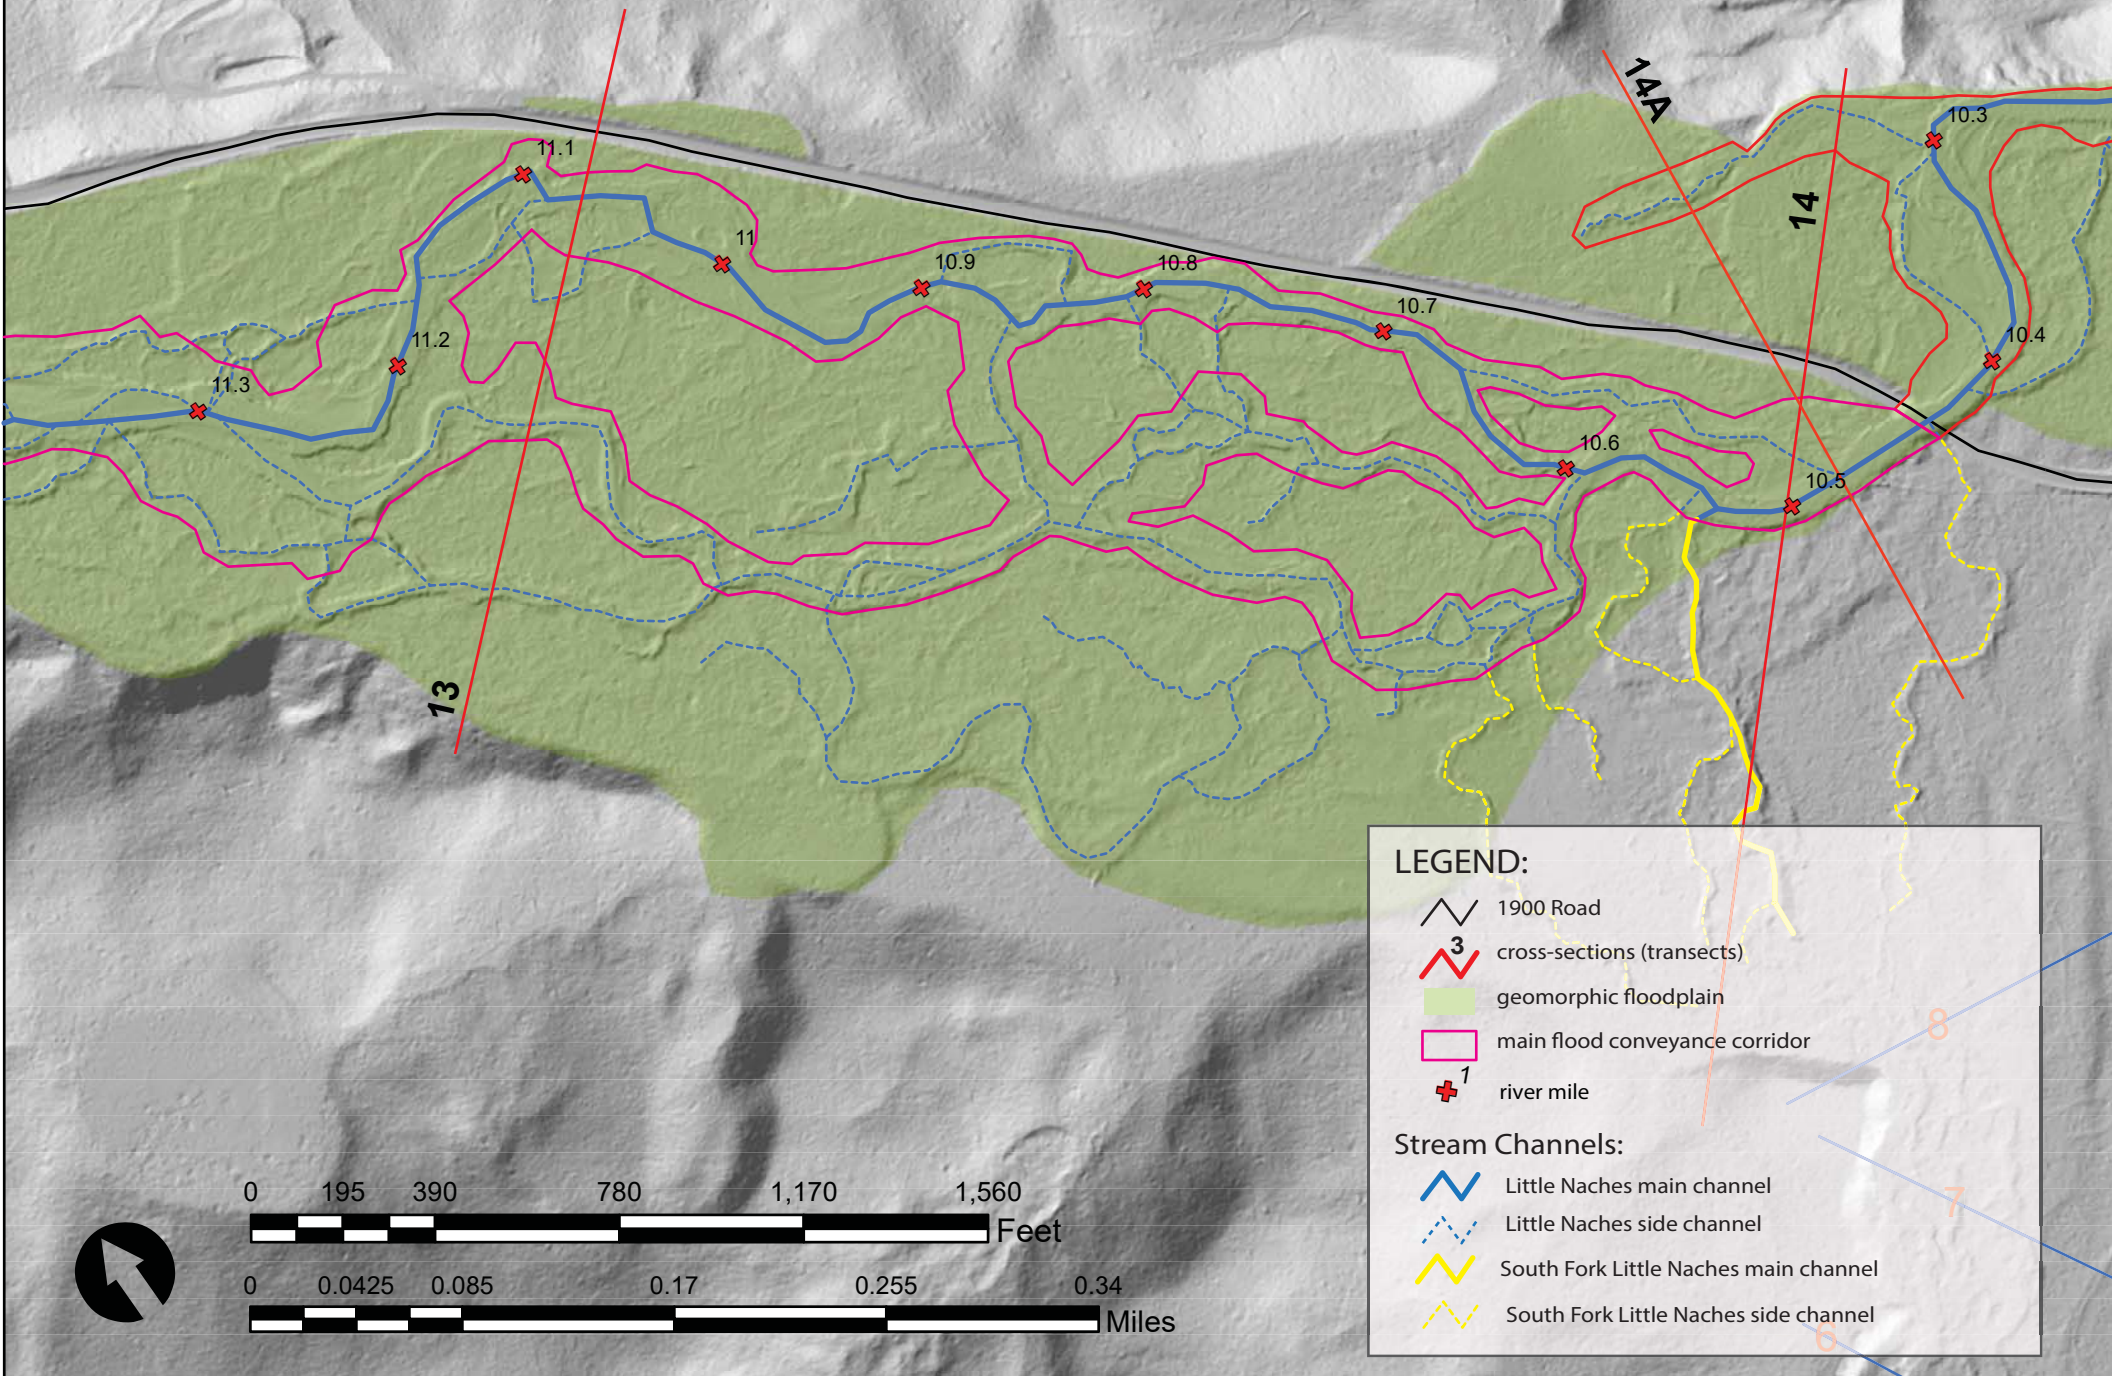
Figure 6A. Map of the confluence of the mainstem Little Naches River and South Fork Little Naches River. A split channel has persisted for decades in the reach upstream of the confluence.

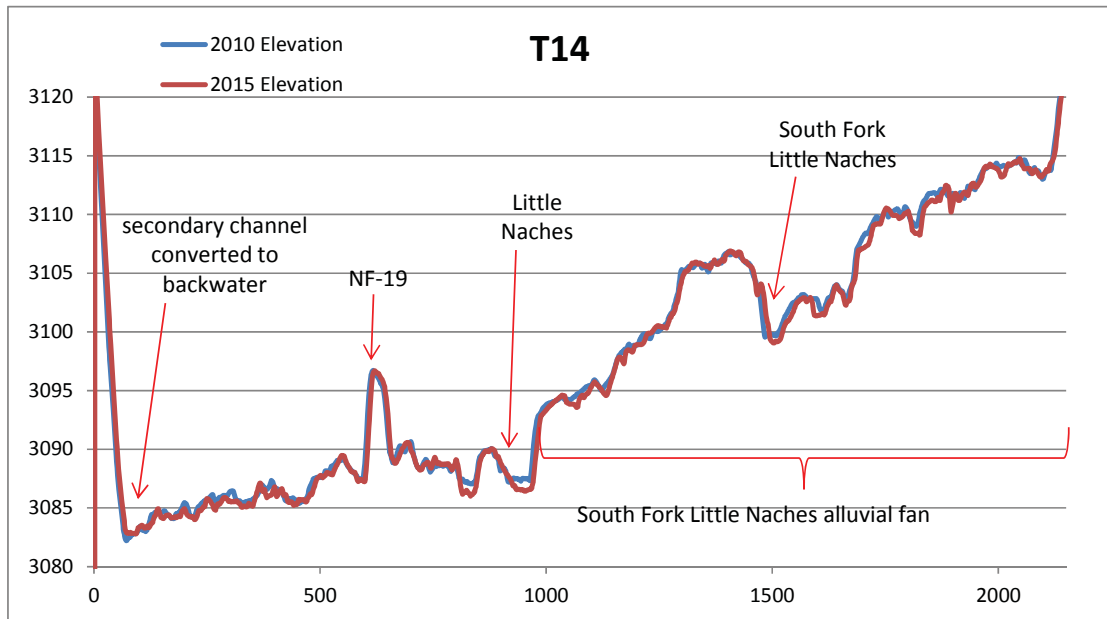
Figure 6C. Transect 14, showing the prominent alluvial fan of South Fork Little Naches. The 1900 Road prism is also shown.

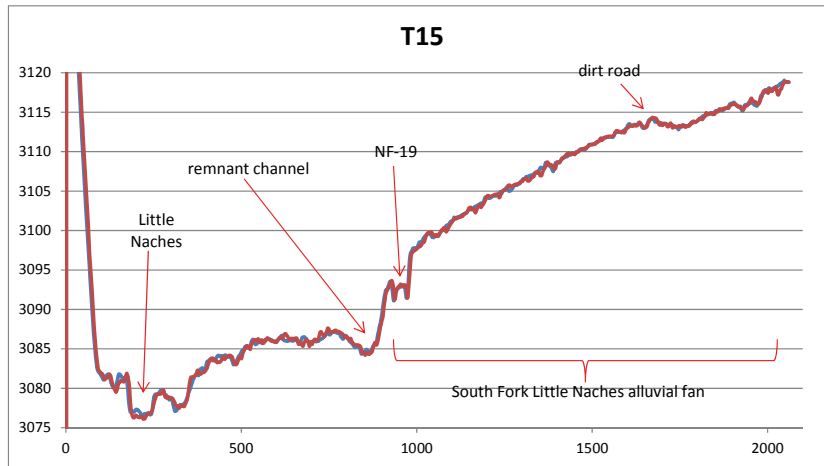
Figure 7C. Transect 15 in , shows the massive alluvial fan of S.F. Little Naches River, and the 1900 Road above the floodplain of mainstem Little Naches River.

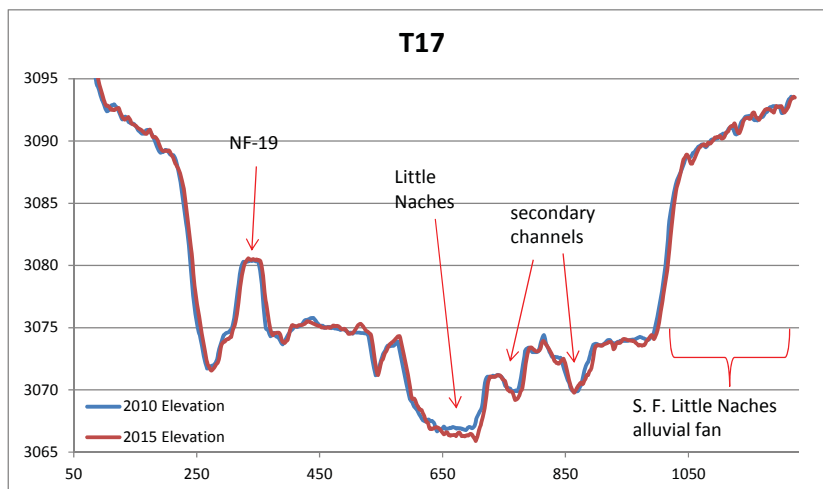
Figure 7D. Transect 17 shows the naturally narrow floodplain of the Little Naches River, and the 1900 Road prism.

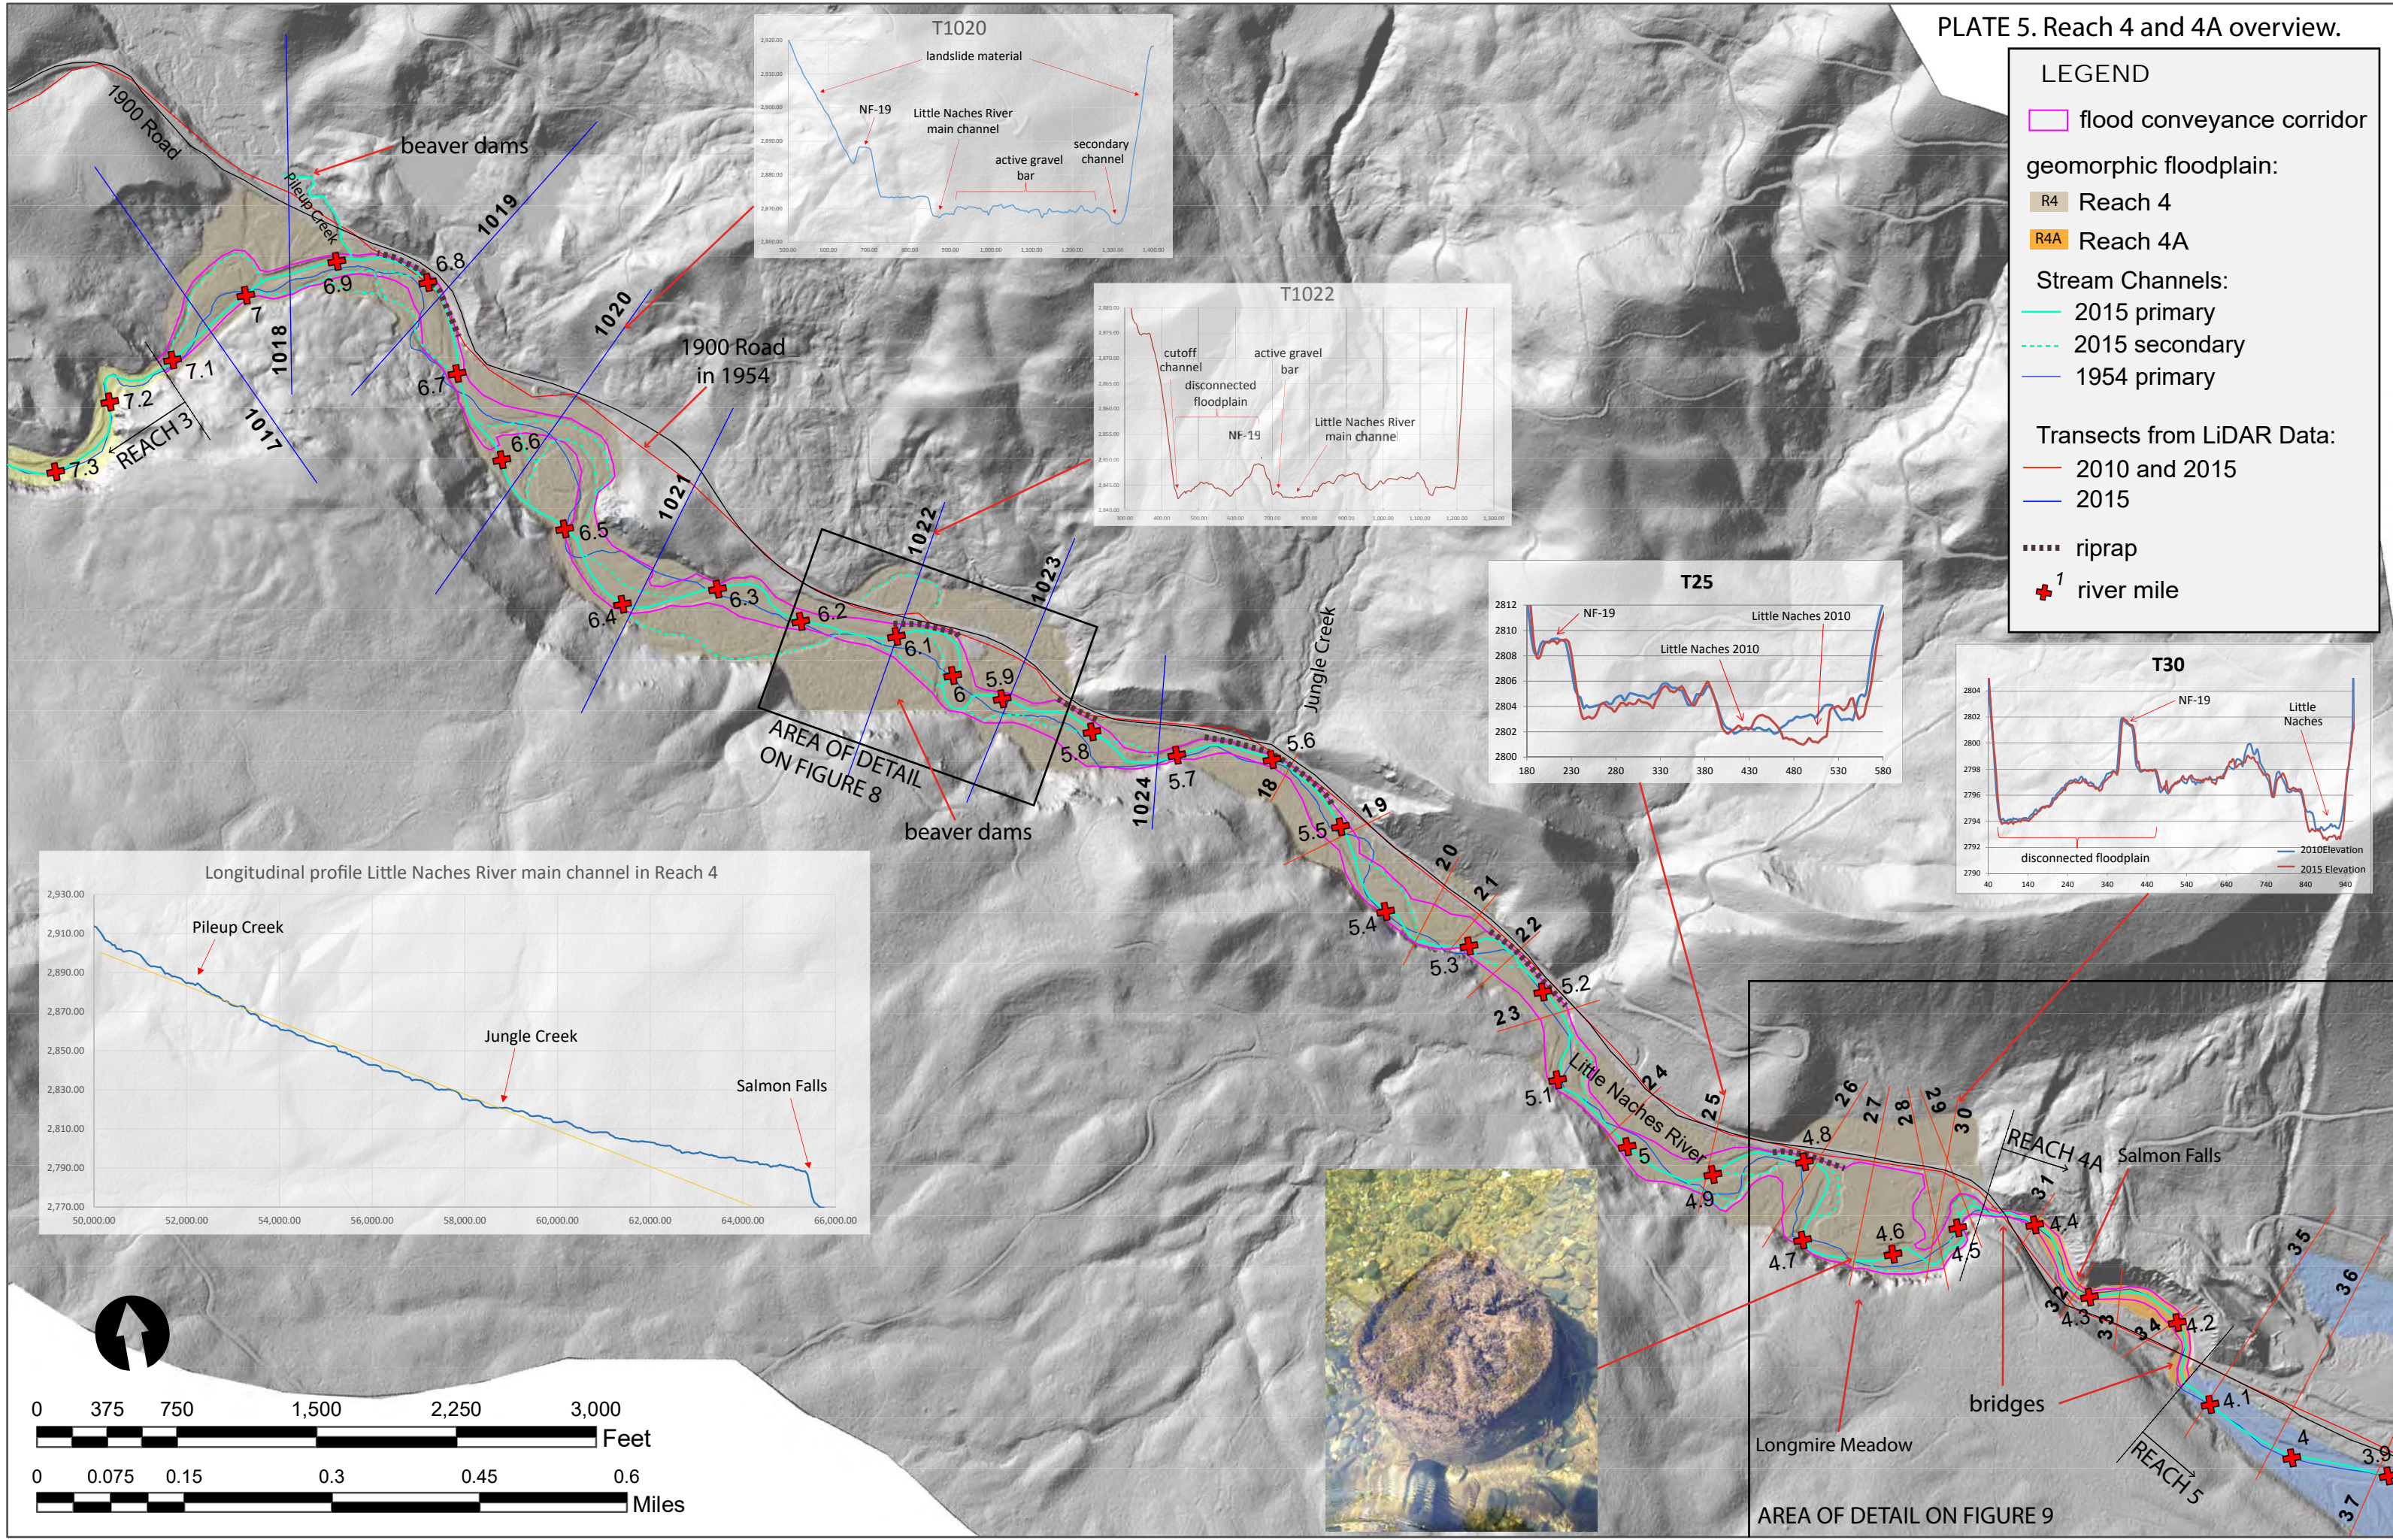
Figure 8A. Map of meander, cut off by the construction of the 1900 Road, on the mainstem of the Little Naches River. This is also the location of chronic threat to the road, requiring repeated shoulder repairs.

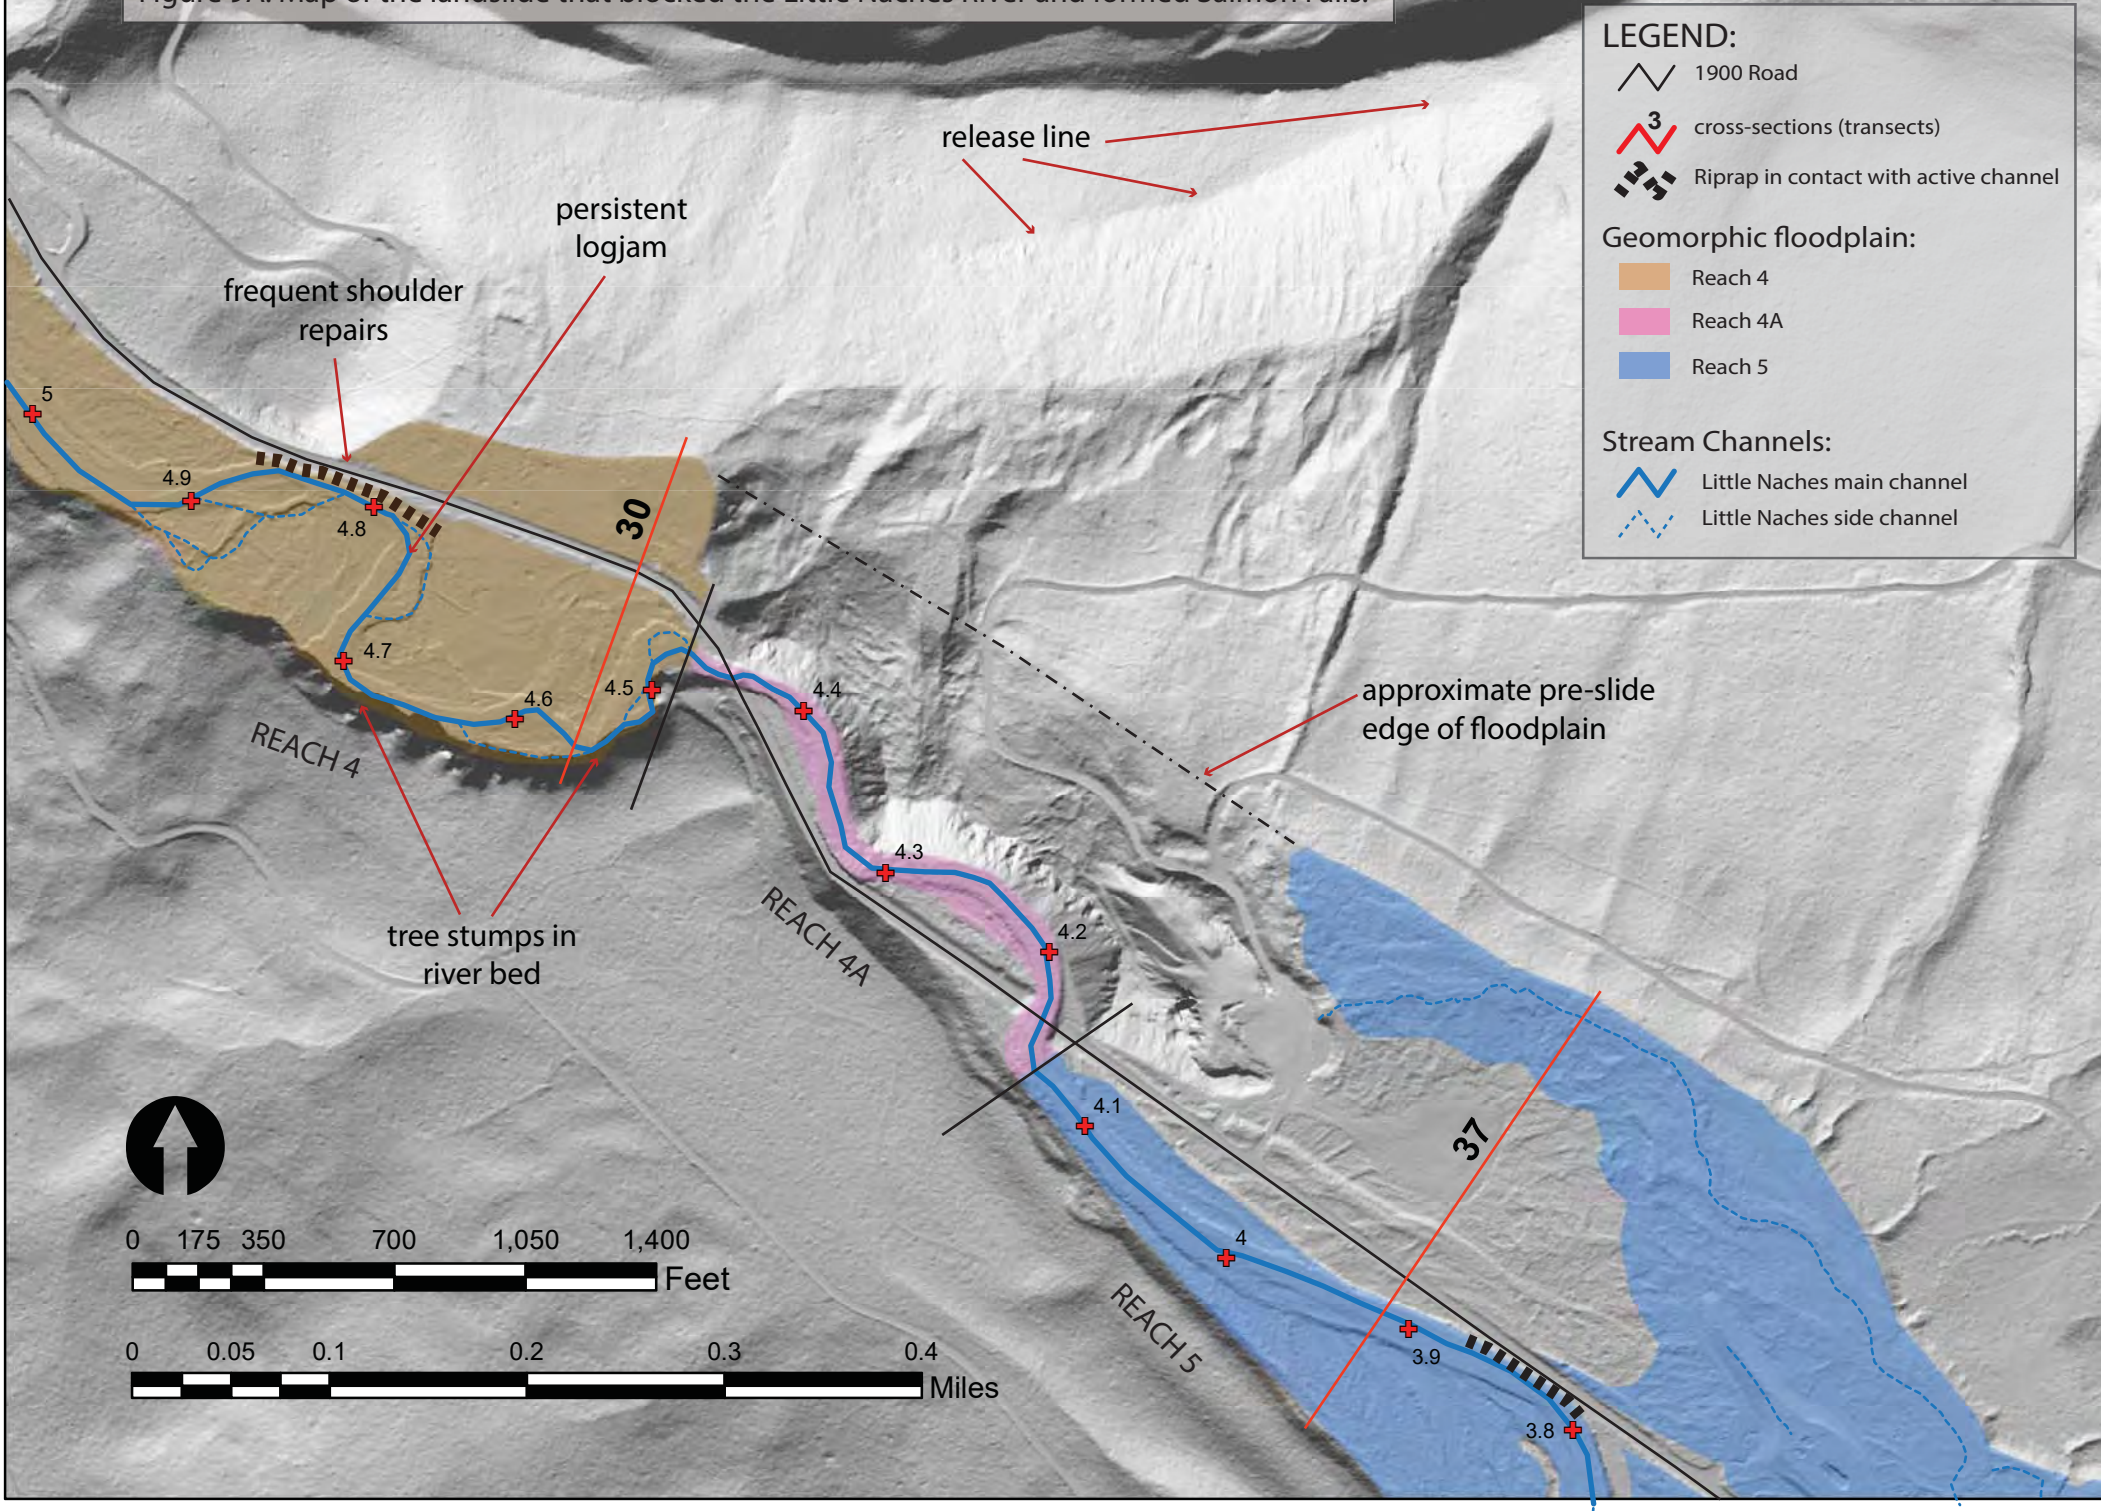
Reach 4A is the short steep reach where Salmon Falls lies (Plate 5). It was created by the young landslide that separates Longmire Meadow from the wide valley containing the excavated borrow pit/fish pond (Plate 1A and 5, Figures 9A-D). Prior to the movement of this landslide, the floodplain containing Longmire Meadow was likely part of Reach 5, and distinct from Reach 4 due to its wider floodplain. The backwater caused by the initial release of the slide likely extended upstream to the confluence of Jungle Creek, and possibly beyond, until enough time passed for the River to carve through the slide material and establish its current configuration. Reach 4A, along with Reach 3, is one of two erosional reaches in this study. These reaches were formed similarly, but are different in age and scale as the Salmon Falls landslide is smaller and younger. The 1900 Road crosses the Little Naches River twice in Reach 4A. These crossings are inherently unstable due to their position at the toe of a slide, but represent little-to-no geomorphic impact because they are at natural constrictions of the floodplain.

Figure 9B. Map of the landslide and formed Salmon Falls, overlying 9/1/1954 aerial imagery.

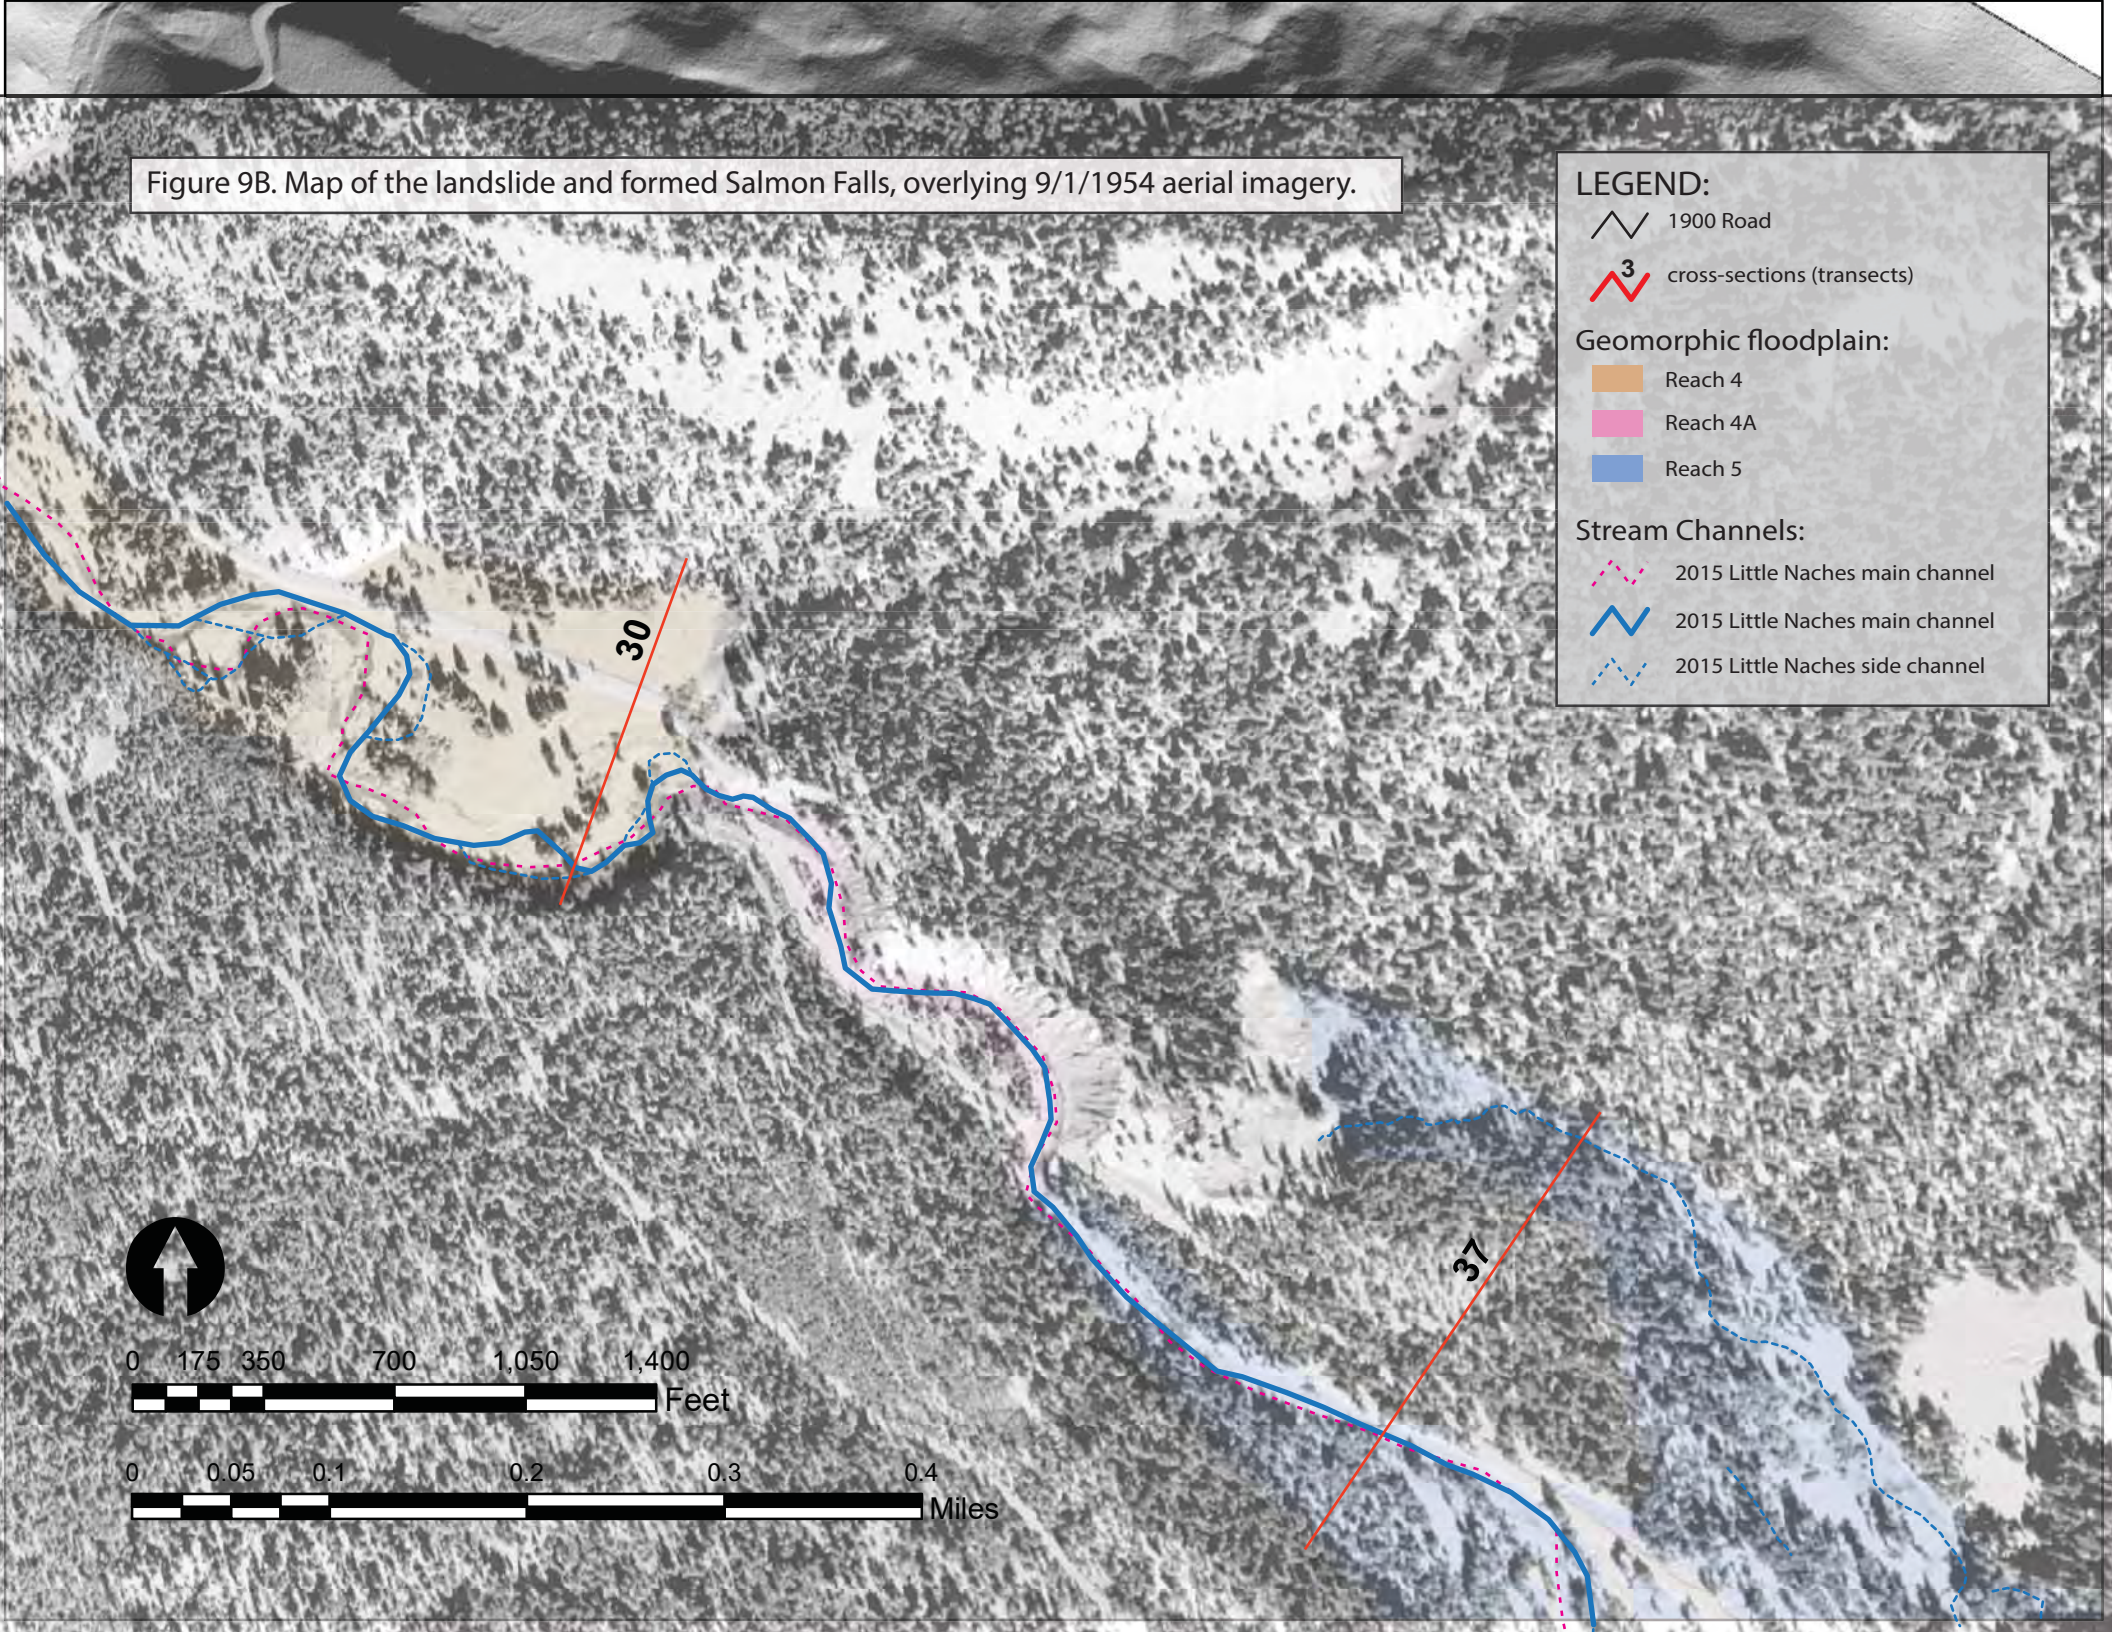
Figure 9C. Transect 30 in Longmire Meadow, shows the disconnected floodplain north of the 1900 Road.

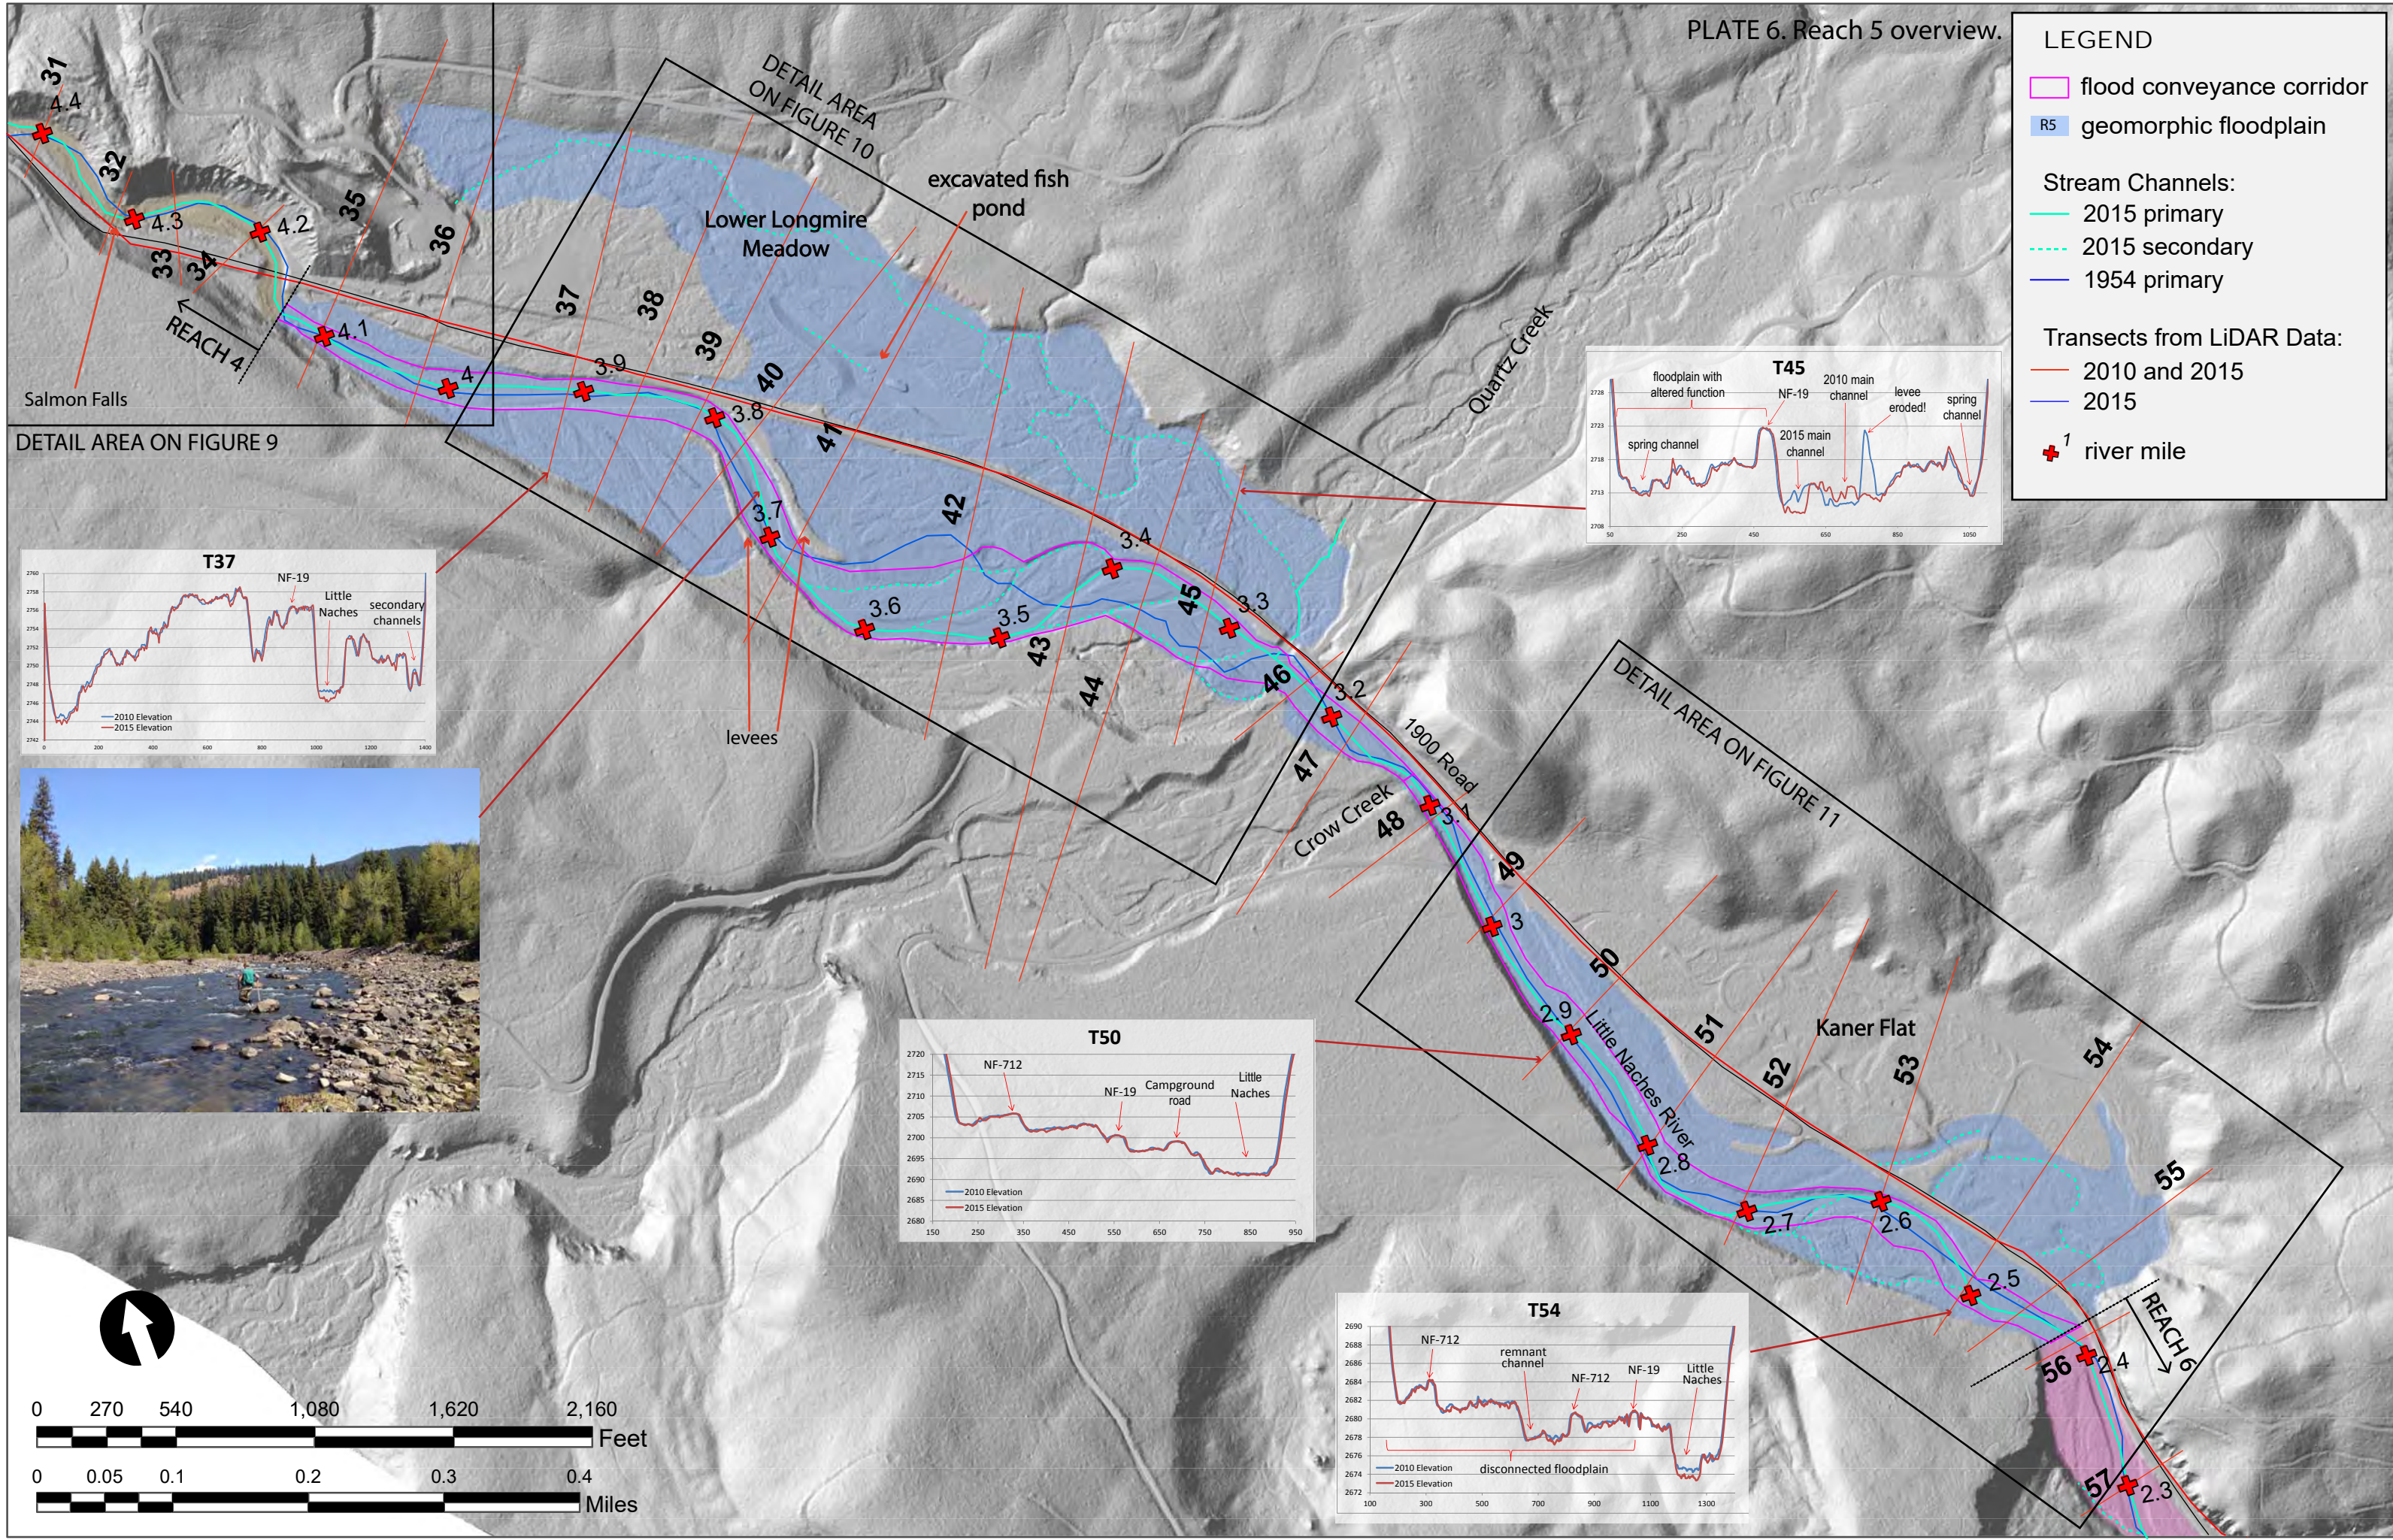
Reach 5 is the most heavily impacted by human activity. The construction of the 1900 Road altered the topography, as well as the hydrologic, geomorphic, and ecological function of this reach. The 1900 Road nearly bisects the floodplain of the Little Naches River in this reach (Figure 10A); 52.6 acres (45% of total acreage) of floodplain are disconnected from the River (Table 1A and 1B). As much as 1660 linear feet of secondary Little Naches channels are also disconnected from the River. The area north of the reworked slide deposits where the rock quarry is, would have been a very valuable backwater for rearing juvenile salmonids (Figure 10A-10D). Disconnection of the floodplain by the 1900 Road prism diminishes backwatering of this area, because floodwaters of the Little Naches can only access this area much farther downstream through the Quartz Creek bridge. This means the backwater pool is at a lower elevation and inundates a smaller portion of the upstream floodplain. The current alignment of the 1900 Road was established prior to 1954, but the levees and fish pond were constructed decades later (Figure 10B).

Figure 10A. Map of human-made topographic alterations between Salmon Falls and Kaner Flats.
