YAKIMA BASIN
FISH AND WILDLIFE
RECOVERY BOARD

Geomorphic Assessment of the Little Naches River Mainstem

prepared for the Yakima basin Fish and Wildlife Recovery Board
by
WPD, LLC, May 2017

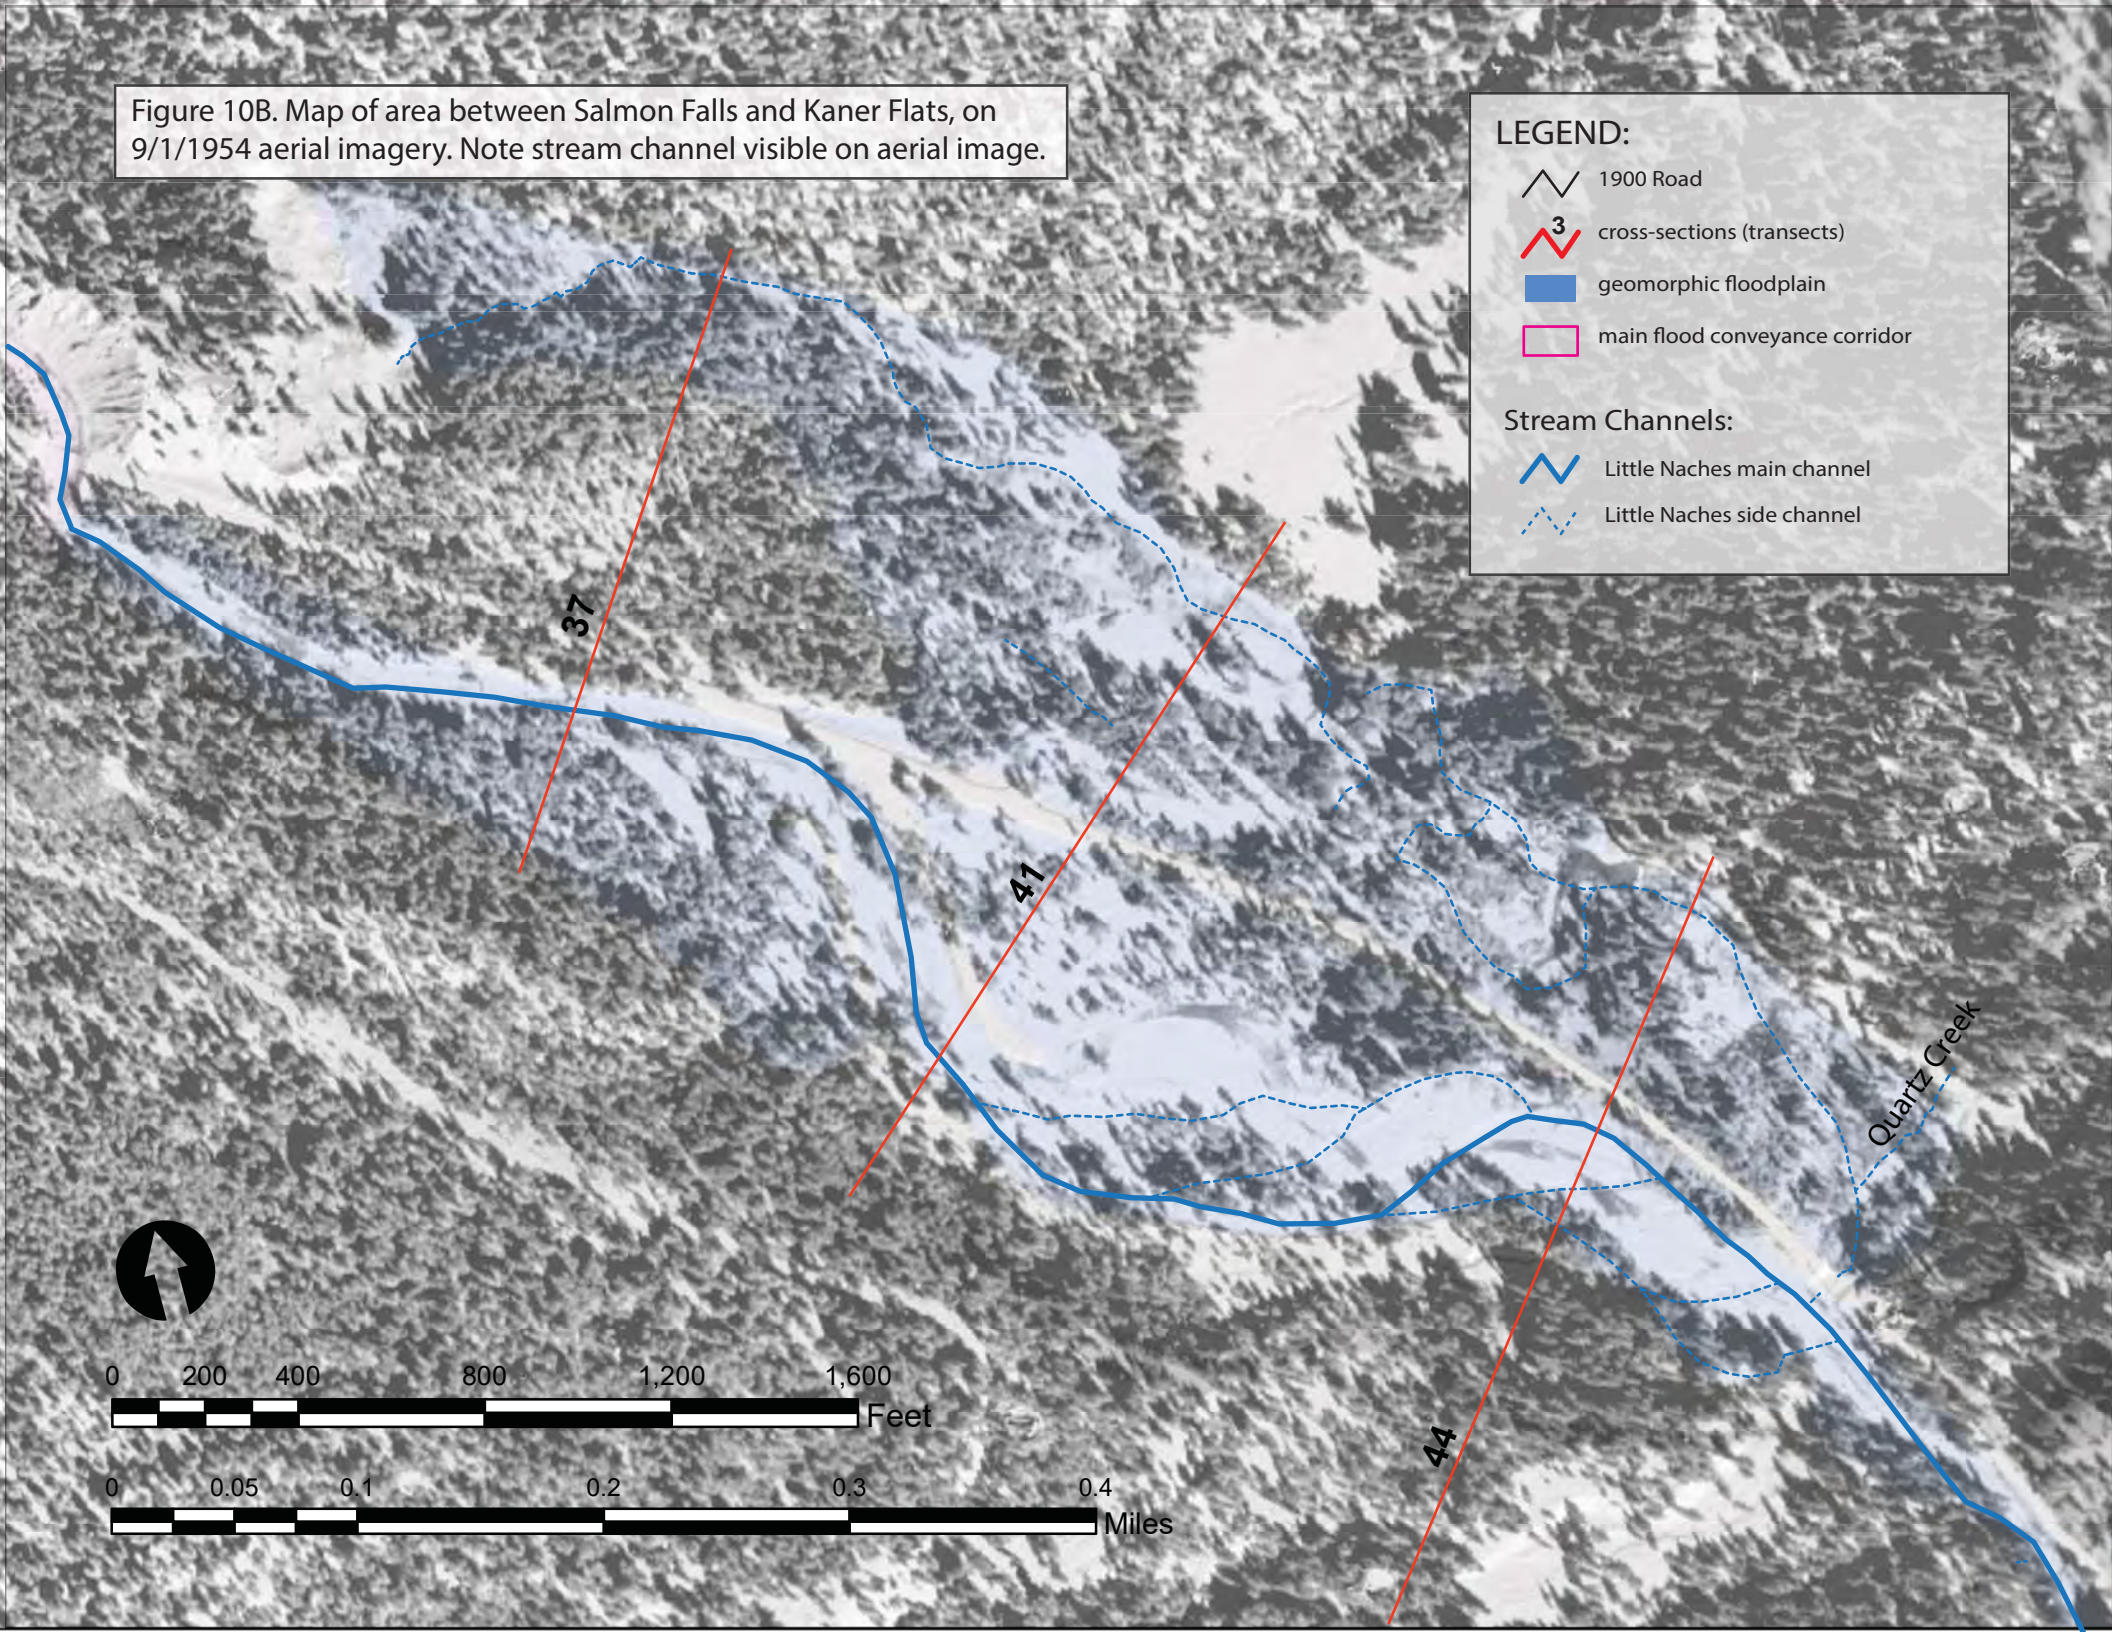
Reach 5 is the most heavily impacted by human activity. The construction of the 1900 Road altered the topography, as well as the hydrologic, geomorphic, and ecological function of this reach. The 1900 Road nearly bisects the floodplain of the Little Naches River in this reach (Figure 10A); 52.6 acres (45% of total acreage) of floodplain are disconnected from the River (Table 1A and 1B). As much as 1660 linear feet of secondary Little Naches channels are also disconnected from the River. The area north of the reworked slide deposits where the rock quarry is, would have been a very valuable backwater for rearing juvenile salmonids (Figure 10A-10D). Disconnection of the floodplain by the 1900 Road prism diminishes backwatering of this area, because floodwaters of the Little Naches can only access this area much farther downstream through the Quartz Creek bridge. This means the backwater pool is at a lower elevation and inundates a smaller portion of the upstream floodplain. The current alignment of the 1900 Road was established prior to 1954, but the levees and fish pond were constructed decades later (Figure 10B).

Figure 10B. Map of area between Salmon Falls and Kaner Flats, on 9/1/1954 aerial imagery. Note stream channel visible on aerial image.

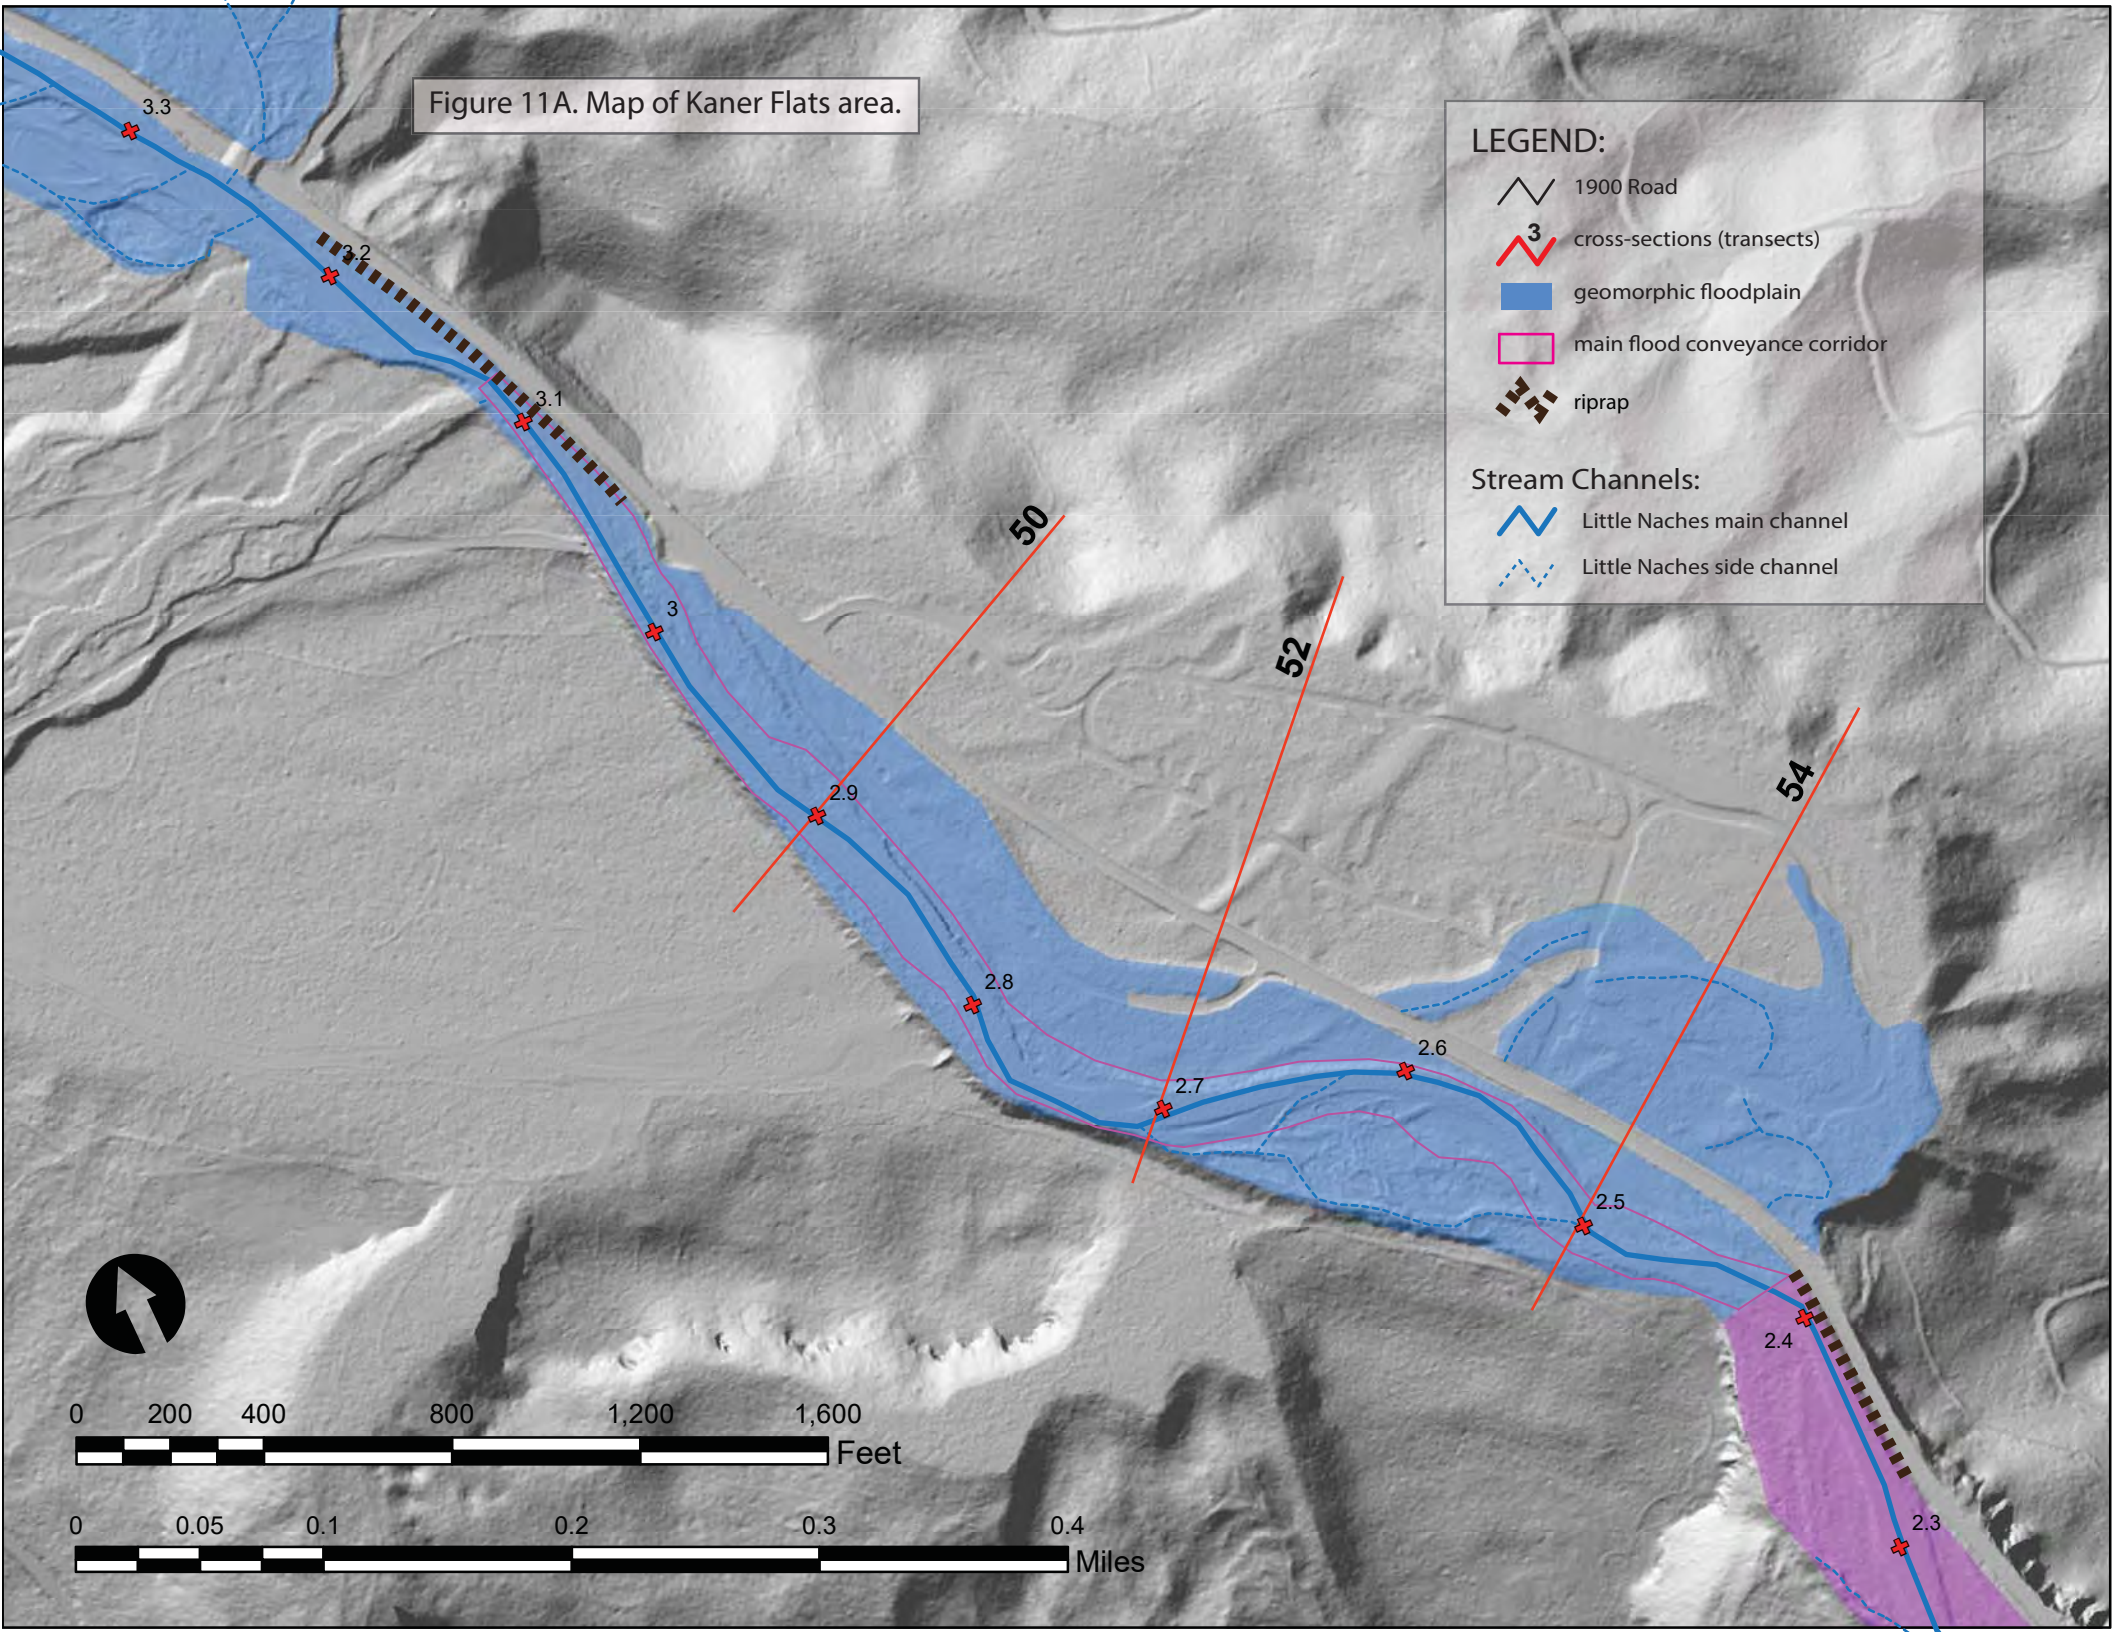
Other than separating a piece of floodplain, construction of the 1900 Road caused little other change to the course of the Little Naches River through Kaner Flats. The channel position of the Little Naches River in this vicinity is virtually unchanged since 1954 (Figure 11B).

Figure 11B. Map of Kaner Flats area overlying 9/24/1954 aerial imagery. Note the position of the 1900 Road and stream channel.
